Date: 20th May, 2011

GEOLOGICAL PRELIMINARY FIELD REPORT OF THE LORCA EARTHQUAKE (5.1 M_w , 11TH MAY 2011)

Translation from the original report in Spanish

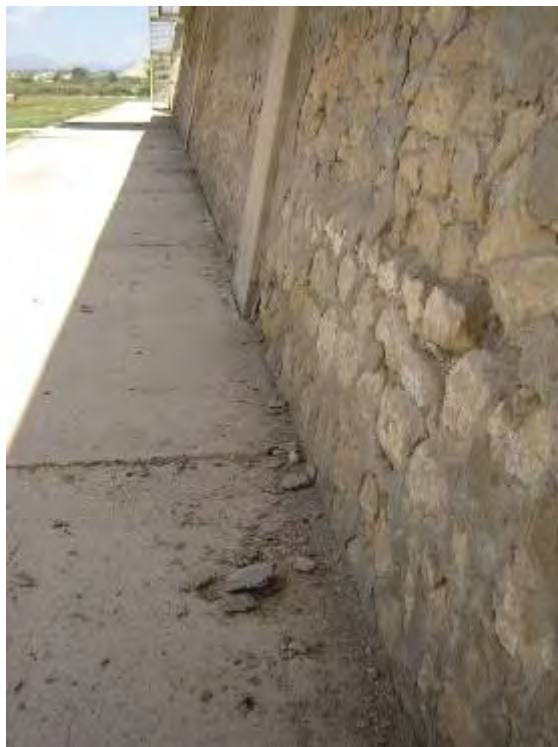
In the village of Lorca we walked along the Guadalentín river banks where the FAM crosses the river. In this area the river course is flanked by two masonry walls more than 6 m high and a concrete channel passing through the city (Fig. 3.1). The orientation of the walls is N113° E in the western section and N140° E in the eastern part. The walk was 600 m long on both margins and no evidences of ground breaking associated with fault displacement were found. The numerous cracks present on the walls do not show movements throughout the wall, and they do not have continuity in the bed of the valley. It is noteworthy that the north wall (Fig. 3.2) has more cracks and pill offs than the southern wall that is only affected by several cracks.

Figure 3.2. Northern Wall of the Guadalentín river valley.

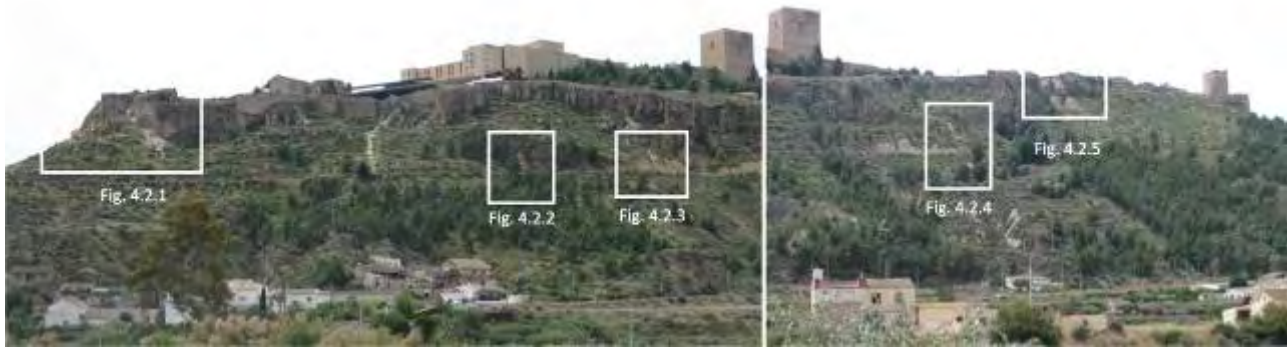
Figure 4.2.0: General view of the north slope of the Lorca's castle cliff. The most remarkable instabilities induced by the 11th May earthquake are identified.

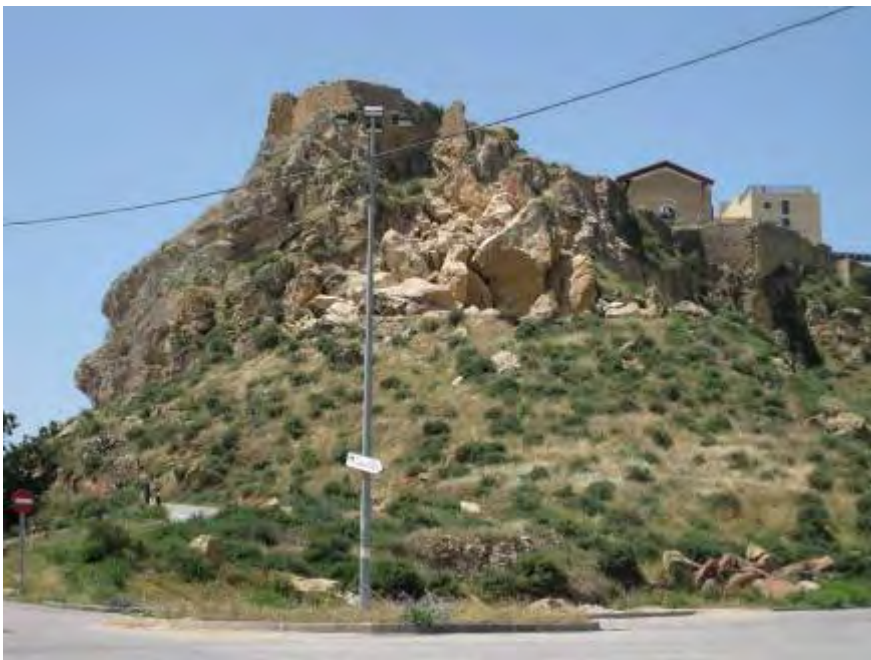
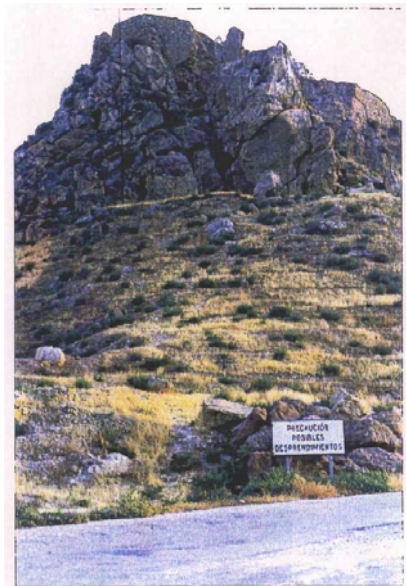
In particular, at the easternmost point of Lorca's Castle cliff, a fallen rock-block has destroyed part of the wall enclosing the patio of a house. Alike, on the road up-the-hill to the castle few rock-falls have badly damaged the pavement. A similar situation has taken place on the road to the Pantano de Puentes, which was temporarily closed to traffic. It is remarkable that on Friday 13th (aprox 24 h after the earthquake) both situations were already solved and driving was possible with relative normality.

Figure 4.2.1a: Partial collapse of the easternmost point of Lorca's castle cliff. A detached rock-block produced damage in a near house (see Fig. 4.2.1c). Picture on right corresponds to the same place few years back (taken from the IGME seismic hazard study of Lorca, 1992).

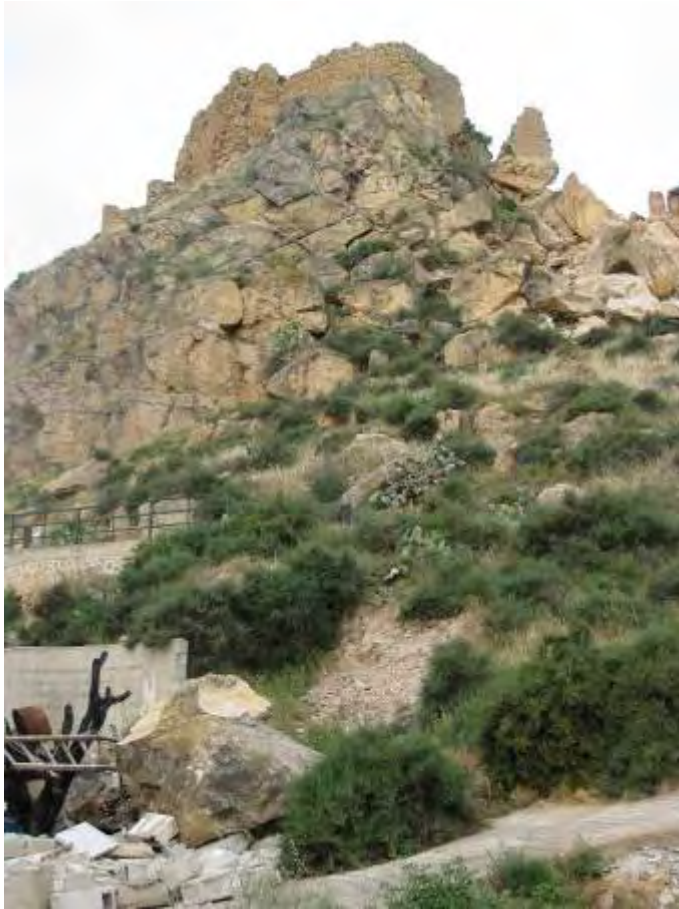
Figure 4.2.1b: View of south lateral of the easternmost point of the castle cliff and of the block that damaged a small wall of a house. The down-the-hill road pavement showed moderate damage at this point. It can be observed on the left the ending of the retaining wire mesh that stabilises the south face of the castle cliff.

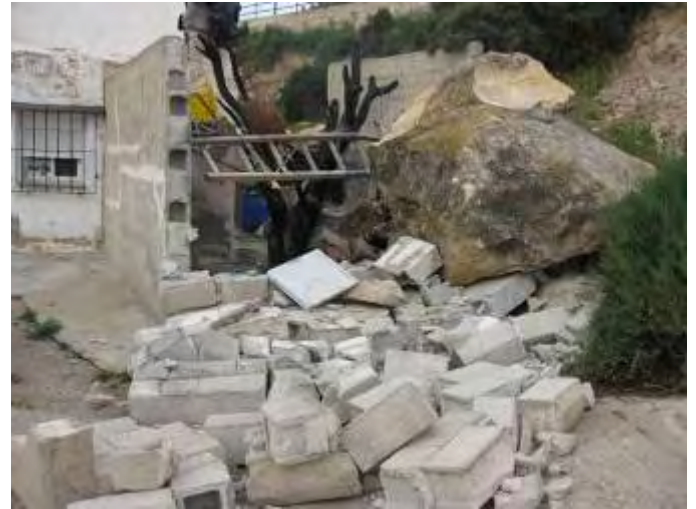
Figure 4.2.1c: Result of the impact on a wall made of concrete blocks enclosing the patio of a house from a rock detached form the easternmost pint of the cliff.

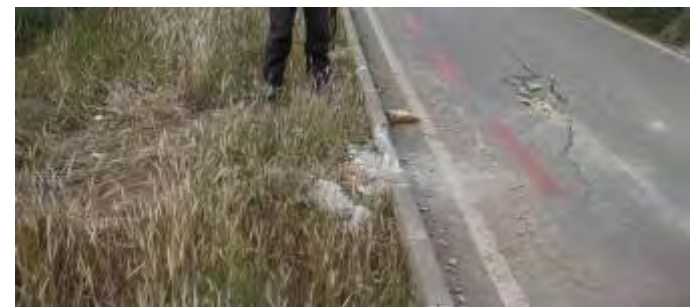
Figura 4.2.1d: Moderate damage on the down-the-hill road caused by the rebound of the block detached from the easternmost point of the cliff (figure 1.b).

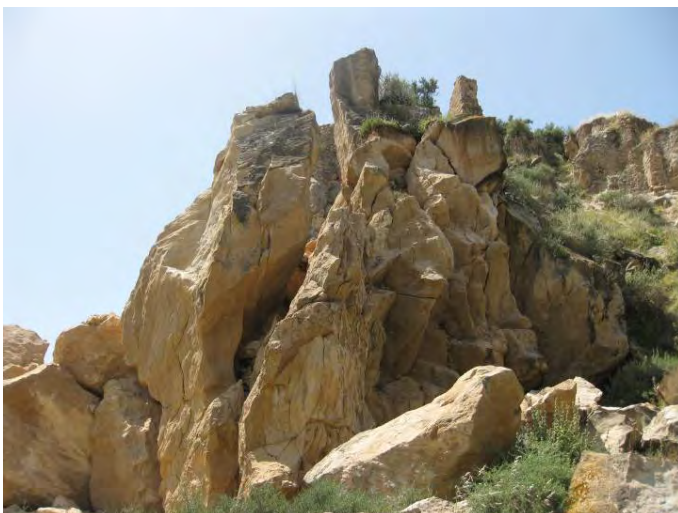
Figure 4.2.1e: Close-up of the collapse of the easternmost point of the castle cliff (looking South) and of the general conditions of the rock mass at this site. On the upper right corner it is observed part of a fallen wall (see figure 1.1f).

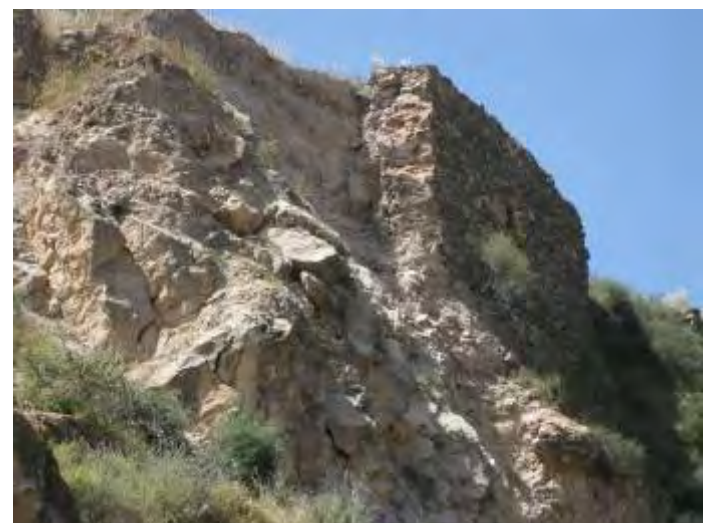
Figure 4.2.1f: Close up of the fall of part of an old retaining wall. It can be observed that the intrados filling remains meta-stable. This type of instability also appears on the south face of Lorca's castle cliff (see figure 2.1).

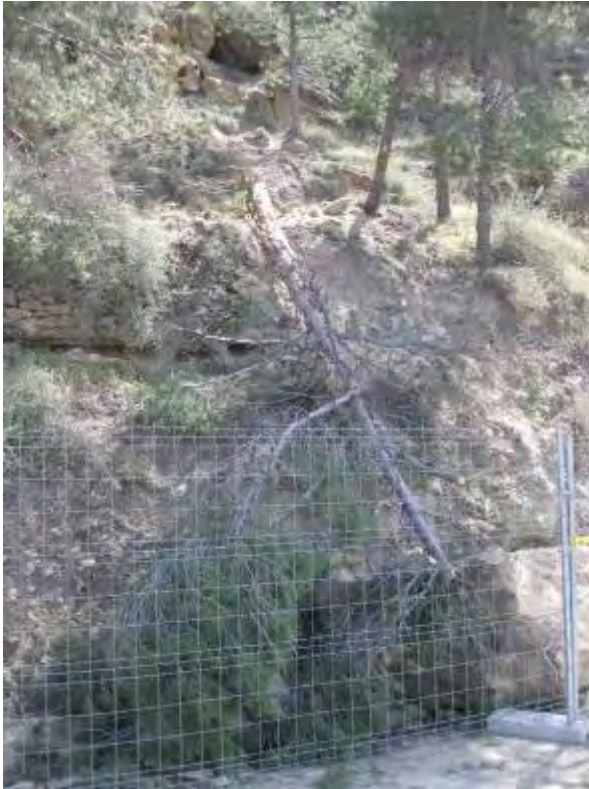
Figure 4.2.2: Small debris dragging a pine tree on the north talus of the up-the-hill road to the castle.

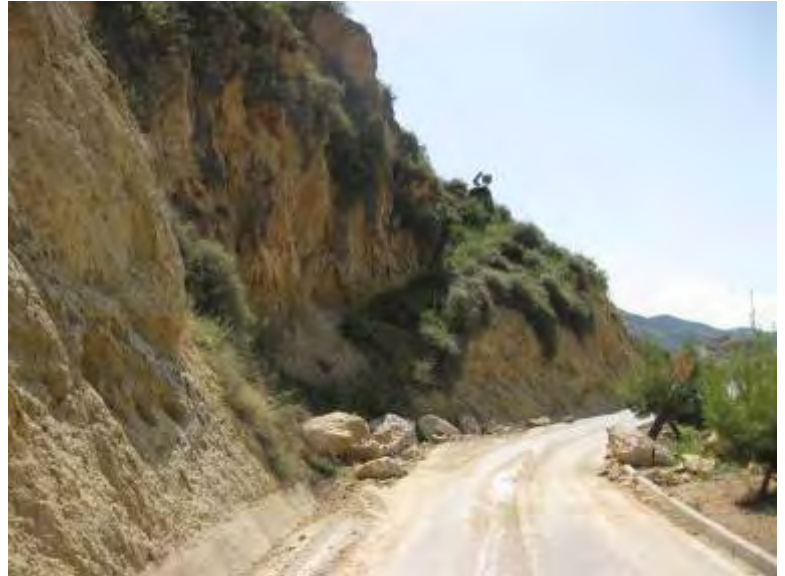
Figure 4.2.3: Rock-falls and debris on the up-the-hill road to the castle.

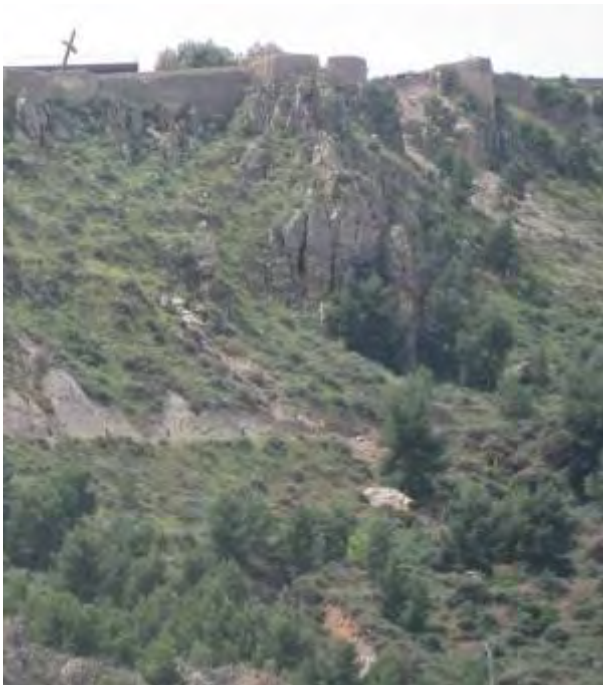
Figure 4.2.4a: Rock-fall of metric size that damaged badly the road (see figure 1.4b).

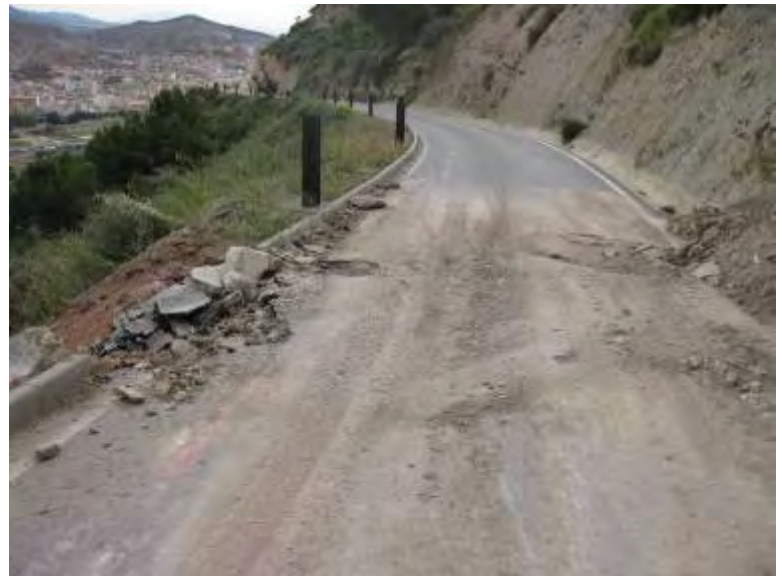
Figure 4.2.4b: Damage on the pavement of the up-the-hill road to the castle due to the fall and rebound of the block shown in figure 1.4a.

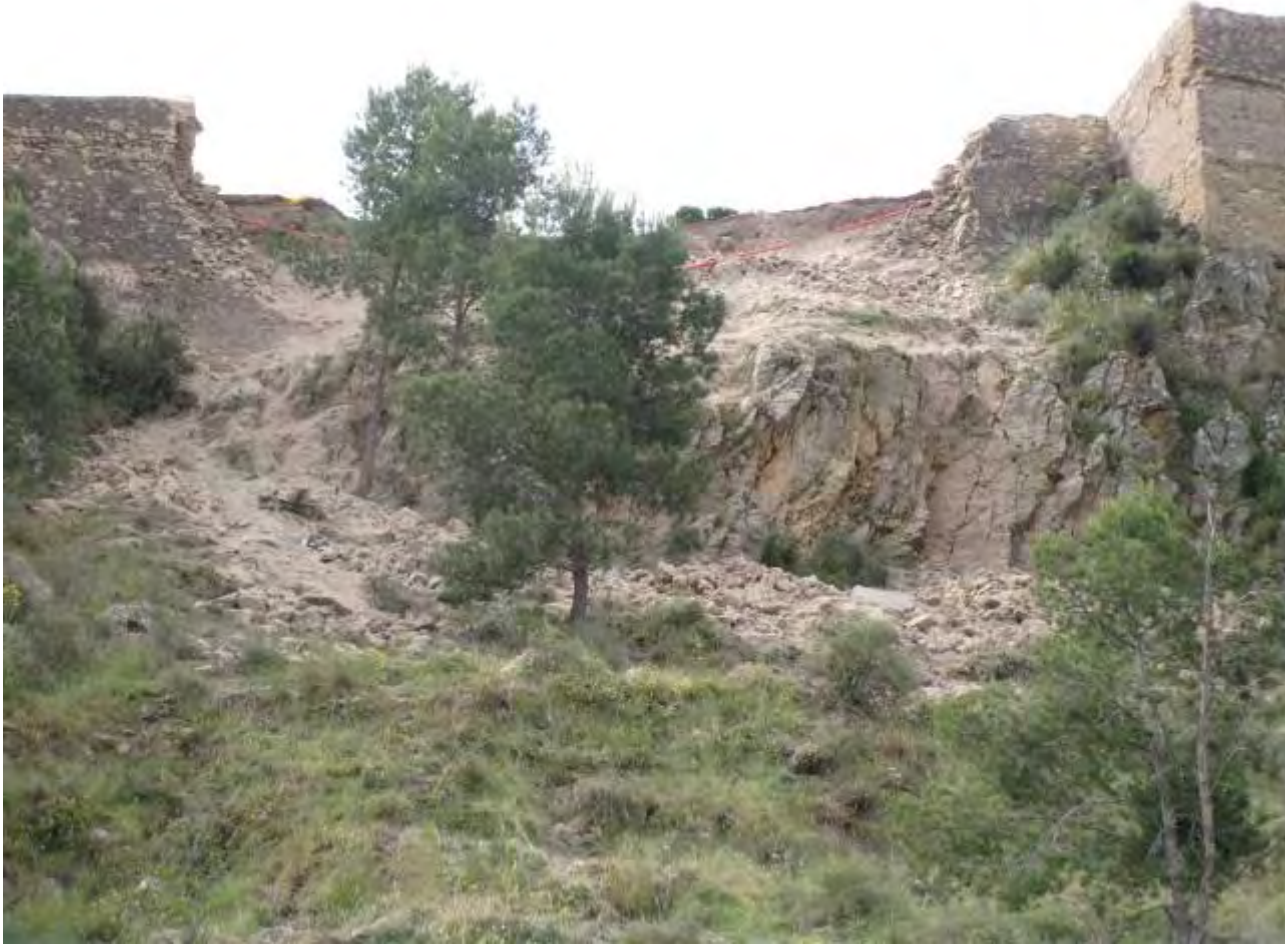
Figure 4.2.5: Collapse of the external wall of Lorca's castle (north face).

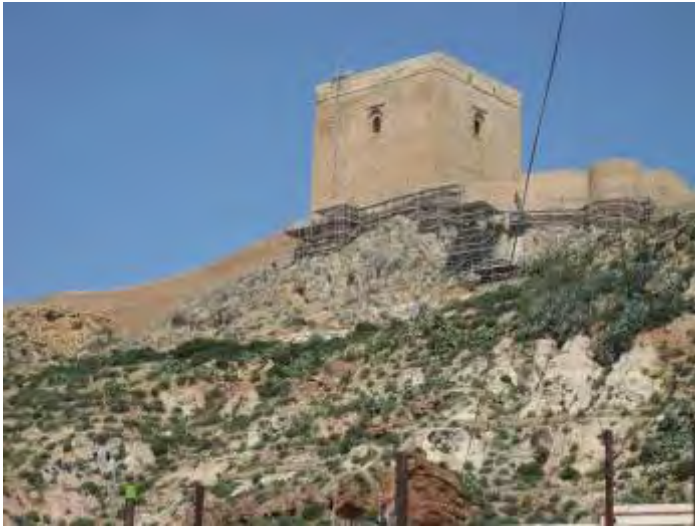
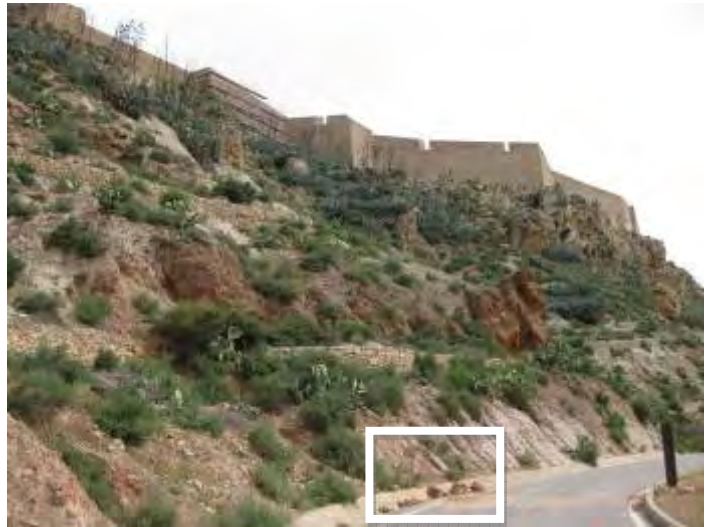
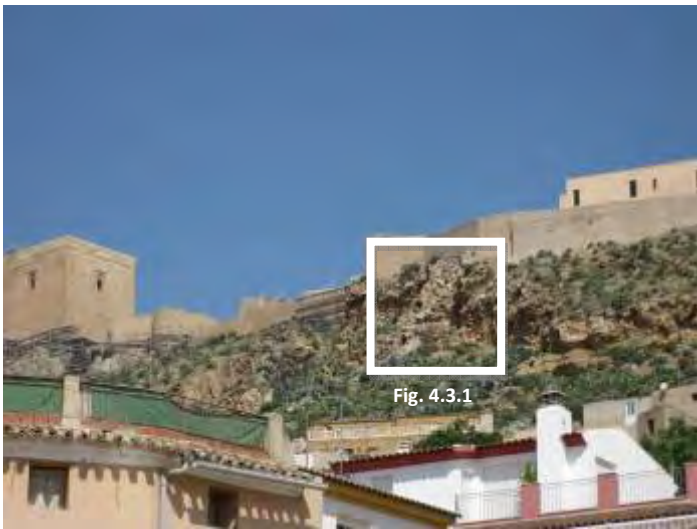
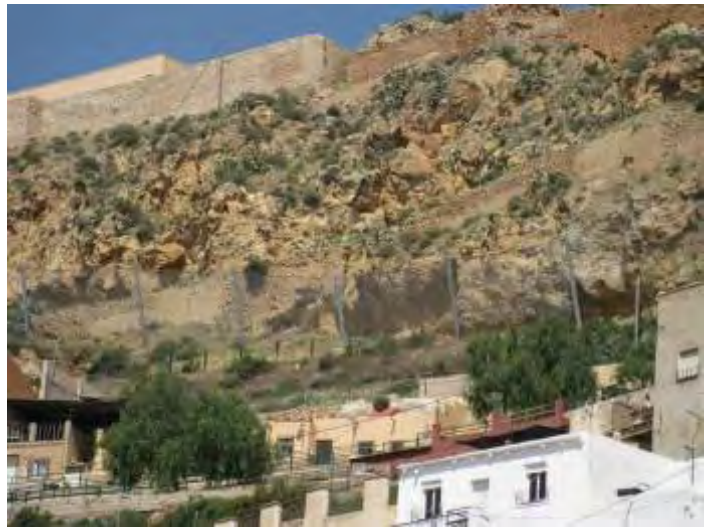
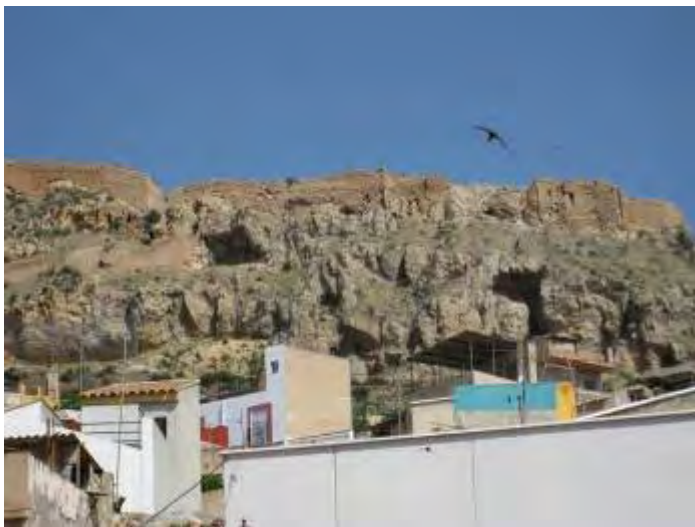
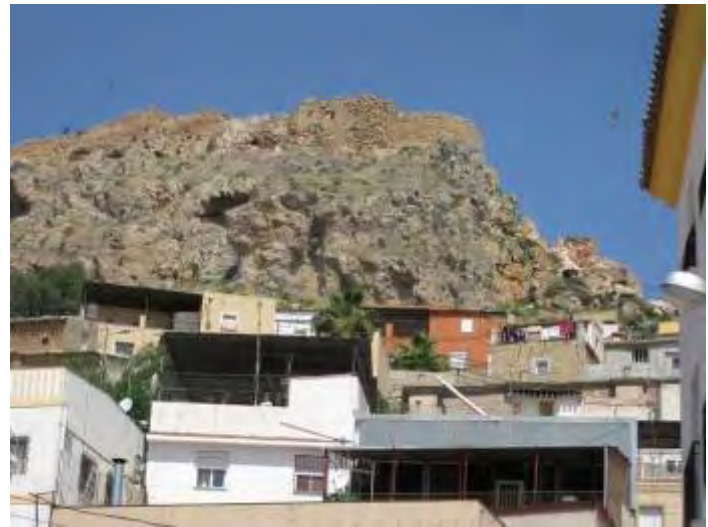
It is highlighted that the stability measures deployed on the southern slope of the castle cliff have performed adequately, avoiding what it would have been an aggravation of the damage produced by the earthquake and may be a larger number of casualties, particularly on the habitations located right under the cliff. A quick visual inspection suggested the perfect state of the measures, although this observation should be confirmed after a systematic and detailed inspection.

Figure 4.3.0: Partial views of the southern slope of Lorca's castle cliff. Photos are arranged from west to east, from left to right. Only two small size instabilities were identified: a small debris fall (photo number 2) and the collapse of the external wall of the castle (photo number 3 and fig. 4.3.1). On the last photo a visual of the easternmost point of the cliff is shown (figure 4.2.1). The stabilization measures of the rock mass performed adequately preventing the occurrence of more damage and personal losses. These consist in a double diameter wire mesh nailed to the rock mass by bolts and a dynamic barrier. These measures were put in place 3 years ago aprox. (pers. com. council).

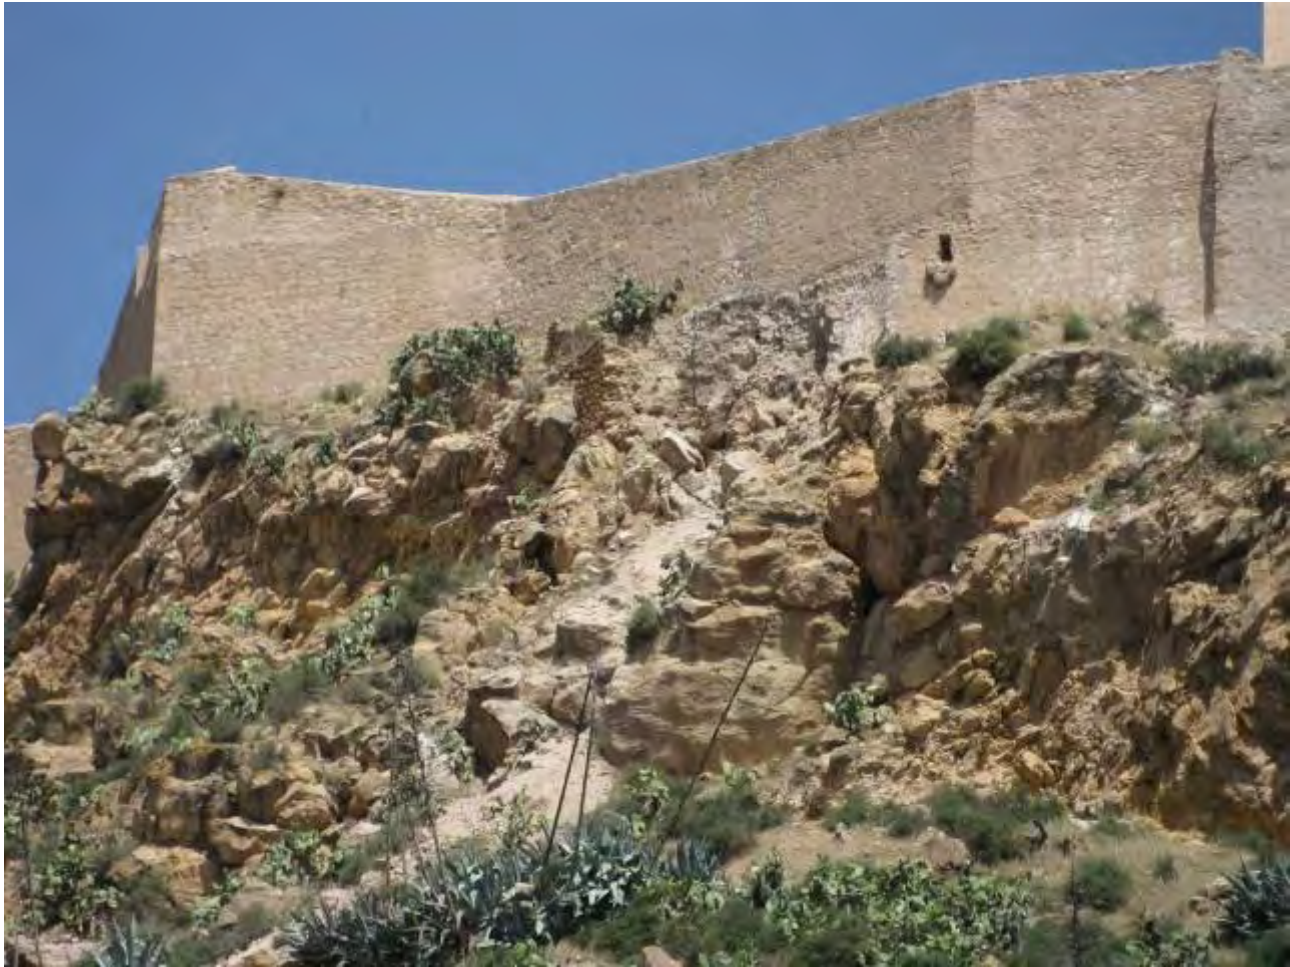
Figura 4.3.1: Collapse of an old retaining wall attached to the external wall of the Lorca's castle on its south face. This instability warned the dwellers of the houses situated right under the cliff, which asked us whether it was safe to return back to their places.

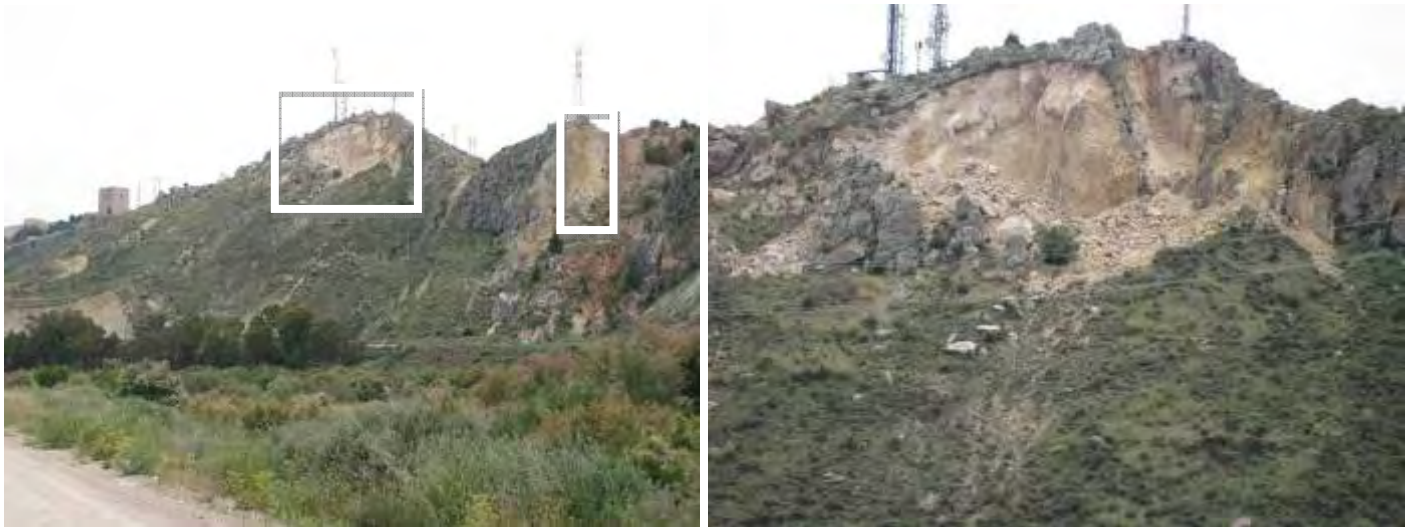
Figure 4.4.1a: Rock-falls and debris on the summit of the north slopes of the Pantano de Puentes road. Their attribution to the earthquake is presumed. The westernmost one (on the right on the first photo) corresponds in part with a previous instability.

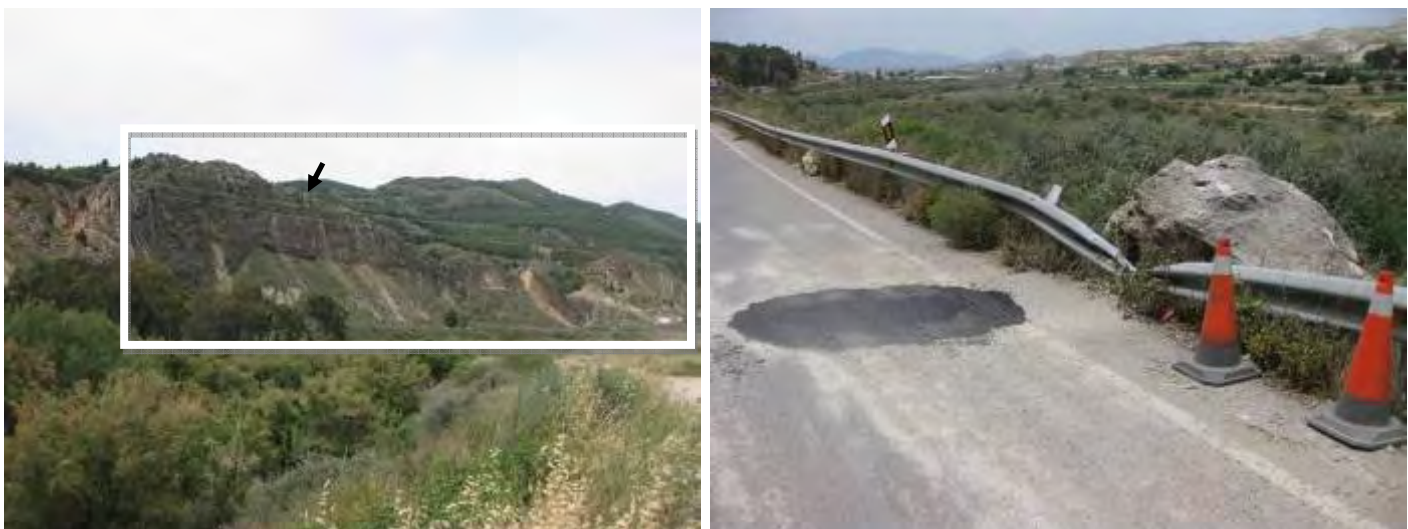
Figure 4.4.1b: Continuation of the Pantano de Puentes road towards the west. Along this road many instabilities were identified, although of a small size in general. Particularly remarkable are the rock blocks fallen from the ridge controlled by Las Viñas Fault (marked with an arrow). Picture on right shows a close-up of the damage produced by one of this rock blocks.

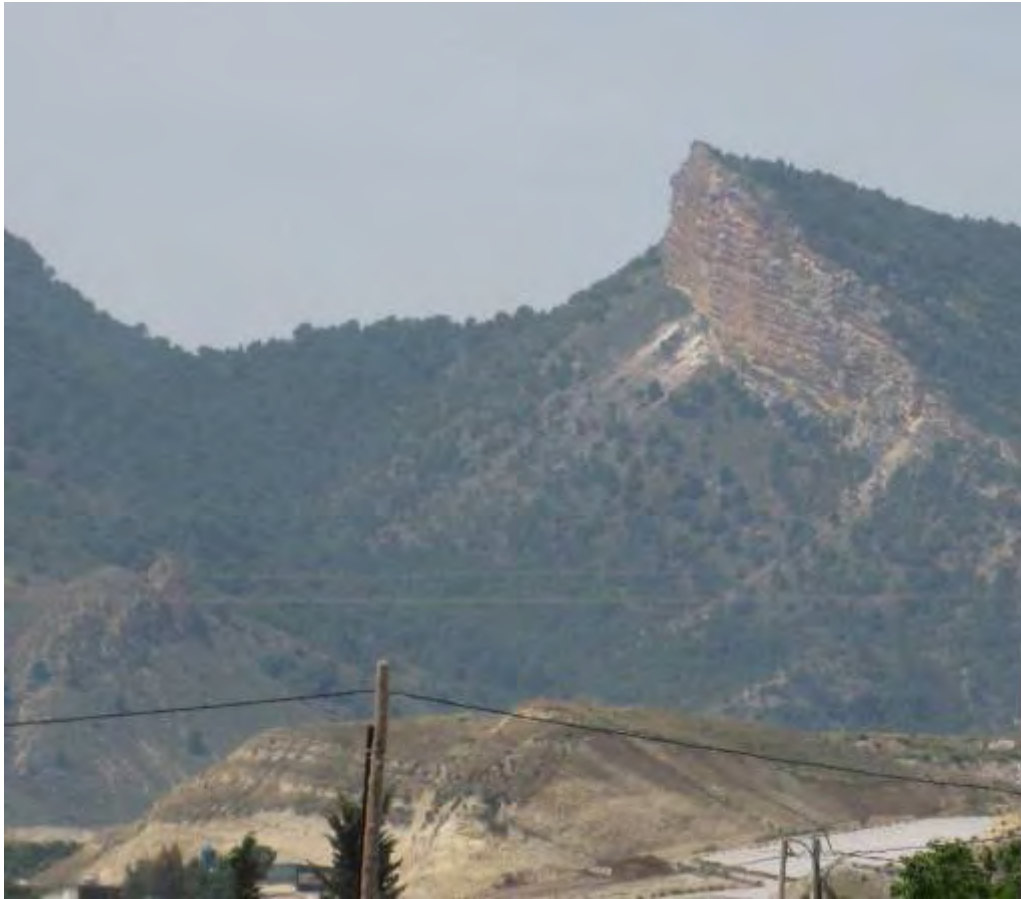
Figura 4.4.2: Rock-falls and rock-debris at the Cejo de los Enamorados.

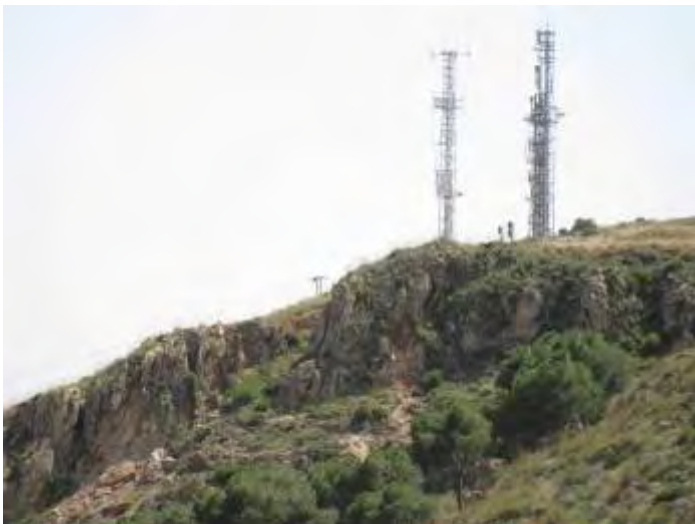
Figure 4.5: Communications towers founded on a hill situated in front of the westernmost end of Lorca's castle cliff. Two recent instabilities are shown, which are attributed to the 11 May earthquakes.

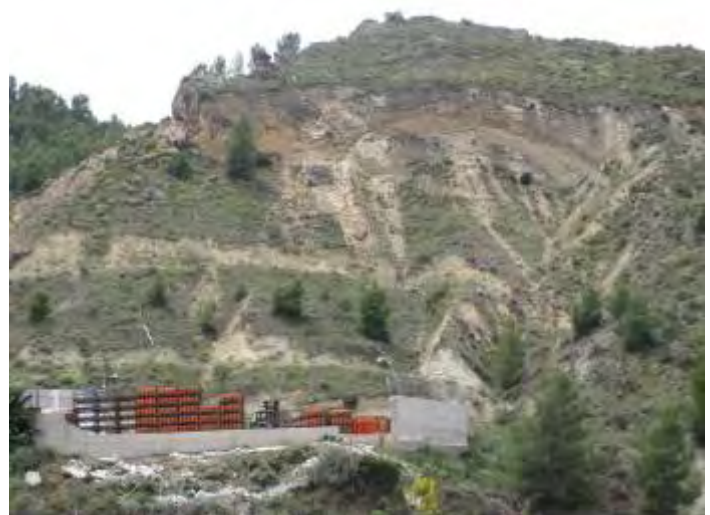
Figure 4.6: View of the slope enclosing a butane-gas storage site on the Pantano de Puentes road. No slope instabilities that could be attributed to the earthquakes were identified here, although the collapse of the concrete-brick wall is attributed to them.

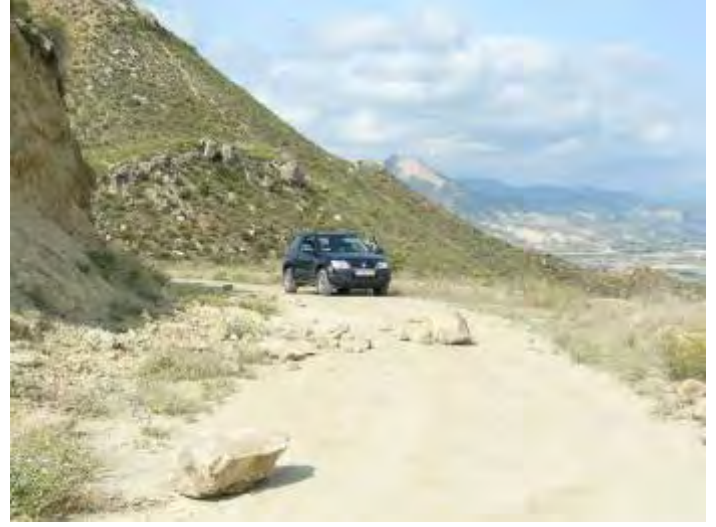
Figure 4.8: Rock falls on a dirt road that runs across the epicentral area (photo courtesy of J.J. Martínez-Díaz).

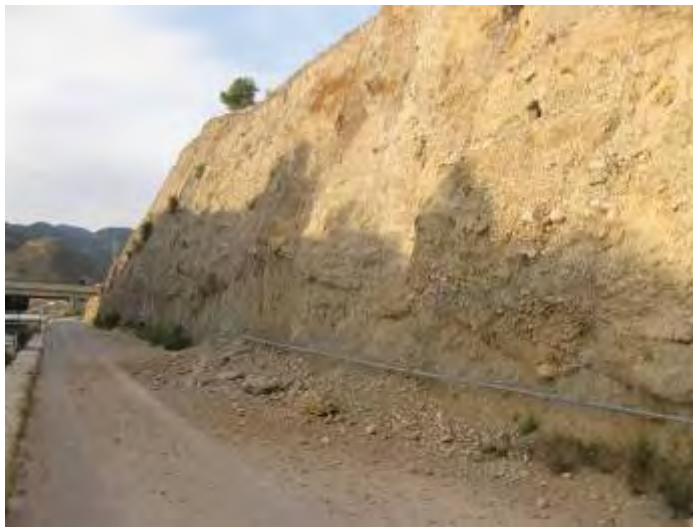
Figure 4.9: Shallow debris falls attributed to the May earthquakes on a service road of the Tajo-Segura canal.

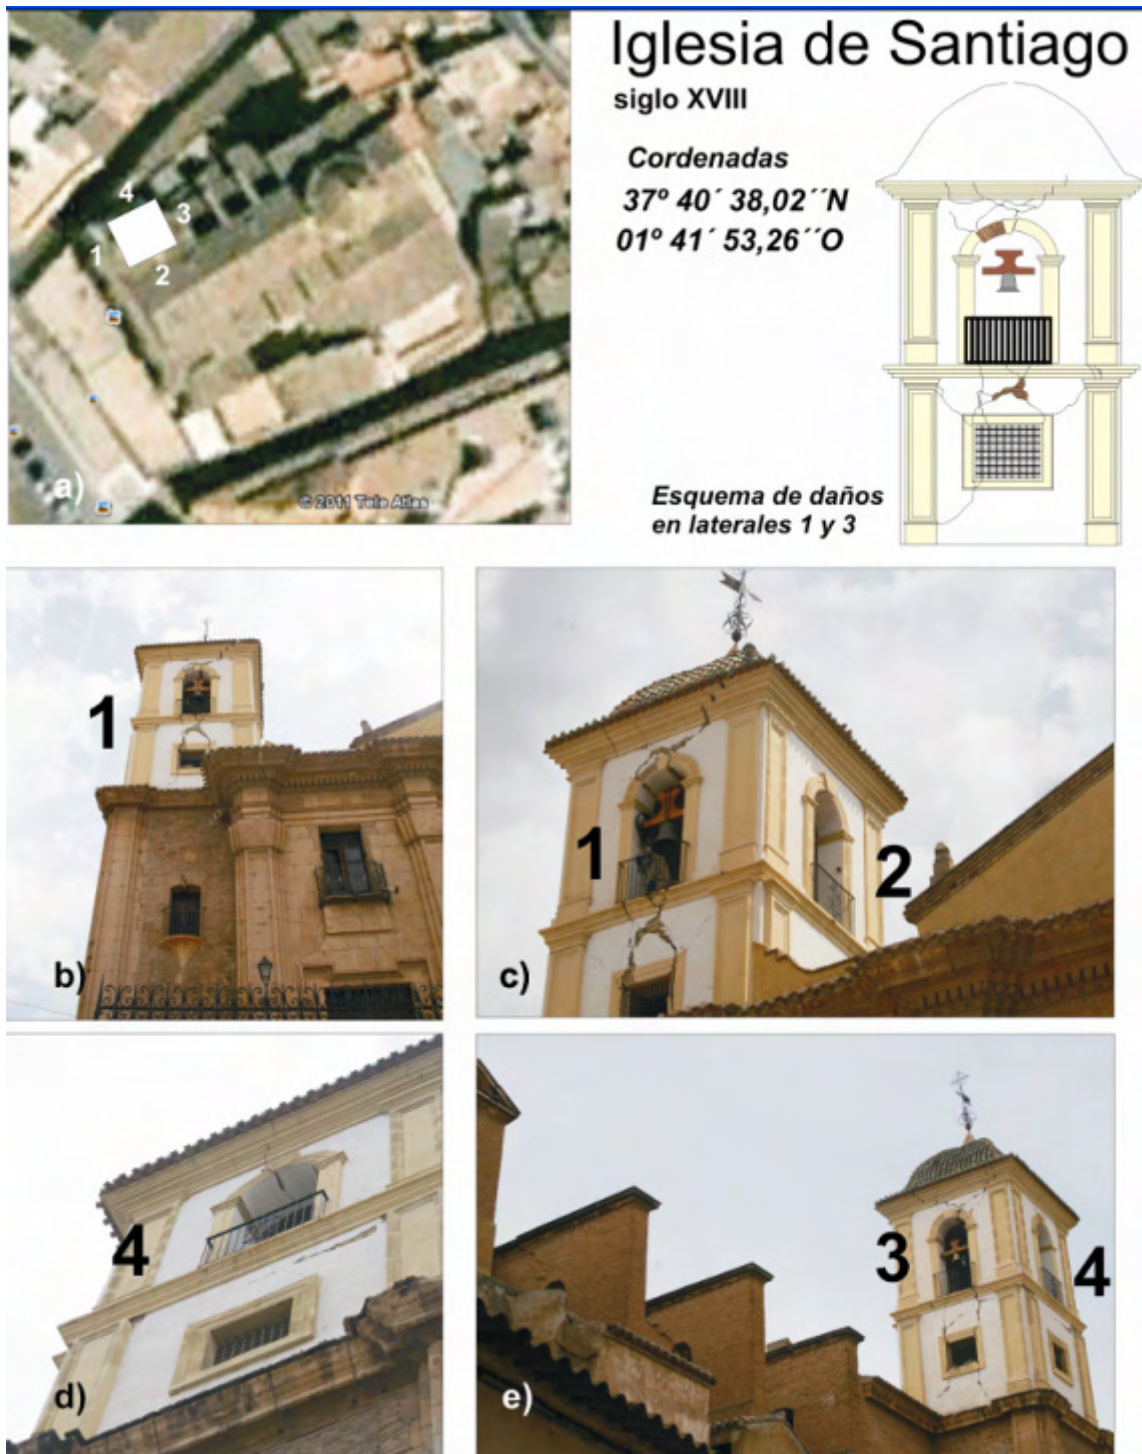
Figure 5.3: Damage in the church's tower of Santiago.

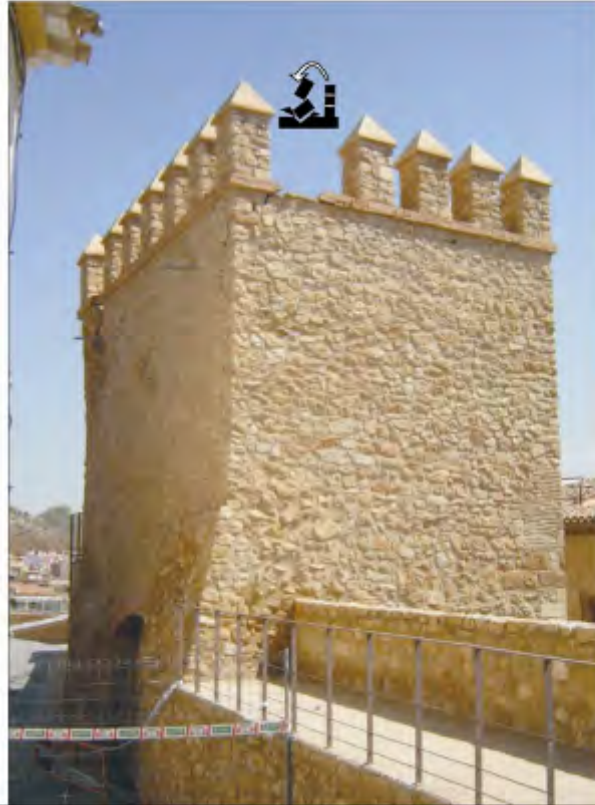
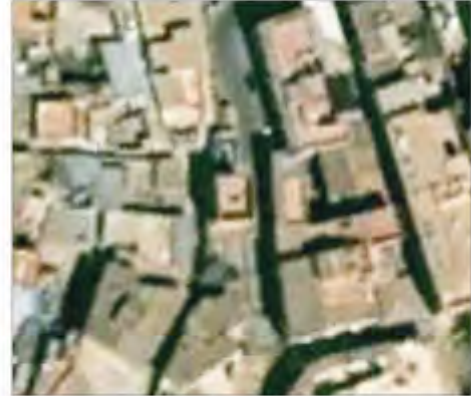
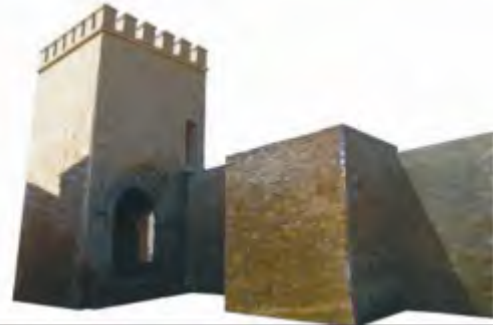
Almena del Porche de San Antonio

Figure 5.4: Damage in the battlements of the entrance of San Antonio (Tower of the old defensive wall of the Islamic Period).

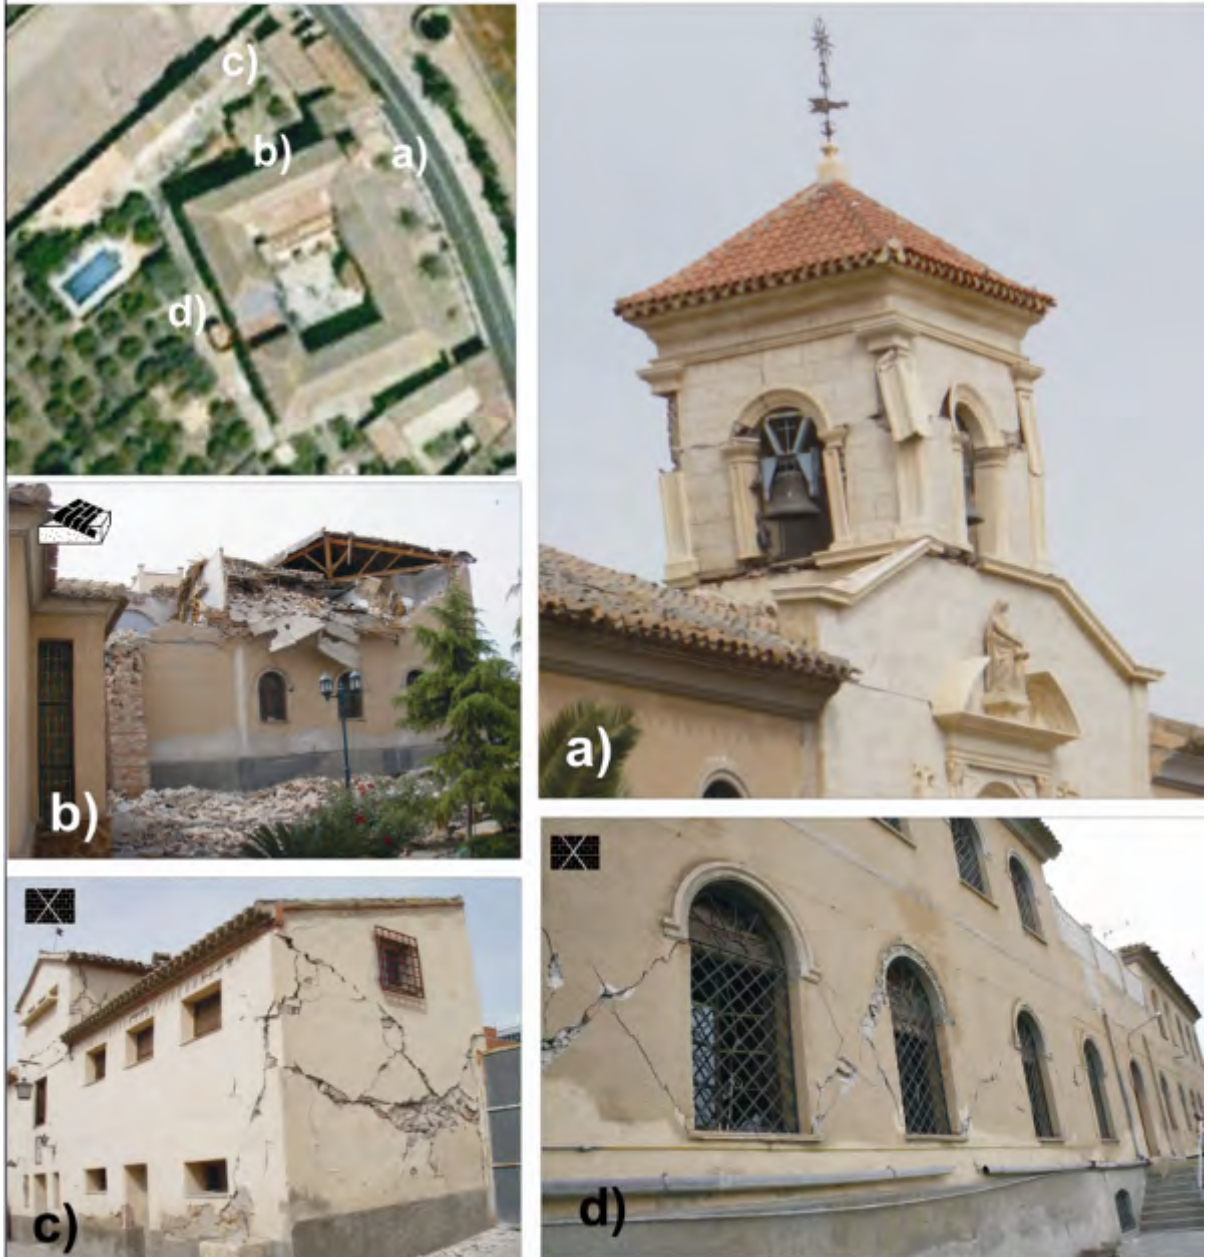
Convento de las Clarisas

Figure 5.5: Damage in the tower and main buildings of the Clarisas' Convent.

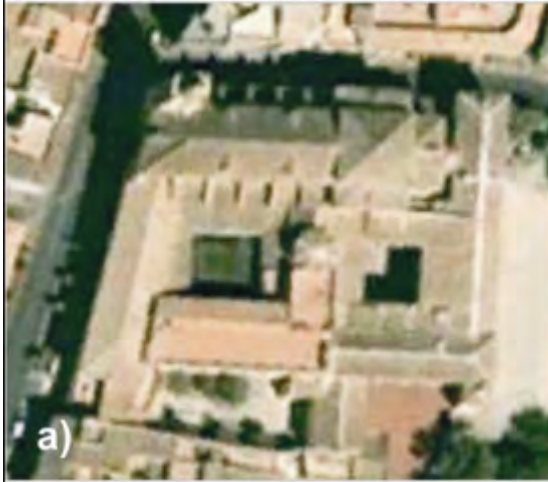
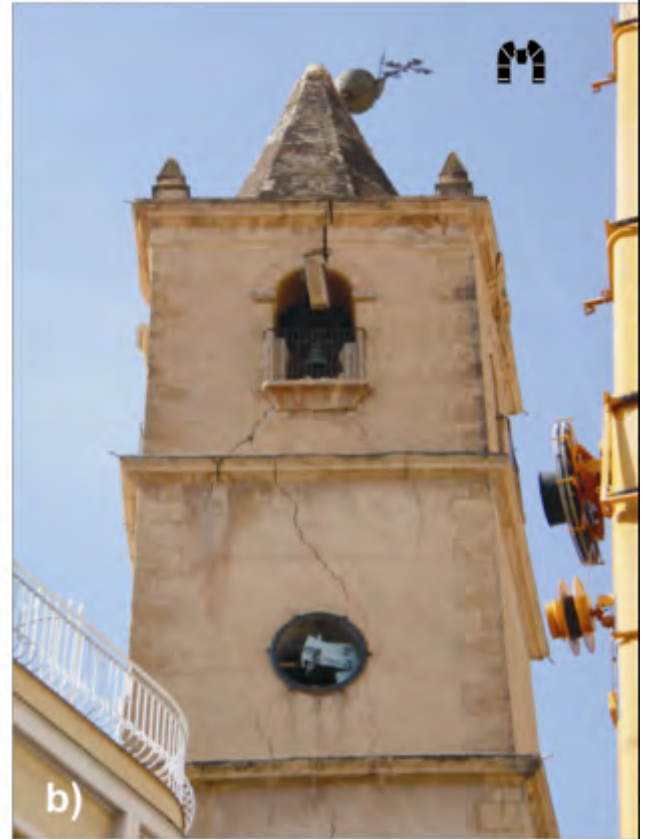
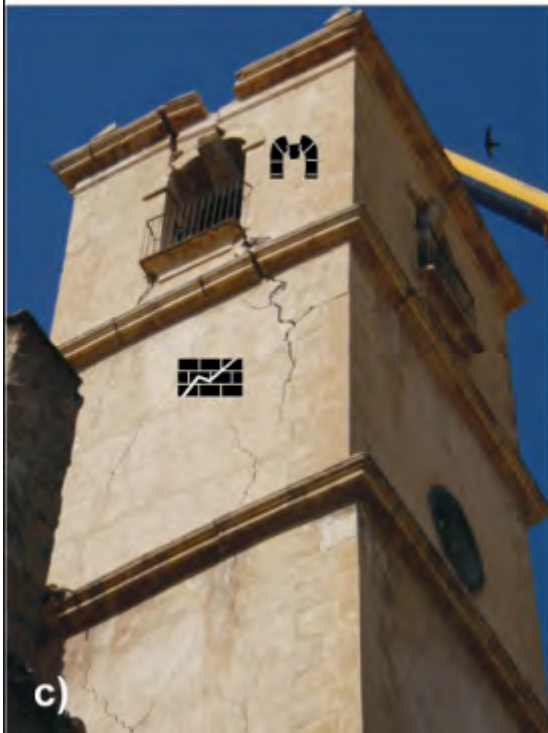
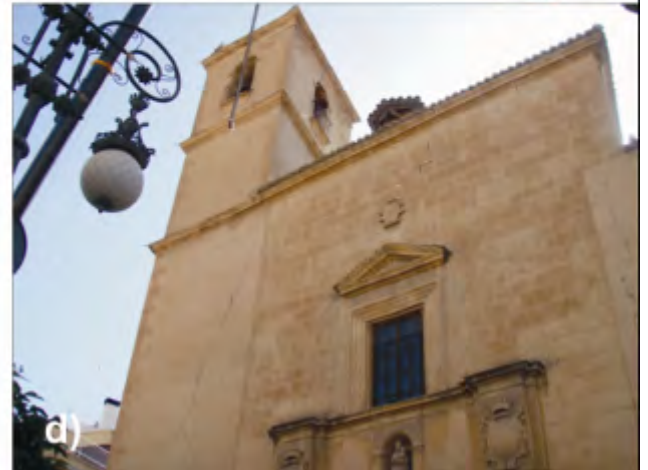
Figure 5.6: Damage in the San Francisco's Church.

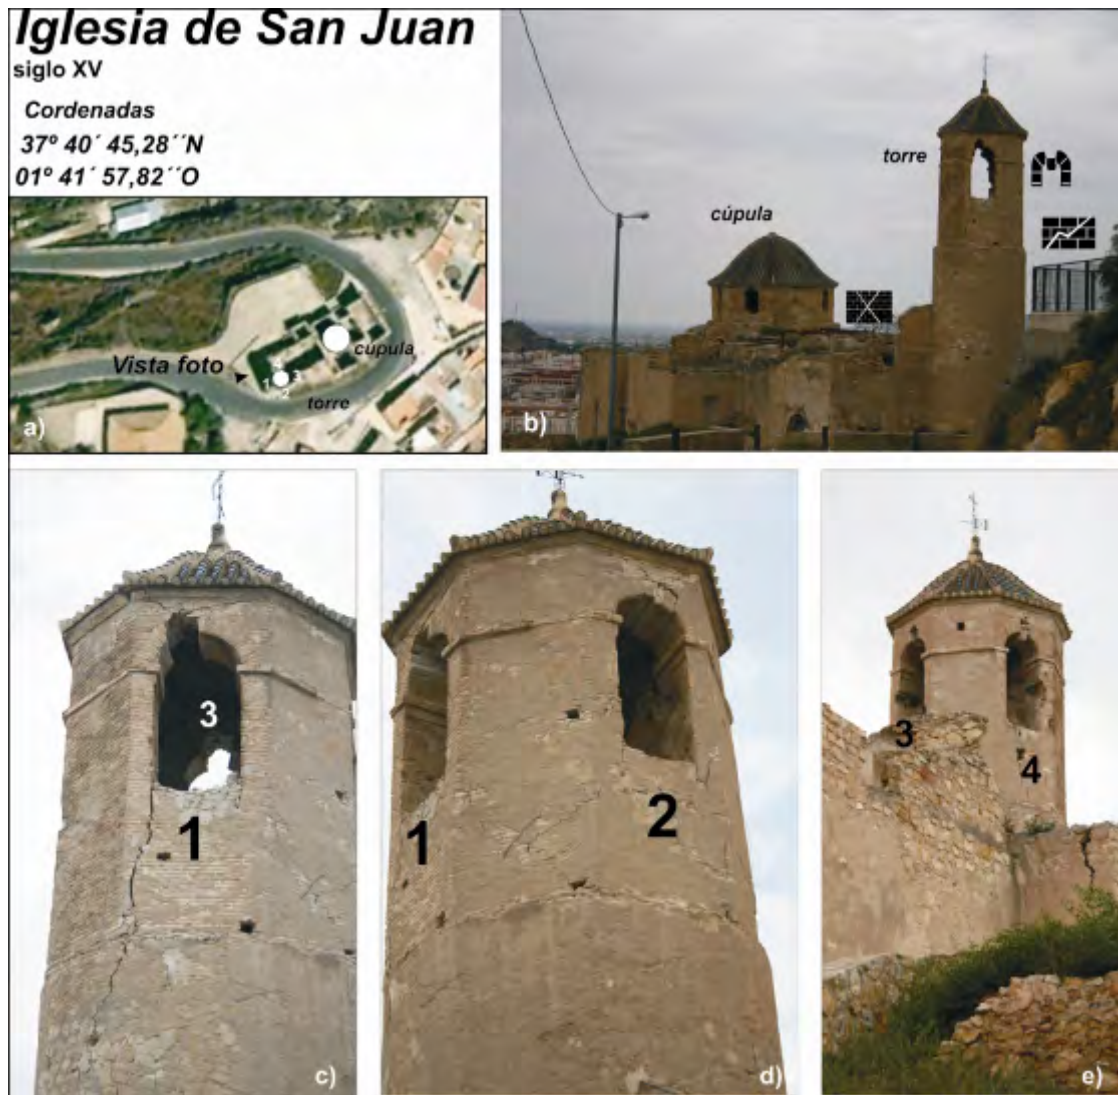
Figure 5.7: Damage in the San Juan's Church.
