Date: 20th May, 2011

GEOLOGICAL PRELIMINARY FIELD REPORT OF THE LORCA EARTHQUAKE (5.1 M_w , 11TH MAY 2011)

Translation from the original report in Spanish

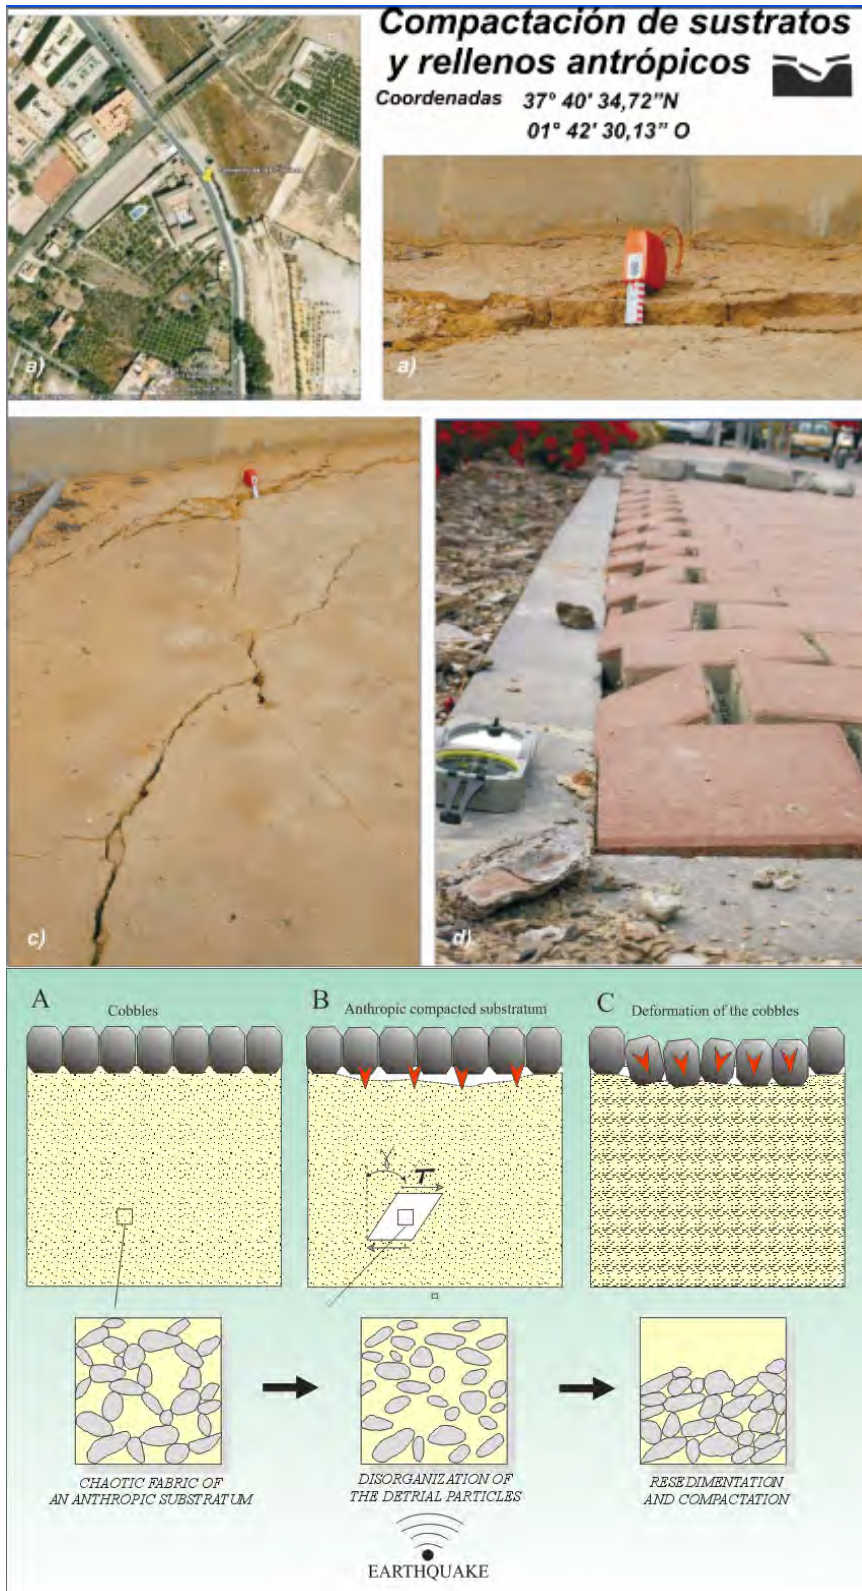
Figure 5.9: Anthropically compacted substratum by seismic shock related to the Clarisas's Convent. New EAE structure.

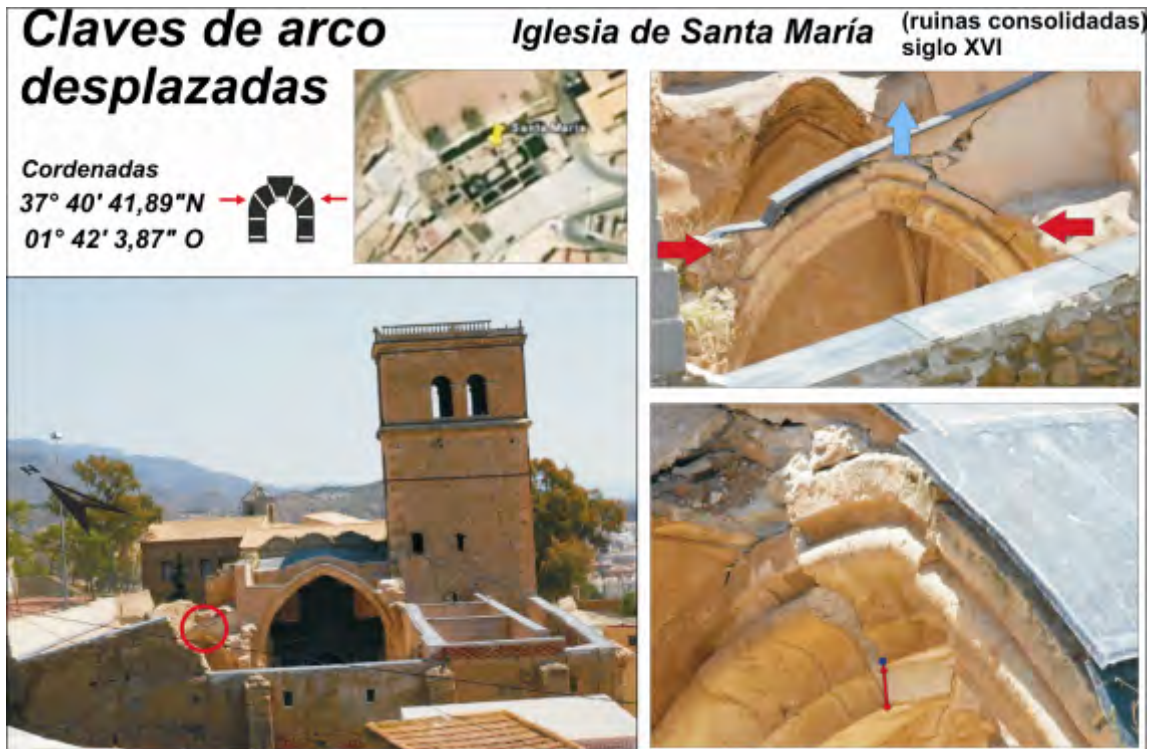
Figure 5.10: Santa Maria's Church. Pop up of a clave stone.
