SEMINARIO DI AGGIORNAMENTO PER ISPETTORI AMBIENTALI ISPRA

**Contributo alla conferenza internazionale ESREL,
relativo all'analisi di un caso incidentale di
duplice interesse Seveso-AIA**

Uncontrolled release of crude oil in the groundwater from a storage tank - critical issues and S-EMS improvements linked to Seveso-IED interfaces

Fausta DELLI QUADRI
Geneve FARABEGOLI

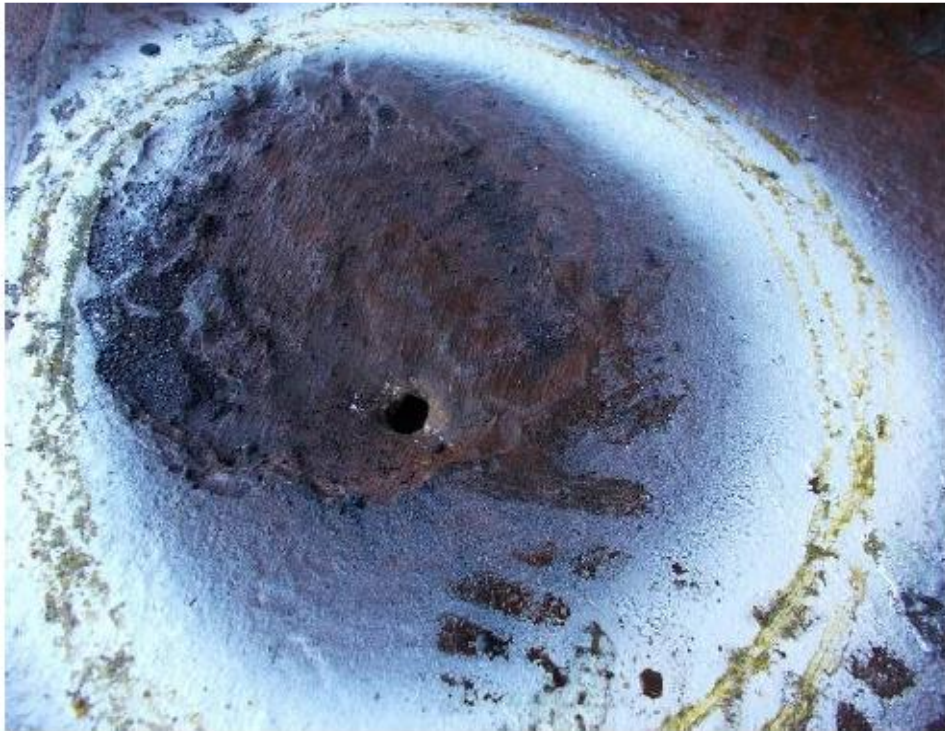
- ▶ accident caused by the corrosion of the bottom tank D, and the formation of 3 through- holes in the central plates, and 7 through- holes in the annular ring

- ▶ internal inspection of tank D showed the presence of crater-like corrosion on the bottom, extended to about 70% of the plates
- ▶ no signals or alerts were detected in the tank D before the accident, which was assumed to be in ‘safe operation’ until the end of 2017-2018 when the double bottom installation was planned

Three through-holes in the
central plates

- ▶ failure of the primary protection system of the tank D: damage to the **bottom** due to a corrosive phenomenon, formation of through-holes and LOC from the tank

- ▶ double bottoms, new continuous double bottoms monitoring system (daily manual monitoring system completely)
- ▶ control/checks activities improvement:
 - ▶ daily specific integrity-functionality checks (check list)
 - ▶ Tracer Tight tests on double tank bottoms, every 4 months
- ▶ inspections improvement during operation:
 - ▶ shell thickness control (ultrasound), every 2 years;
 - ▶ AE checks of the tank bottoms, every 2 years
 - ▶ improvement of safety instrumentation inspections

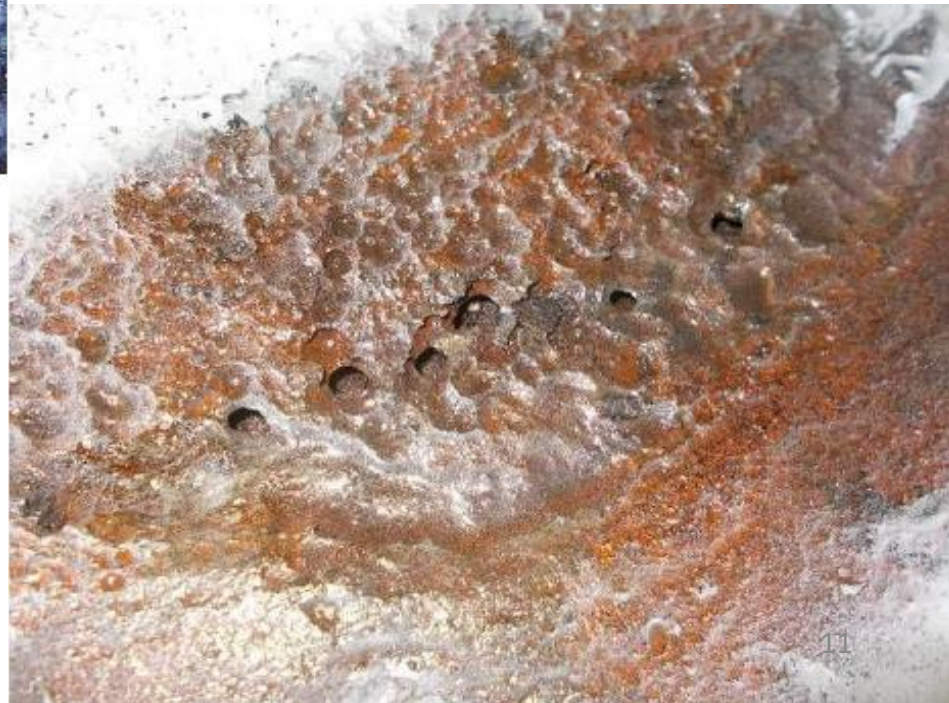
- ▶ oil leakage under the bottom due to possible cracks in the (flexible) bituminous membrane, in contact with the annular (rigid) concrete foundation
- ▶ oil vertical migration from soil towards the underground aquifer for 6 meters; the horizontal drainage route below the tank helped the rapid oil migration underground, and its extension outside the perimeter

Seven through-holes in the
annular ring

- ▶ failure of the secondary protection system of the tank D: damage to the **asphalt barrier** and consequent cracking. The oil vertical migration in the layers below the bottom of the tank was due to the damage of the impermeable layer (bituminous conglomerate barrier) 80 mm thick under the bottom. Cracks might be generated by contact of the less rigid bituminous layer with the annular (rigid) concrete foundation, due to the different behavior of the two materials under stress
