Quick report on the surface effects of the June 8, 2008, NW Peloponnese earthquake

by the Aristotle University of Thessaloniki – Department of Geology team:

15 June 2008 contact: ac@geo.auth.gr, pavlides@geo.auth.gr

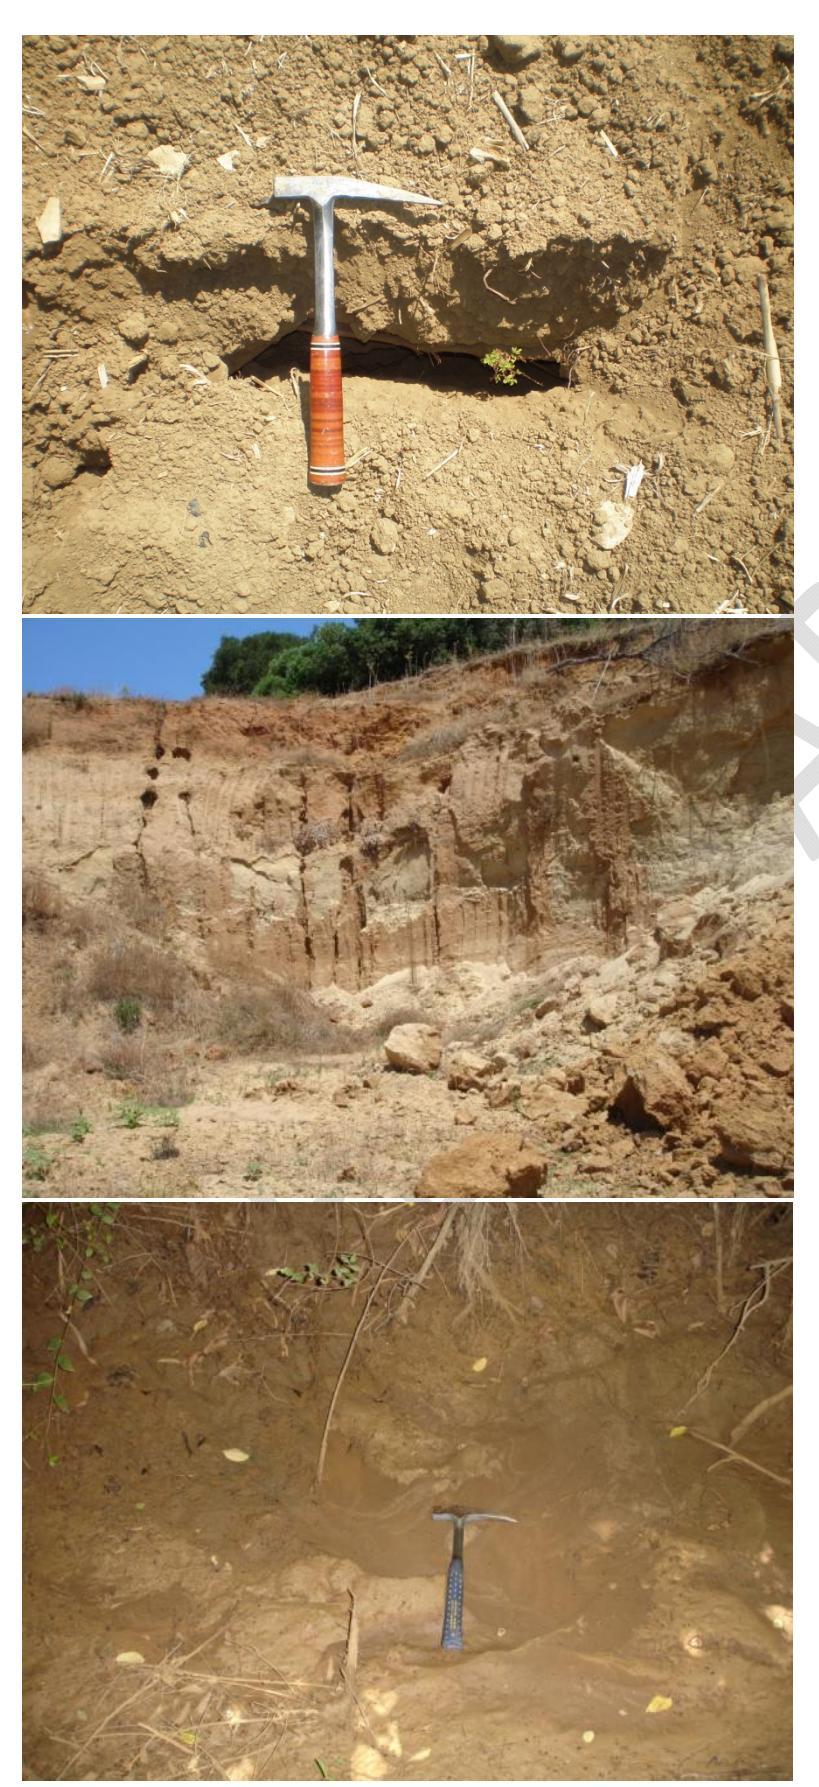
This is a long (>5 km) line of NNW-SSE striking open ruptures with local normal character and slight strike-slip component (Figure 1). They are aligned in a left-stepping *en échelon* arrangement and generally follow the adjacent river scarp. A shear zone with no significant vertical displacement coincides with the general strike of the surface ruptures (Figure 2). It is also associated with liquefaction and slope movements along its strike (Figure 3).

Figure 1. Detail of part of the NNW-SSE trending fracture line near Psari village. The vertical displacement is evident.

Figure 2. A high-angle shear zone aligned with the Psari-Nisi surface rupture. Small seismic ruptures of the same NNW-SSE strike, as well as aligned slope movements, were observed in this area.

Figure 3. Ejection of liquefied material associated with the Psari – Nisi rupture line.

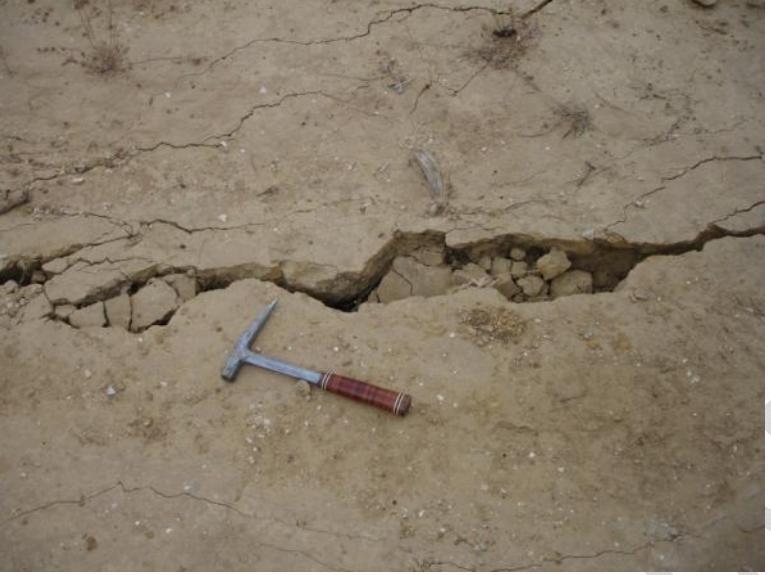
Mihoi is the village that rests closest to the epicenter. A rather long (>2 km) rupture line of WNW – SSE strike was observed at the hills west of Mihoi (Figure 4). It forms a deformation zone of up to 6 m wide, while it is also associated with rock falls and landslides (Figure 5).

Figure 4. Part of the seismic Mihoi fracture line.

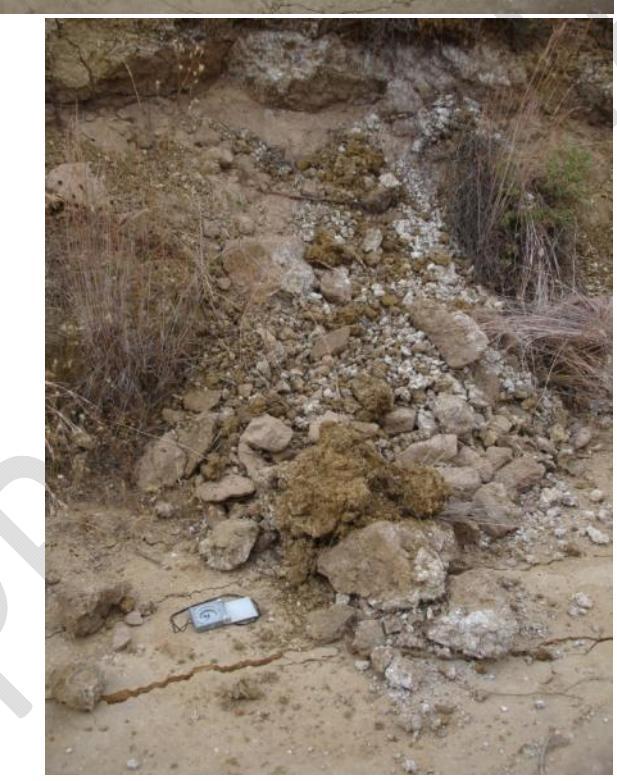
Figure 5. A small rock fall associated with ruptures of the Mihoi line at the foreground.

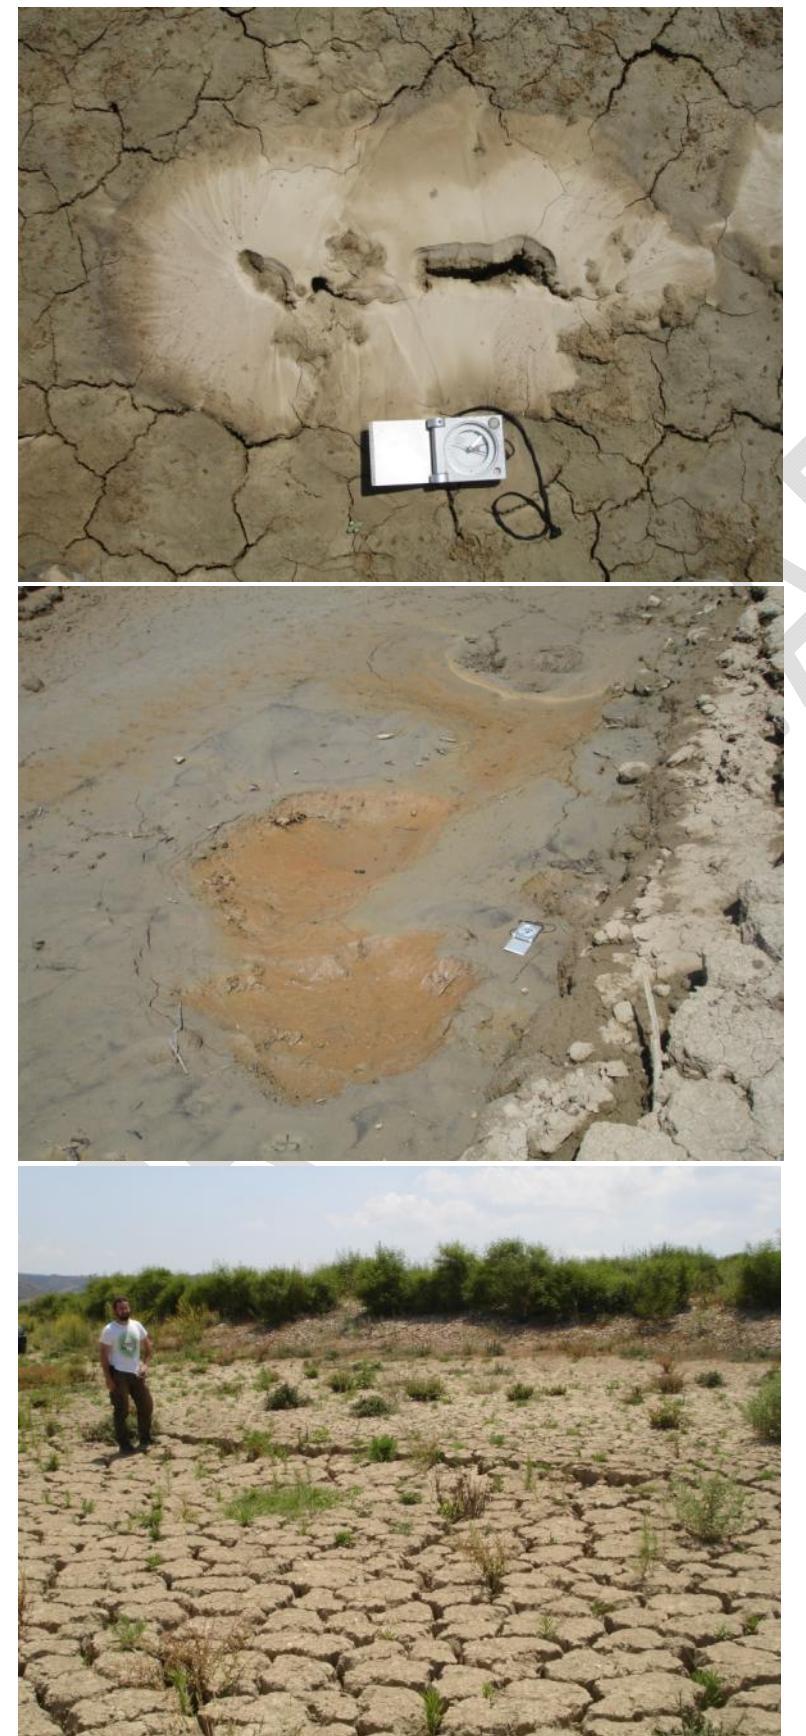
1. Ejection of material along ruptures (Figure 6).

- 2. Sand and mud volcanoes (Figure 7).
- 3. Sand and mud flows.
- 4. Lateral spreading (Figure 8).

Figure 6. Detail of a surface rupture through which fine material was ejected.

Figure 7. A series of mud volcanoes.

Figure 8. Part of a long (>500 m) rupture associated with lateral spreading.

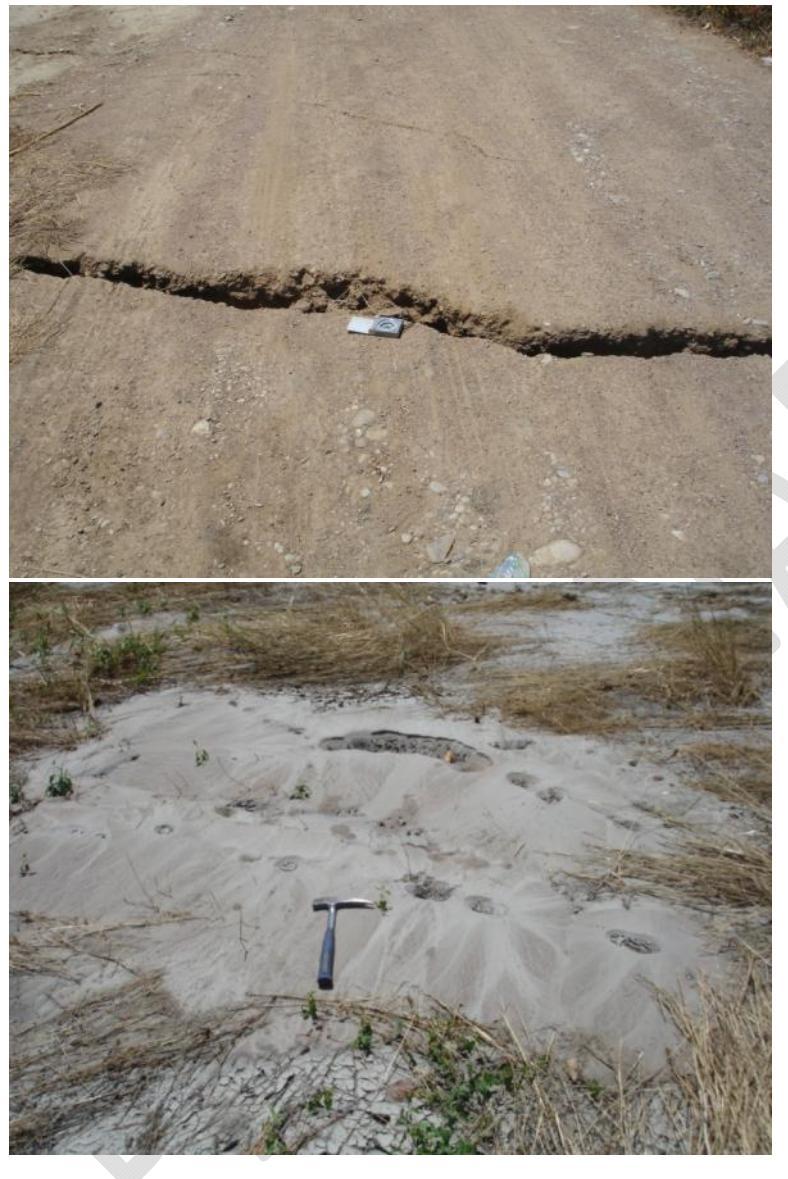
Kato Achaia is located way north of the epicenter, but local conditions (sandy soil and high aquifer level) caused very high acceleration values, resulting in impressive liquefaction phenomena, including surface ruptures (Figure 9), rupture ejections (Figure 10) and mud volcanoes.

Figure 9. Surface rupture parallel to the coastline associated with liquefaction at Kato Achaia.

Figure 10. Ejection of liquefied material along surface ruptures of NNW – SSE strike.

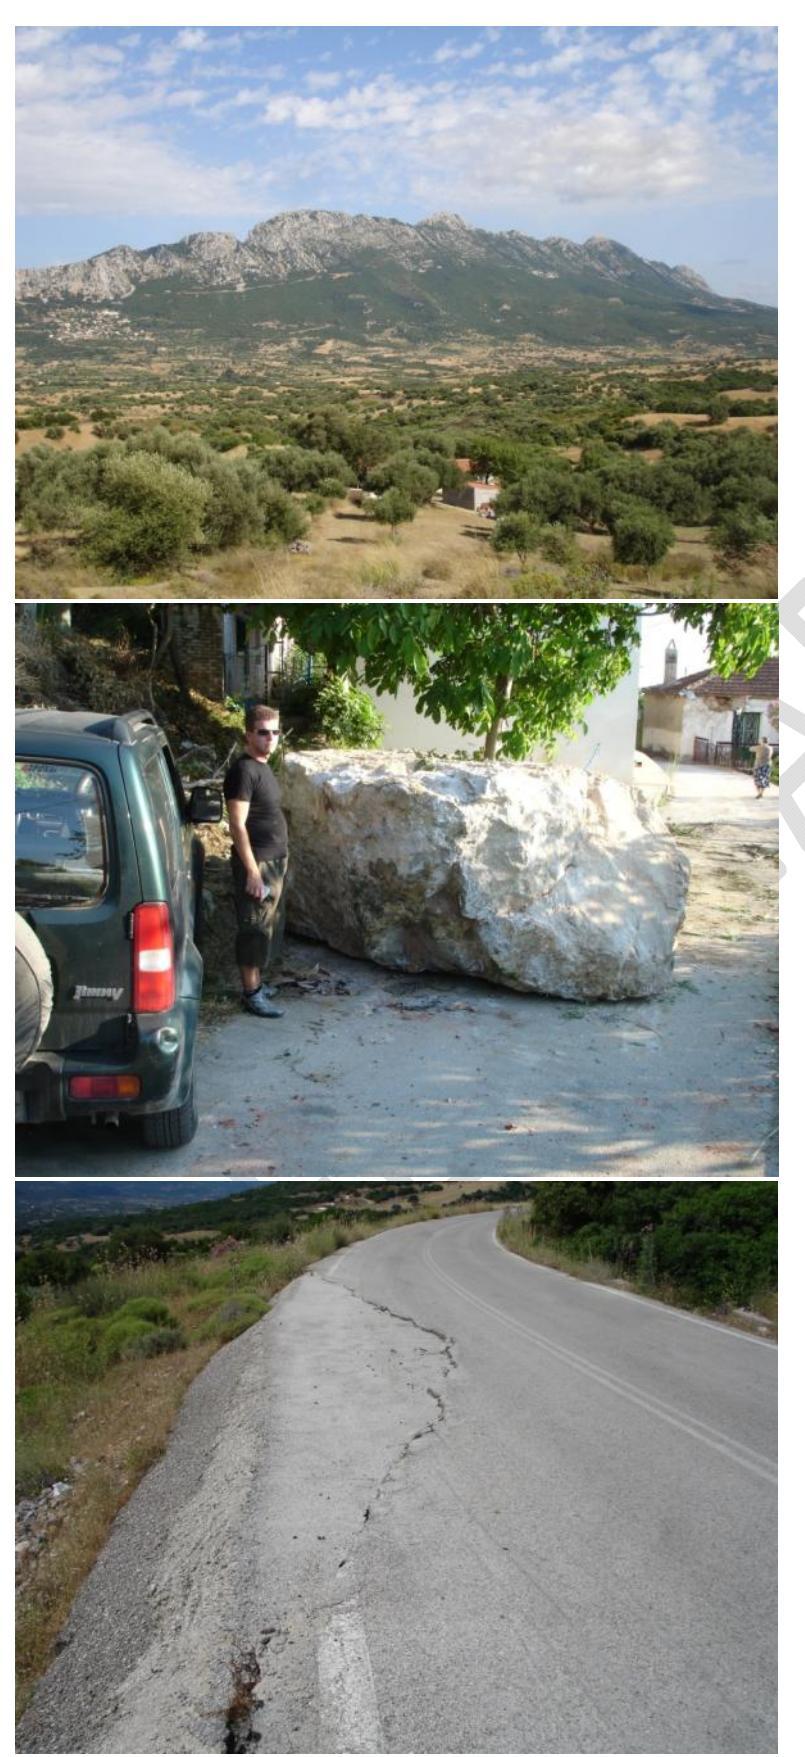
Earthquake associated slope movements (rock falls, landslides, etc.) were spread over a very wide area. The epicentral area was mainly affected by rockfalls along the steep slopes of the very impressive Skollis Mountain (Figure 11), which caused damages at roads and houses around Santoneri village (Figure 12). The road network was affected in many areas, either by failures (Figure 13) or rock falls.

Figure 11. View of Skollis Mountain. Both its western and eastern slopes were totally affected by rockfalls and landslide. According to eyewitness accounts, the slopes were covered "in a white dust" for more than 15 mins due to widespread slope movements.

Figure 12. A large rock blocked this road in Santoneri after destroying a house at its course.

Figure 13. Road failure due to slope movement be-tween Santoneri and Portes.

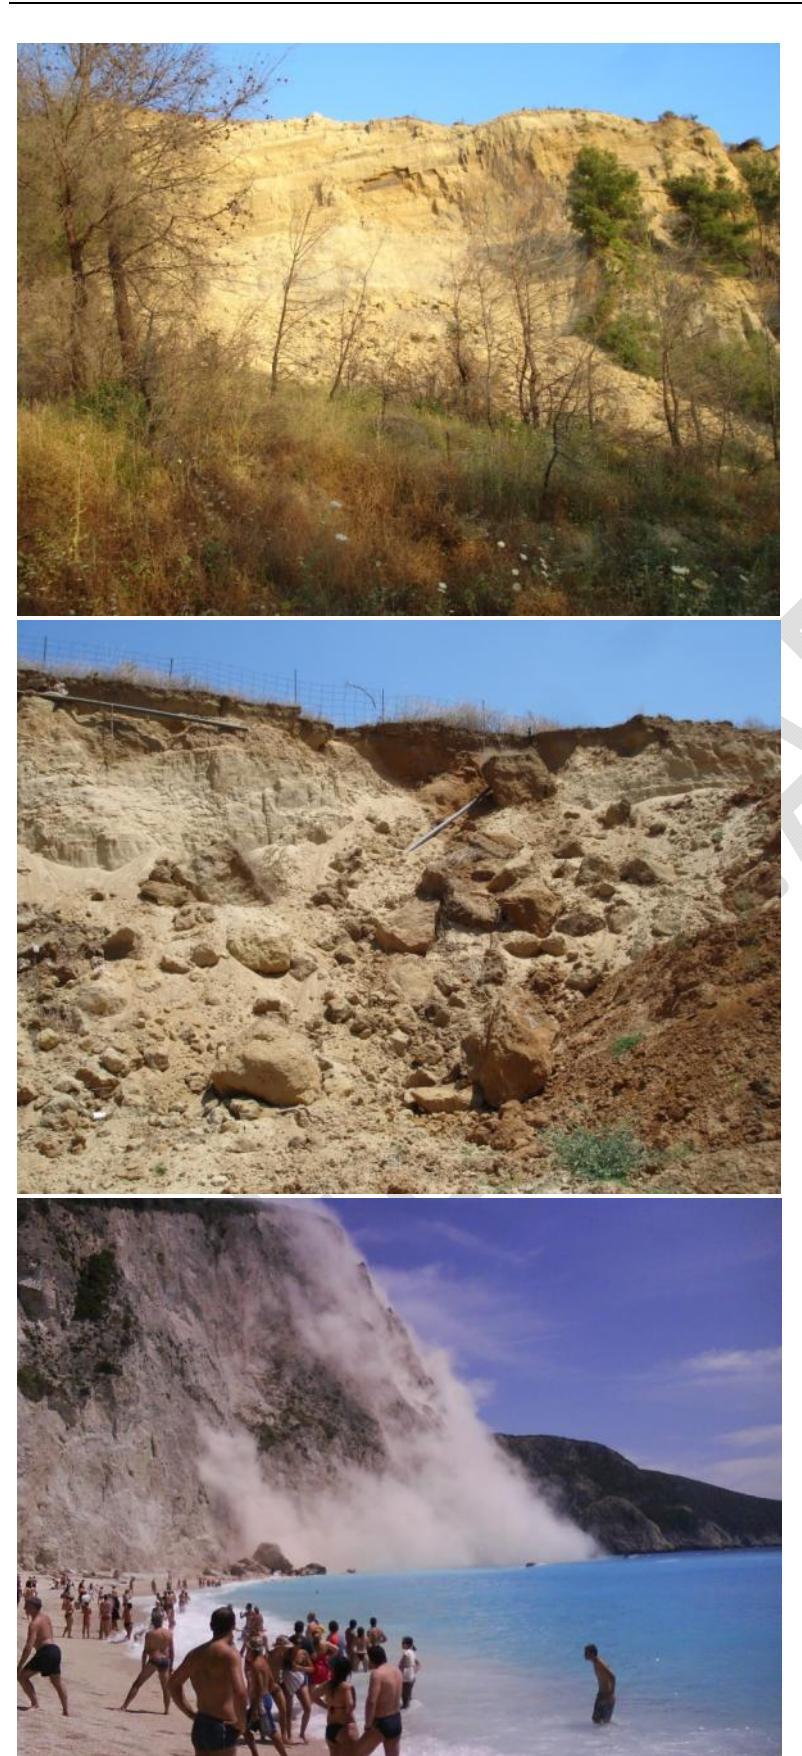
Other slope movements in many other sites were associated with either morphological or secondary tectonic causes (Figure 14 and Figure 15). Environmental effects of the earthquake were observed as far as Livadia (Arkadia) to the east or Porto Katsiki beach (Lefkada island) to the west (Figure 16).

Figure 14. Slope movements like this one were observed in many sites at the epicentral area.

Figure 15. This slope failure exposed and damaged the irrigation pipe.

Figure 16. Rock fall at Porto Katsiki beach (Lefkada island) during the earthquake. Photo published in Greek electronic media.
