Geomorphological hazard assessment on natural rock wall for free climbing practice

MOTTA M. (*), PANIZZA V. (**),
PECCI M. (***)

3. – THE CLIMBING CASE STUDY OF THE PIETRA DI BISMANTOVA ROCK WALL: AN APPLICATION OF THE PROPOSED METHOD

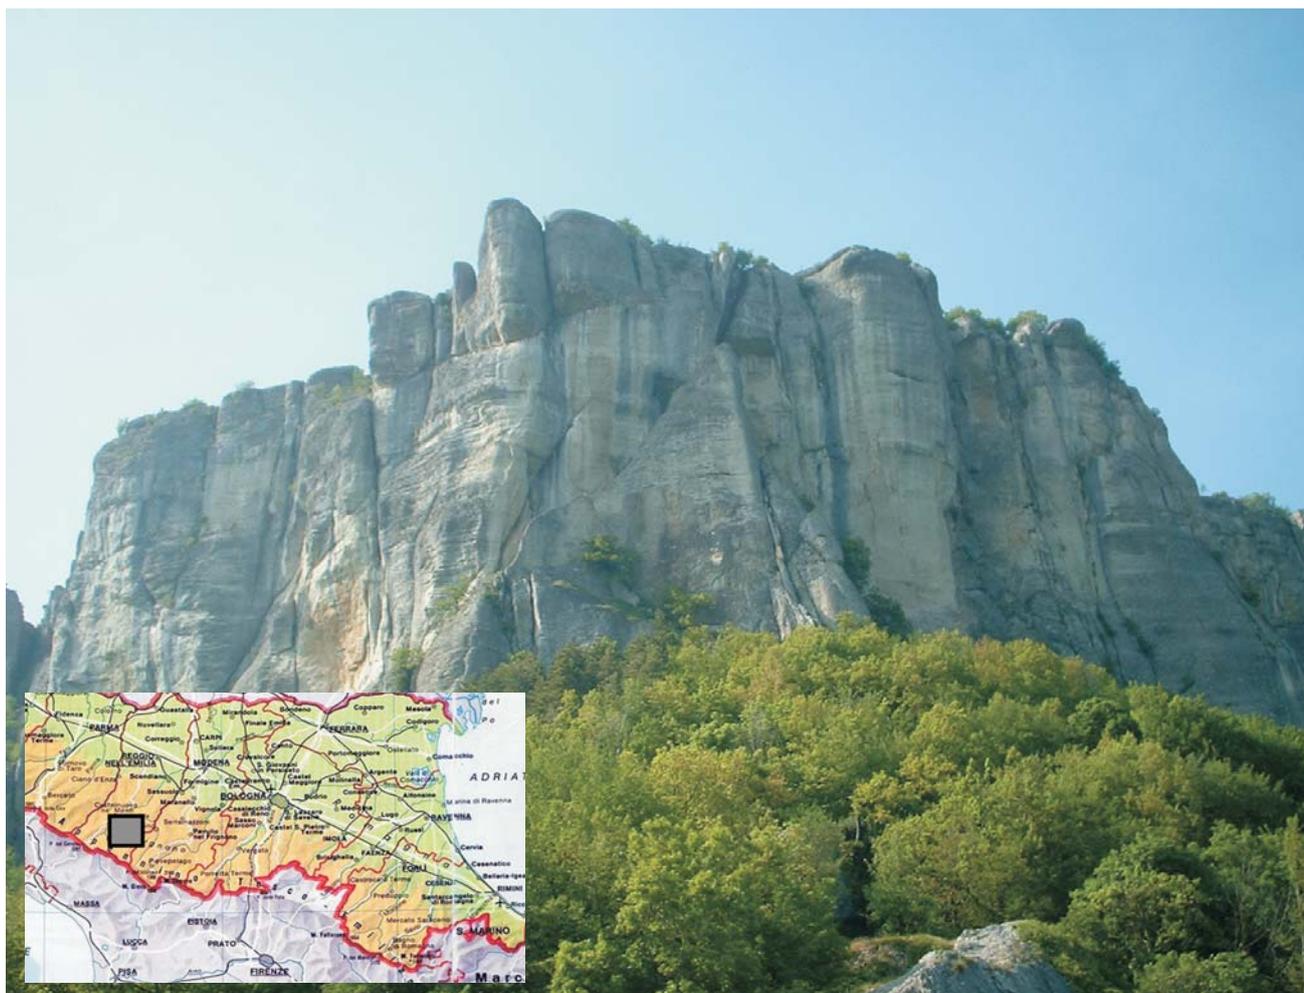
Fig. 1 – Location and general view of Pietra di Bismantova.
 – Ubicazione e veduta generale della Pietra di Bismantova.

After a review on the available methods and tools and the discussion on the best draft, a general control of the form has been performed in the test site of the *Pietra di Bismantova* (indicated more briefly “*Pietra*” in the following, figure 1).

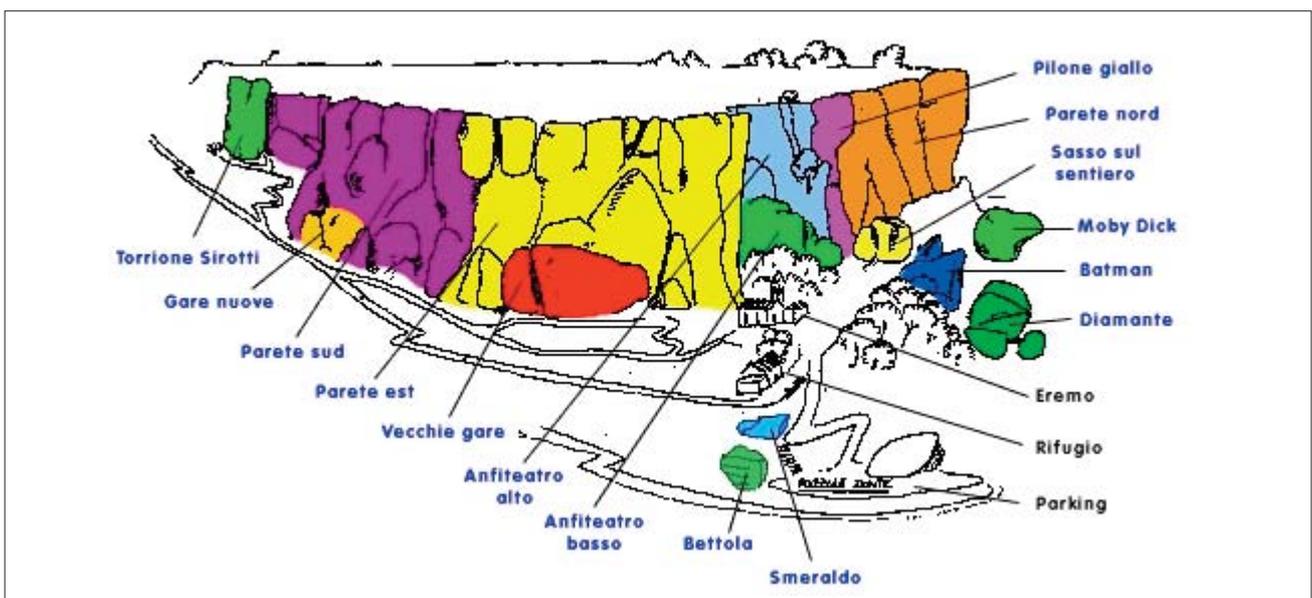
Fig. 2 – Sketch of the equipped walls of the *Pietra di Bismantova* (www.sincretech.it/bismantova/html/arrampicata).
 – Schema delle vie attrezzate per il freeclimbing della *Pietra di Bismantova* (www.sincretech.it/bismantova/html/arrampicata).

paths, characterising also today the southern and equipped face (fig. 2).

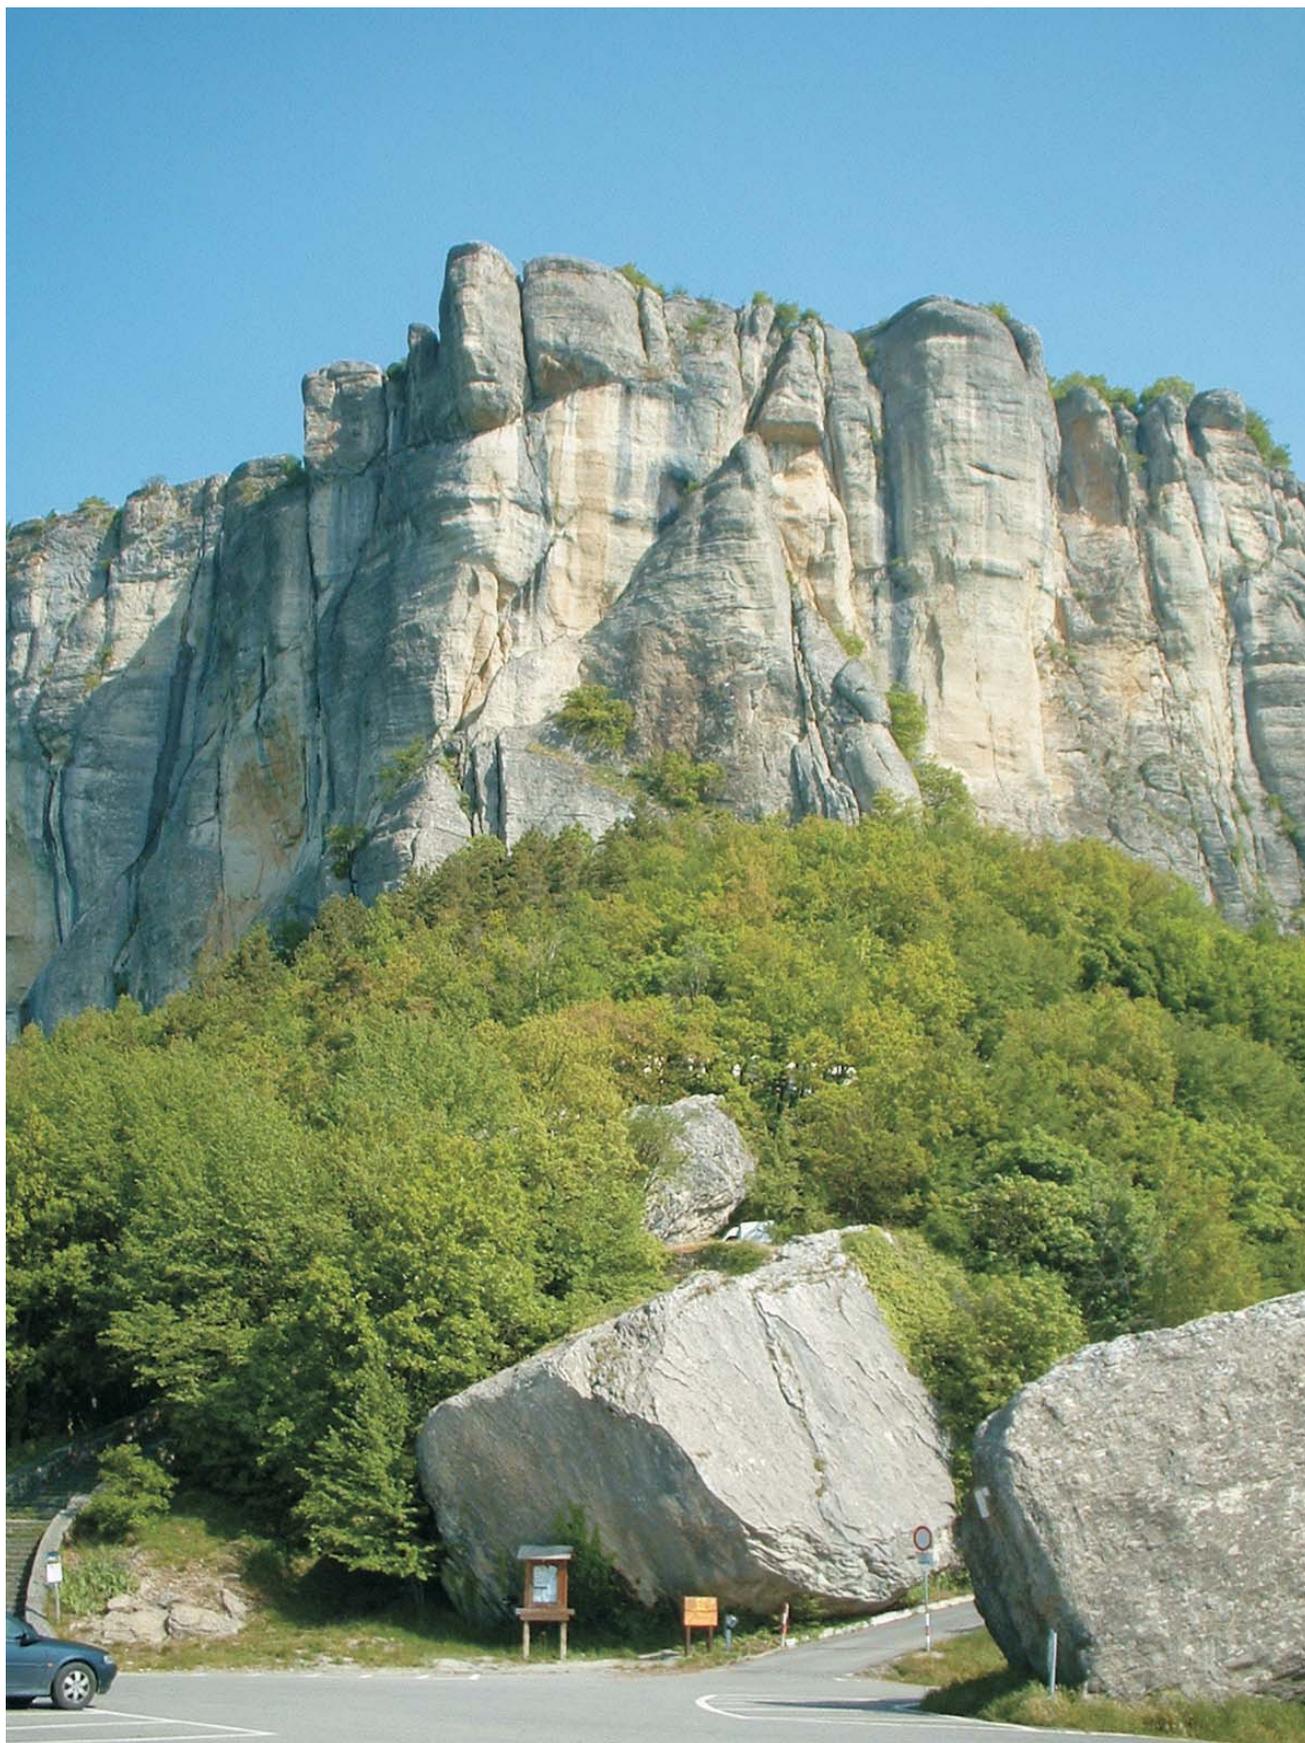
Fig. 3 – The high walls of the southern slope.
– *Le alte pareti del versante meridionale.*

The obtained value and BMRMR are in agreement with the stability condition of the rock mass, controlled at meso and macro scale respectively by stratification and sub-vertical tensile discontinuities. They produce, respectively, little “brick pattern” at the toe of the wall (fig. 4) and mega-boulders at the toe of the whole slope (fig. 3).

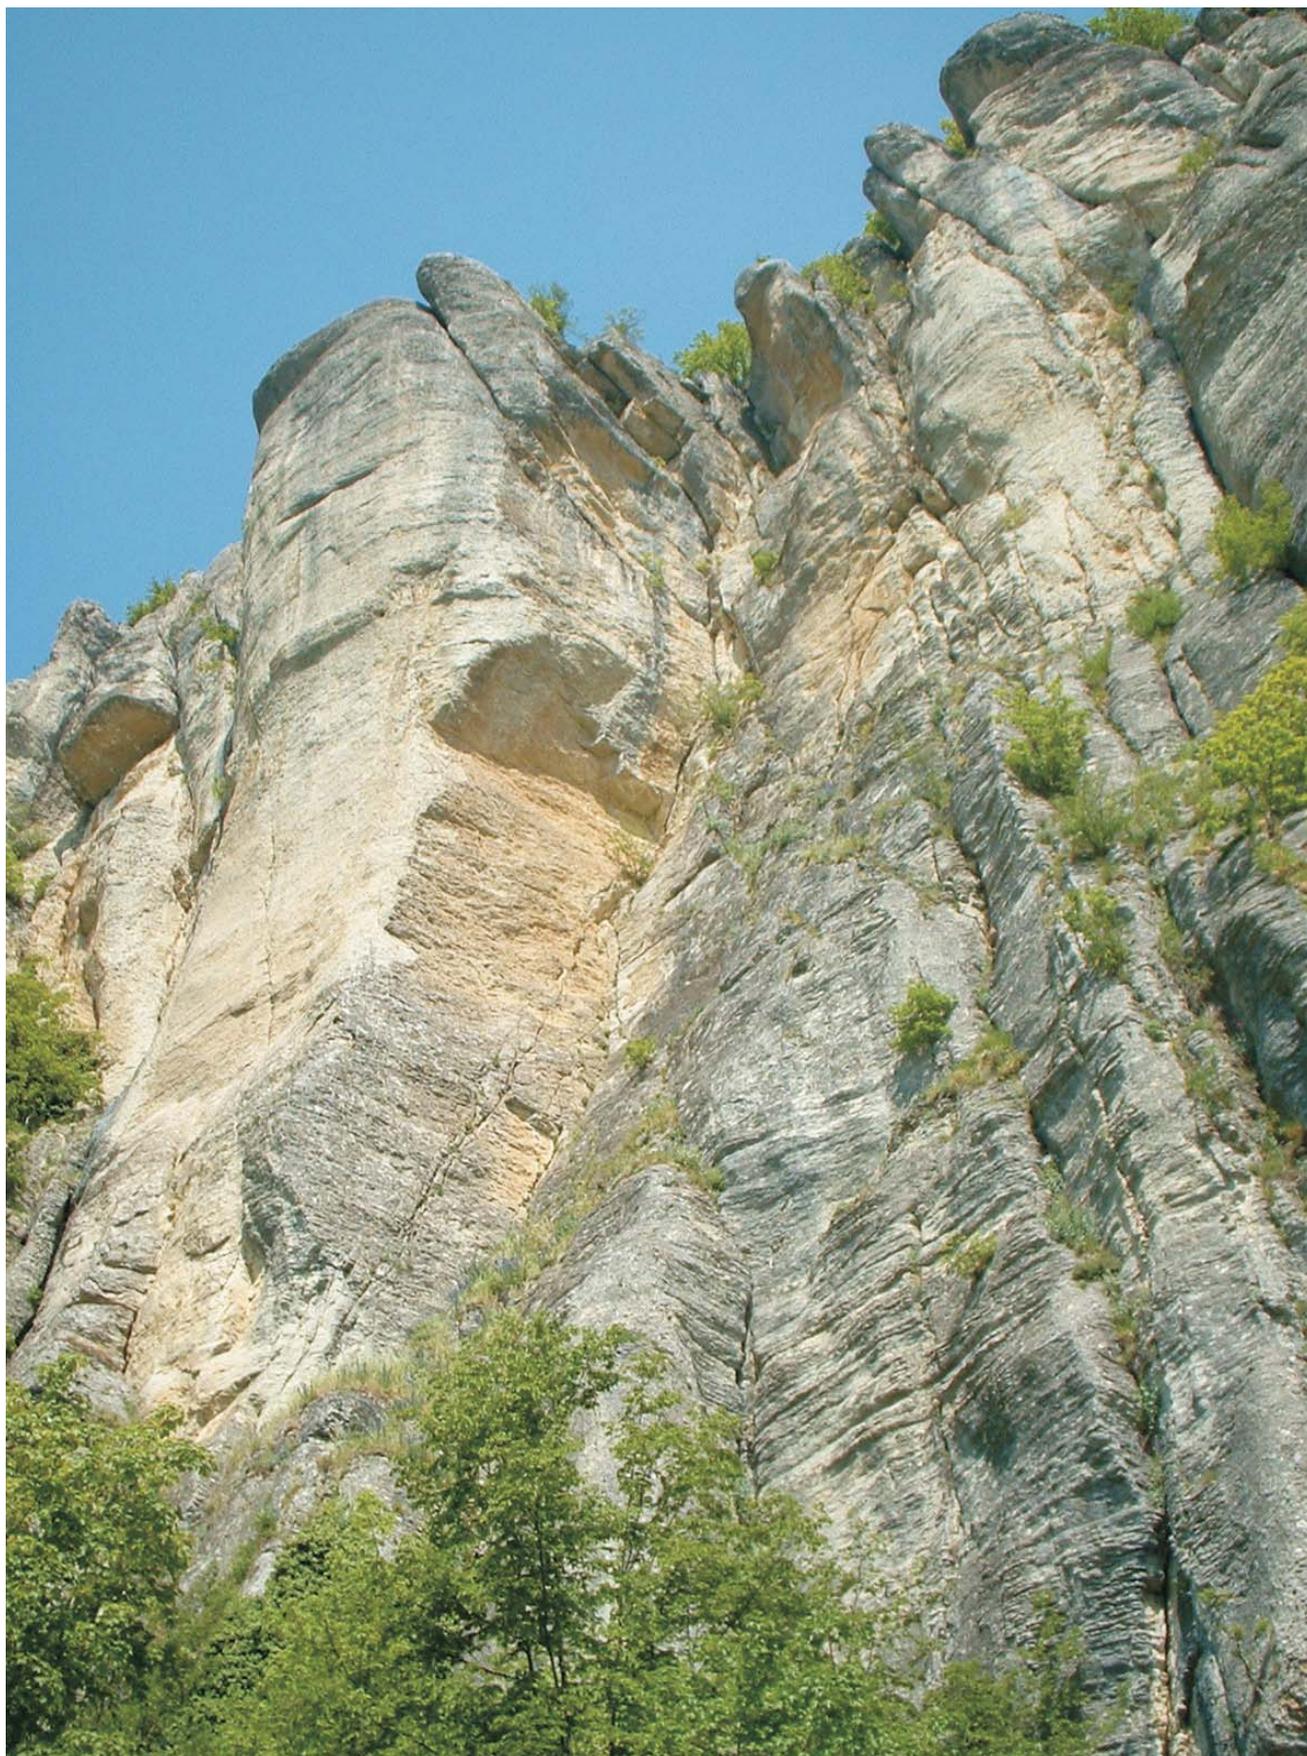
Fig. 4 – One of the walls of the climbing sector *Vecchie Gare*.
– *Una delle pareti del settore di arrampicata Vecchie Gare.*
