Italian Coast Guard - APAT/ARPA - ICRAM

# **Italian Ministry of Environment Mission in Lebanon**

## **Activity Report**

**September-November 2006**

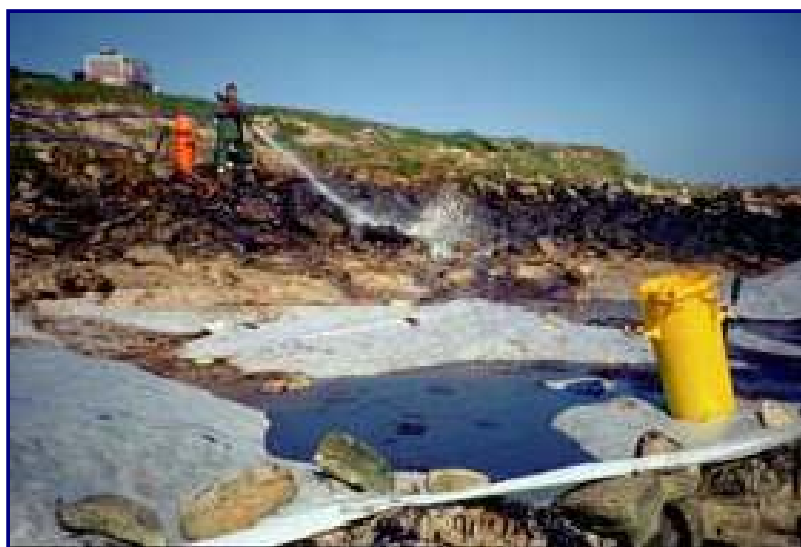
Figure 1. A low pressure water pump utilized to collect bulk oil (source [www.cedre.fr](http://www.cedre.fr))

The first operation to be done (after removal of waste material) is to recover the bulk oil. This operation can be carried out manually or through vacuum units or other skimmers on pooled oil. Low pressure flushing with sea water may also be employed to wash oil residues to collection points.

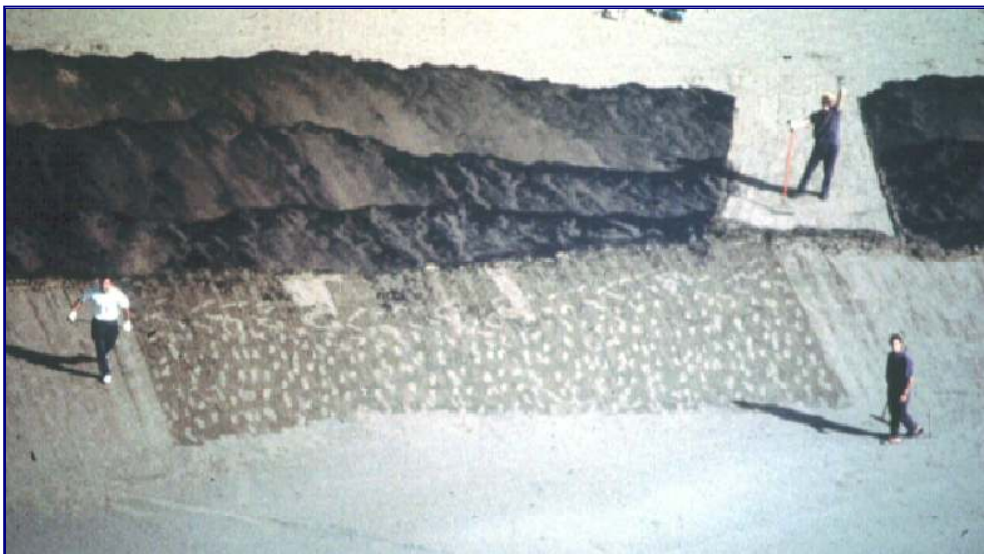
Figure 4. A sandy beach partially cleaned by wooden scrapers (source [www.itopf.org](http://www.itopf.org))

As for the rocky shores, the first operation to be carried out (after removal of waste material) concerns the recovery of heavy accumulations. This action could be accomplished through the use of wooden scrapers which allow a significant separation of oil from sand. The material is then collected manually with shovels and rakes and stored in dedicated tanks.

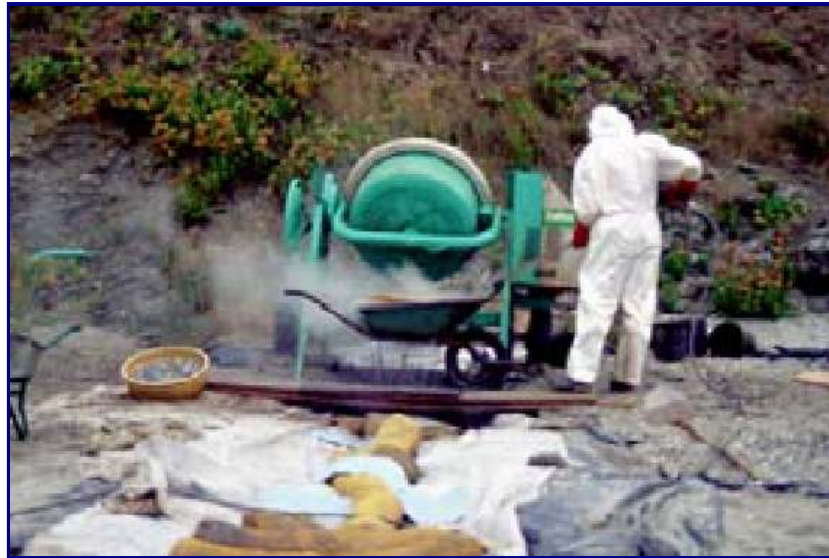
Figure 7. A mortar mixing machine utilized for cleaning pebbles contaminated by hydrocarbons (source CEDRE, [www.le-cedre.fr](http://www.le-cedre.fr))

and positioned on the beach. Pebbles are collected by means of a shovel and included in the mixing machine. A solvent able to effectually dissolve hydrocarbons is added leaving it for a few minutes to act; finally hot water is added to complete the washing operation.

With the aim of minimizing the quantity of waste following the washing operations, the volumes of water, solvent as well as the time necessary to complete the activity will be assessed through a preliminary test. Once the washing operation is over the content of the mixing machine is poured into a container having an upper grid able to retain the pebbles and to let the washing liquid pass. The pebbles on the grid are once again washed with water by means of a high pressure water pump in order to eliminate any residue of solvent and/or hydrocarbons. Finally pebbles are repositioned on the beach taking care of maintaining the original profile of the beach.

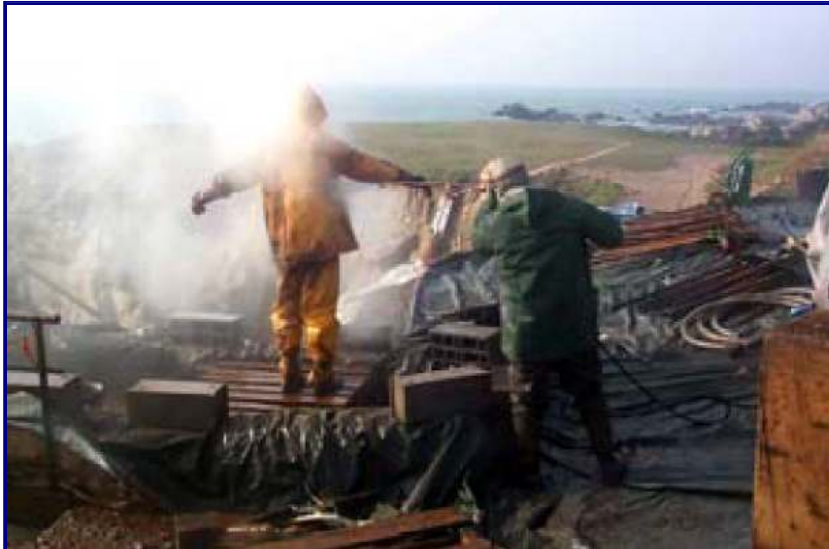
Figure 8. Clean up of personnel once operations are concluded

The working site must be clearly visible and interdicted to non authorized personnel. It is highly recommended to identify well-marked areas dedicated to the stockage of the recovered material and to the clean up of material and personnel once the operations are concluded.

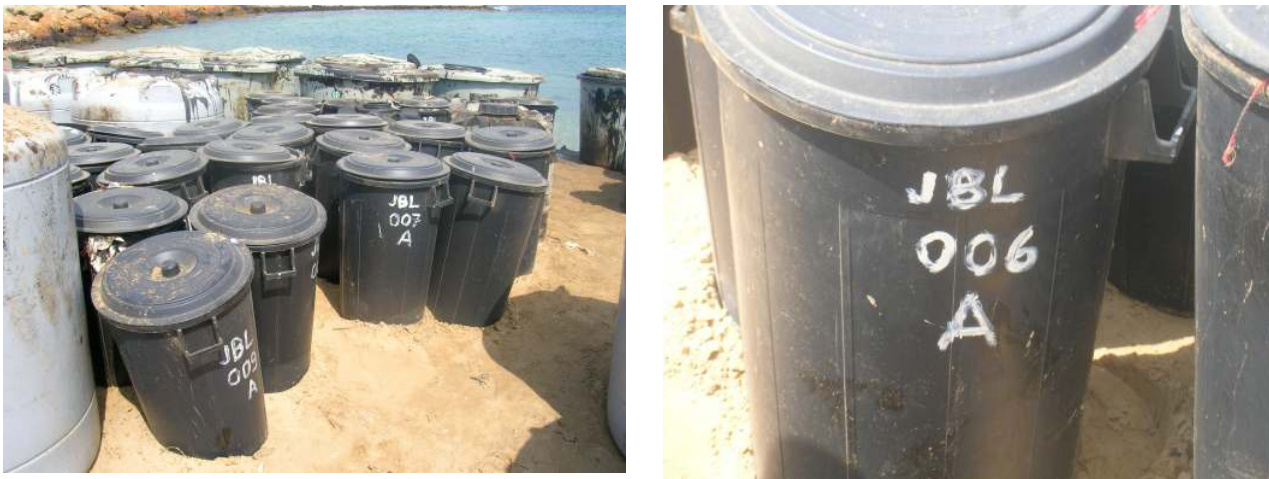
Figure 1

The Italian delegation is now proceeding with the labeling of all the tanks located in Jieh where the sunken oil collected by divers is stored (Fig. 1).

In the example showed in figure 1 the code is J BL 006 A

An alphanumeric code could be applied with the aim to track the container that should include information on the area of collection, the workers team who gathered it, the container progressive number and its volume.

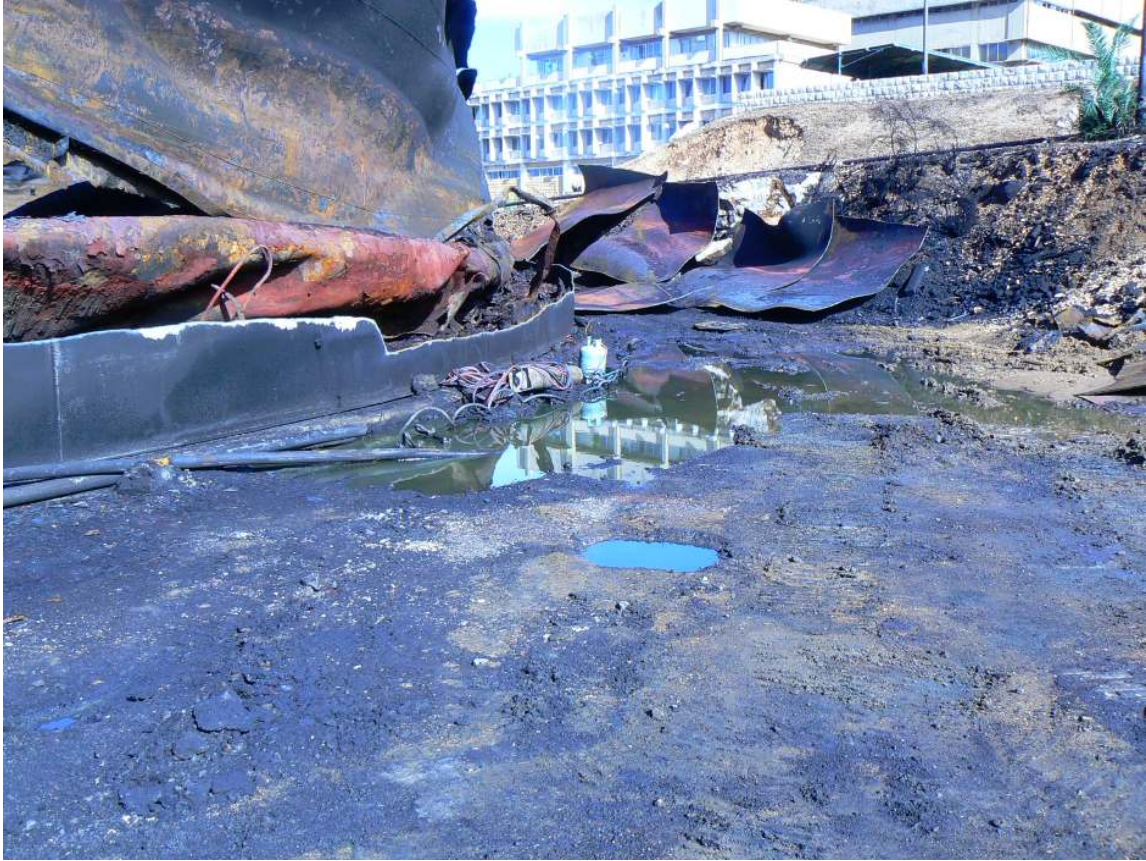
**Photo # 1**

Operations of ground levelling and debris removal are still active in the region of the Jieh site damaged by the bombing. Such activities are executed without taking any particular concern towards environmental related issues: the ground of the area is still loaded with oil that, as a consequence of the strong rain and the absence of a rainwater collecting system, can freely infiltrates into the soil (see Photo 1).

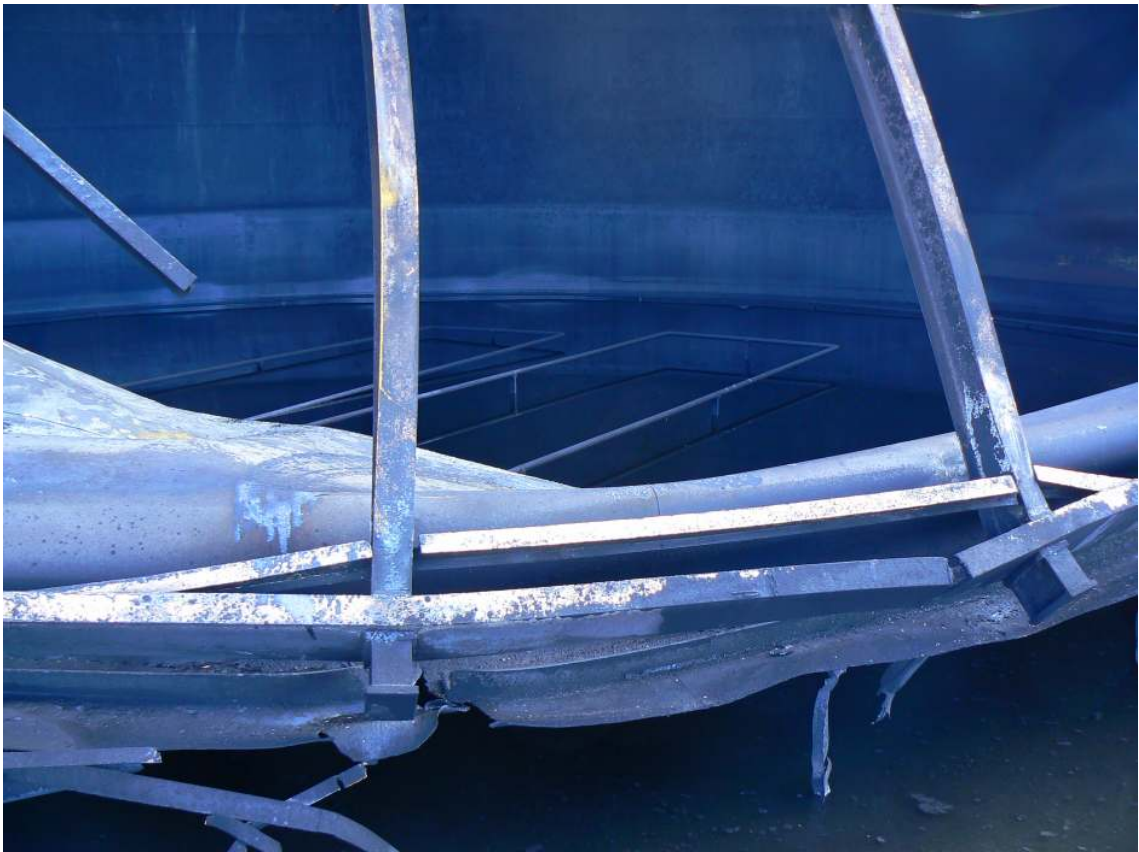
**Photo # 2**

While the bombed oil tanks were geo-referenced, one could notice how the tanks – whose top has been damaged or removed, are partially filled with rainwater mixed with oil residues that were still stored in the damaged tanks (see Photo 2). Care should therefore be taken in the phase of removal of the damaged tanks: the rainwater/oil residues mixture shouldn't be pumped out and dispersed without treatment on the ground of the site.

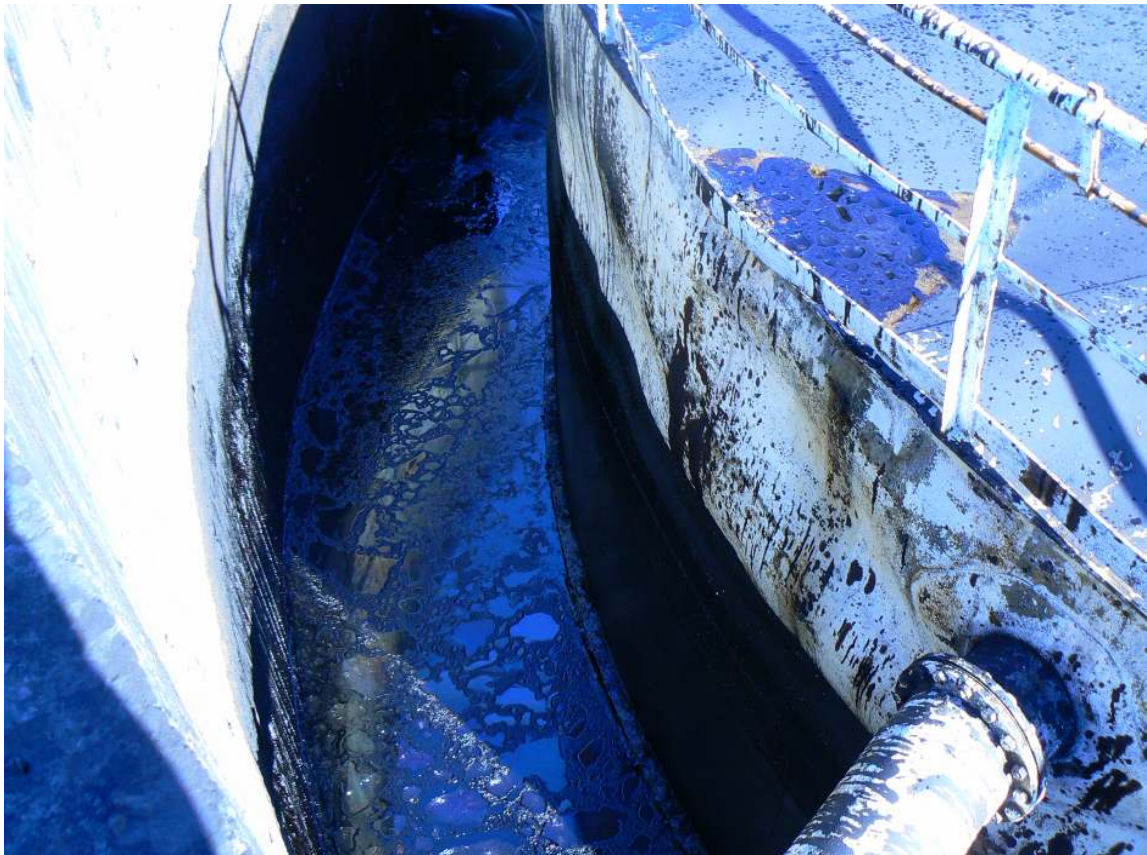
**Photo # 3**

In the Southern area a (completely underground) old tank has been identified, characterized by a storing capacity of 600 m<sup>3</sup>. This tank is presently used to store the oil to be burnt at the power station. This groundwater tank, however, appears to be heavily damaged from a structural point of view. The volume separating the tank from the outer cement containment wall was found to be partially filled by heavy fuel oil mixed to rainwater (see Photo 3).

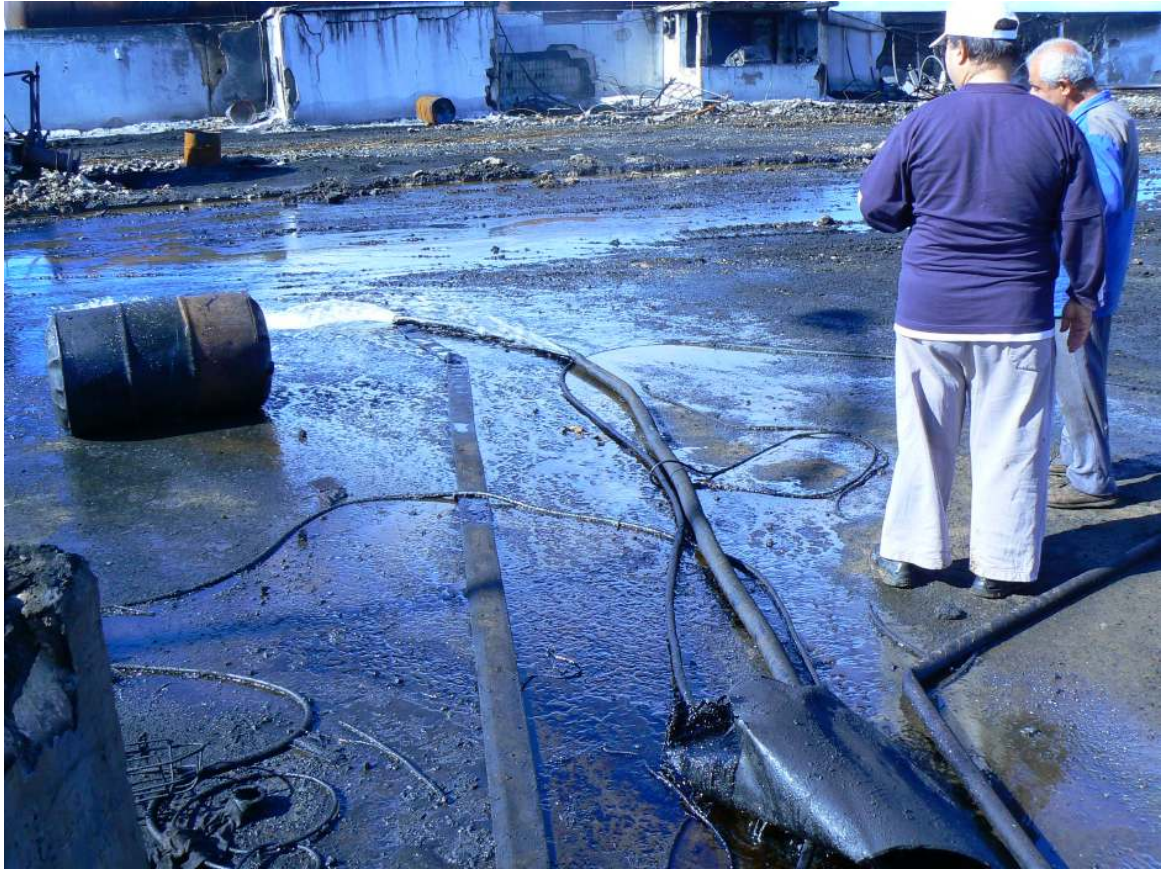
Photo # 4

The oil present in this volume is routinely pumped and dispersed in the environment (see Photo 4).

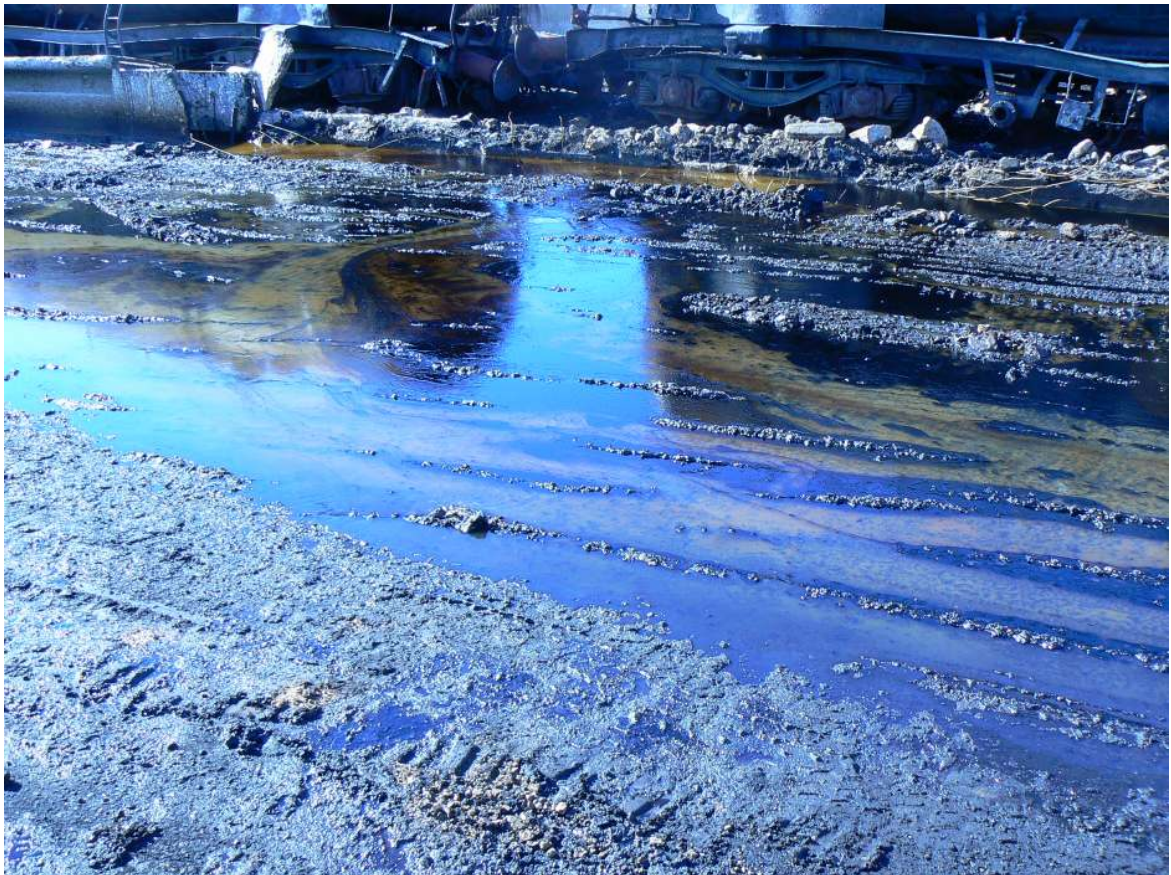
Photo # 5

*Water seems to accumulate on the ground in that area (see Photo 5), infiltration being relatively slow and the mixture of water and pollutants, which is only partially intercepted by the (heavily damaged) rainwater collecting system, could easily reach other sensitive `environmental objects`. It has been not possible to identify the final fate of the collected water, one could however imagine that the mixture would be, at least partially, infiltrates reaching groundwater and further dispersing in the local environment.*

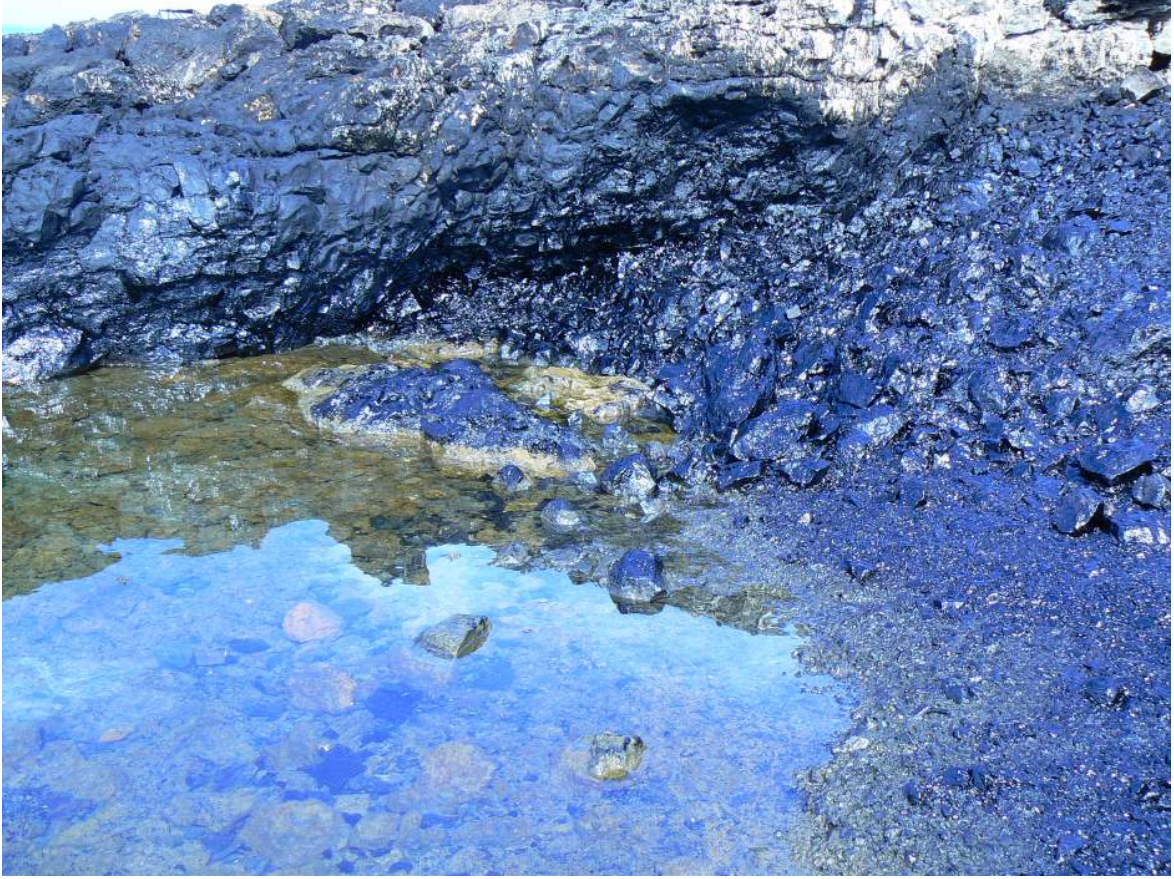
**Photo # 6**

Along the coastal area protecting artificial breakwater rock-cliff, at the time of writing (end of October 2006) it is still possible to identify diffused regions where the cliffs and the rocky substrate are still soaked with fresh oil (see Photo 6). On the base of the previously reported scenario, following the indications contained in the submitted document “*General recommendations for the characterization and recovery of Jieh power plant*”, one could put forwards the hypothesis that the oily mixture infiltrating in the rocky substrate, pushed by groundwater, could reach the sea and re-emerge from the rocky sea bottom. Groundwater transport and the intrusion of salt water of different densities could create a preferential dispersion path for the percolated and transported hydrocarbons. The Jieh`s typical oily residuals, slightly less dense than water and with their characteristic physical-chemical parameters could `float` along the salt water intrusion surface, re-emerging from the sea-bottom in the immediate vicinity of the coasts.

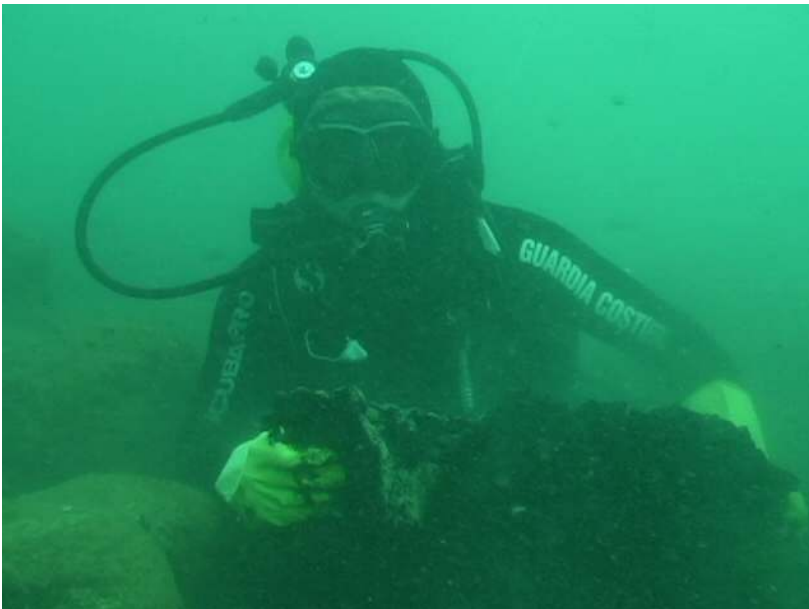
- The sea bottom in front of blown- off tanks is characterized by degrading rocks bordered on the north, south and west by large sand patches;
- In the sand bottom between the rocks the pollutant appears to be present on a scattered basis;
- The pollutant has been found prevalently in the solid and semi-solid appearance (see pictures).

Solid appearance pollutant

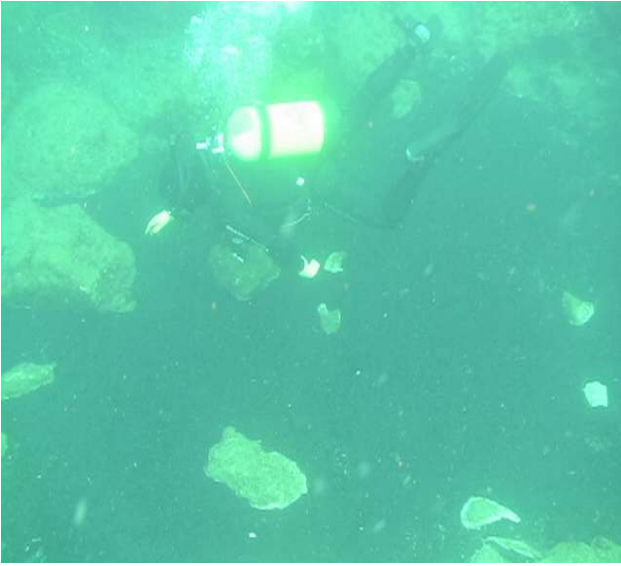
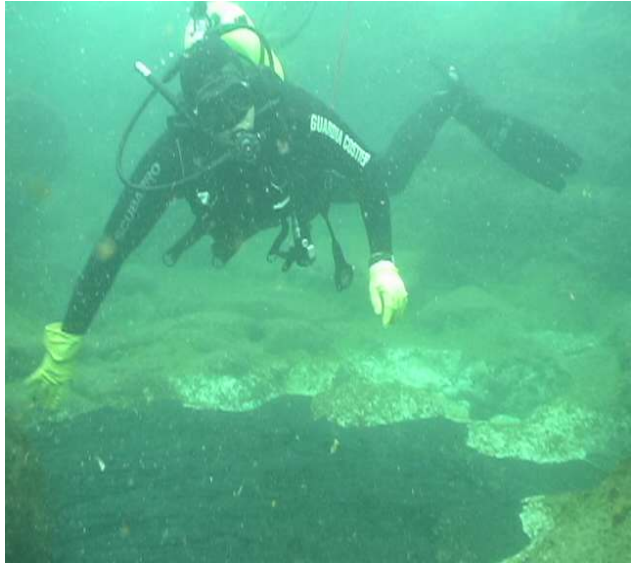
- On the sea bottom, in front of the spillage point, there is the higher concentration of pollutant;
- The pollutant concentration decrease progressively northbound and southbound from the tank area close to the coast;
- As noted during the first dive large patches of pollutant is hidden by a sand layer in almost every space between the rocks.

Pollutant trapped between the rocks

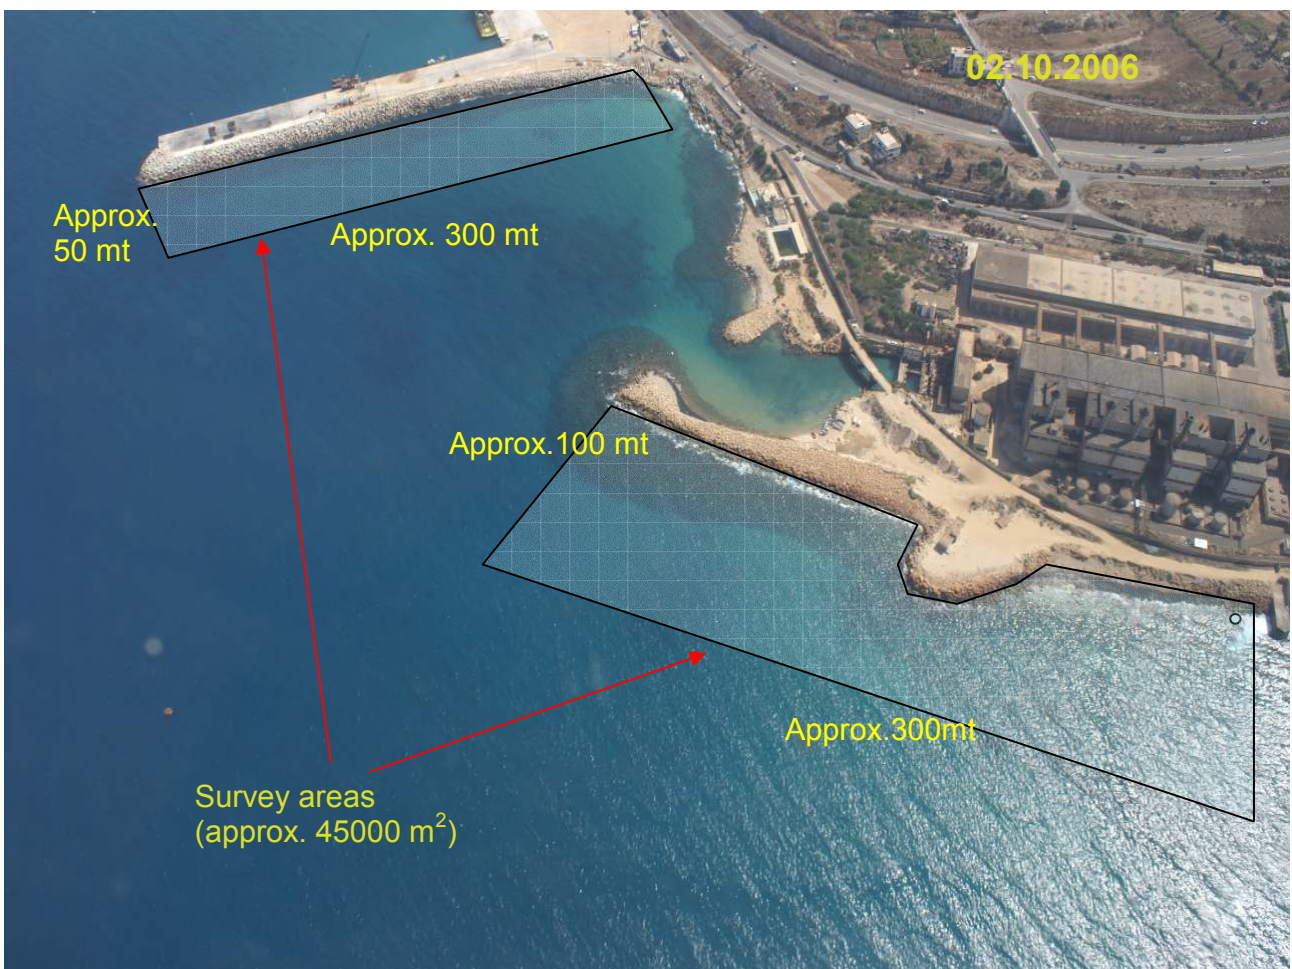
The survey, located on the coast area between the exhaust and the plant piers, permitted to verify that the pollution is very poor in the area and, since the sea bottom is mostly sandy, it appears to be necessary more accurate investigation techniques.

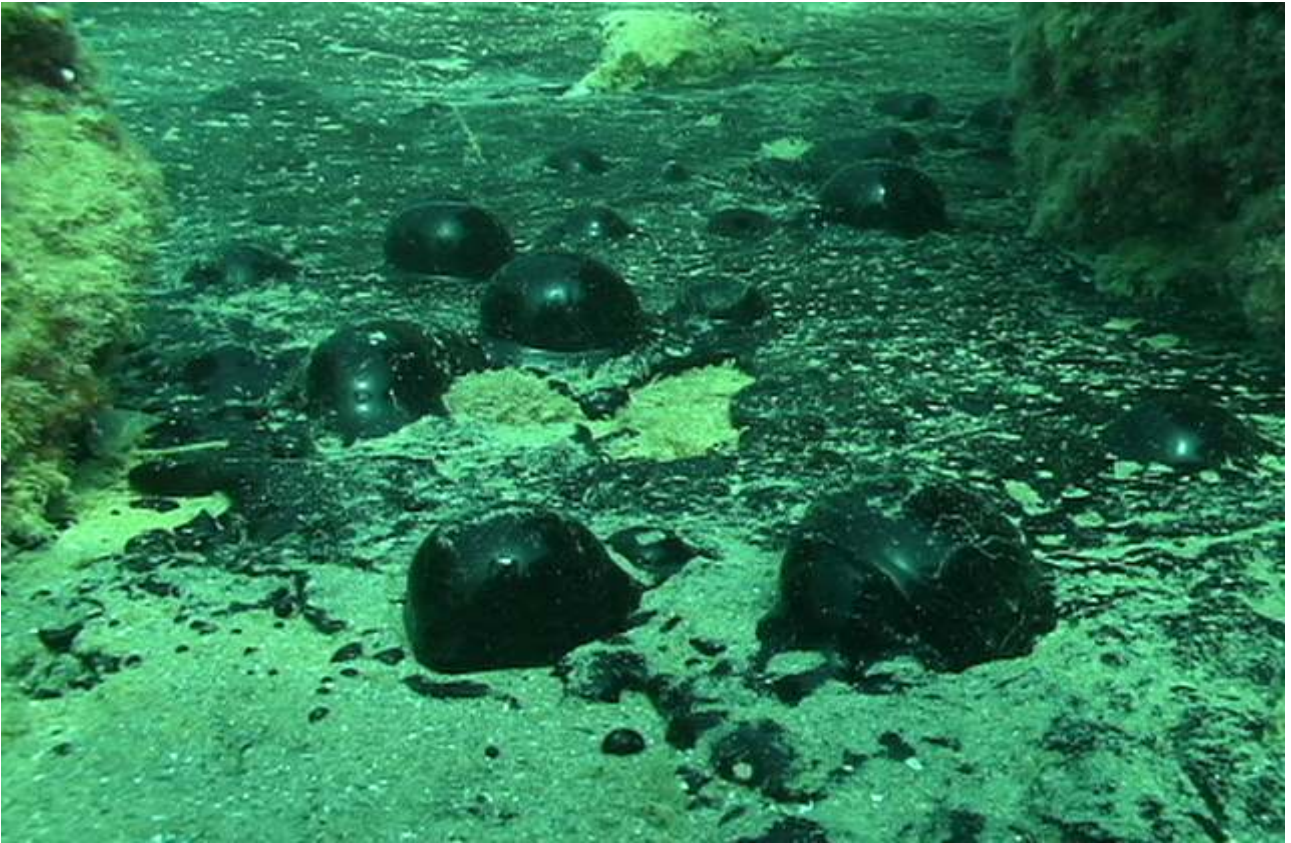
It has been noted a kind of partial “melting” process of the pollutant, meaning that from the amount of product on the sea bottom some oil bubbles rise to the surface producing the iridescence often found on the sea surface.

Oil bubbles (about 5cm in diameter) observed in a pollutant agglomerate partially covered by sand.

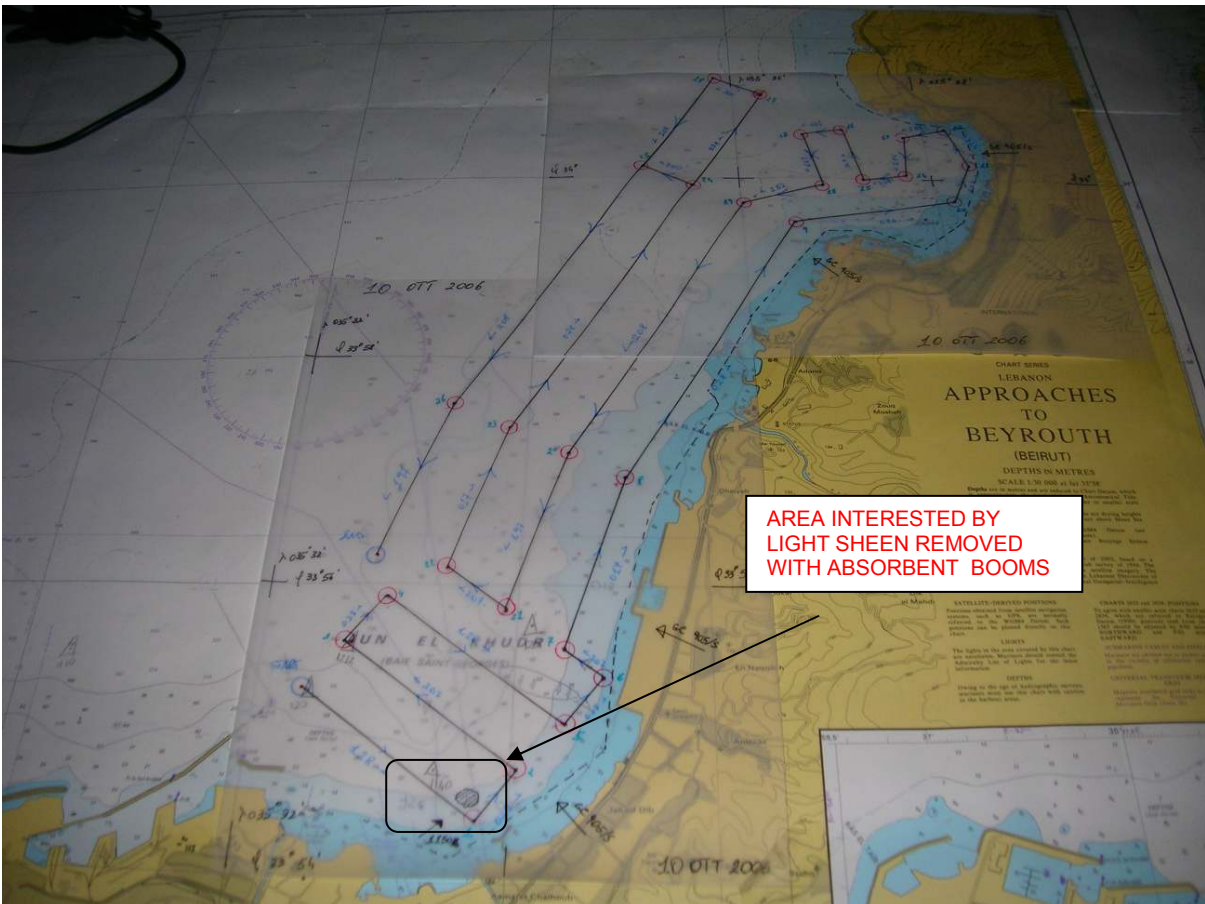
During the transfer navigation from Beirut harbour to Jieh operational area, the ship has been diverted to a polluted area north of Beirut.

Two oil slicks have been located and removed with absorbent booms.

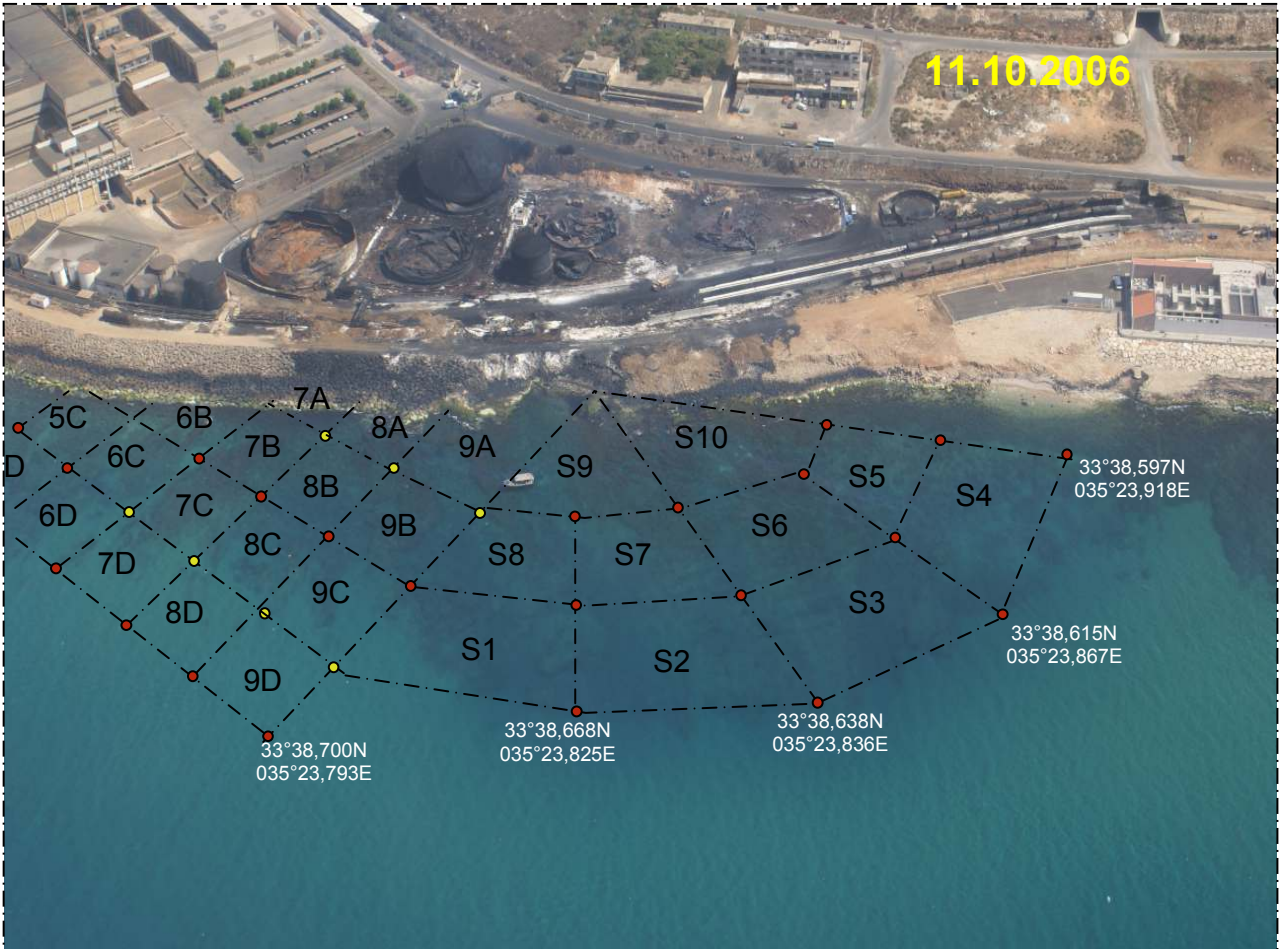
The grid has been placed over the entire polluted area. The southern part of the area has been divided using a sector scheme. Ten more areas are then determined.

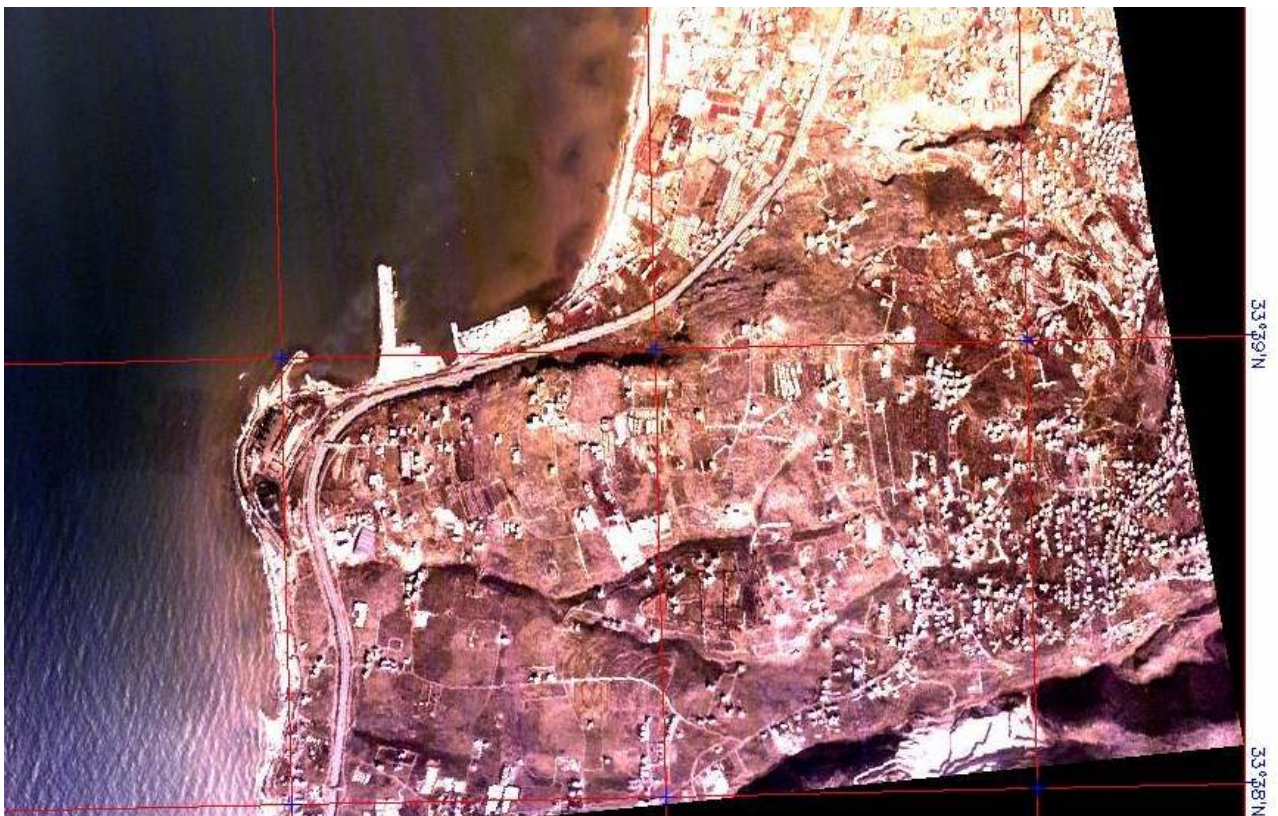
ATM Image of Jieh Power Plant area

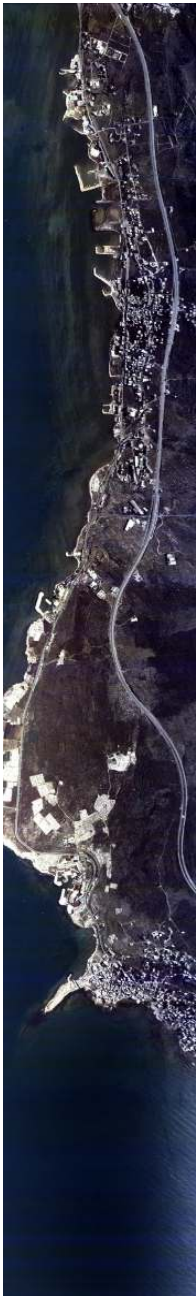
Raw data image

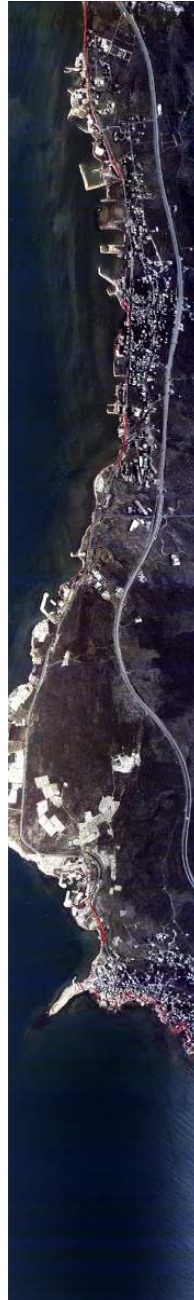
Processed image

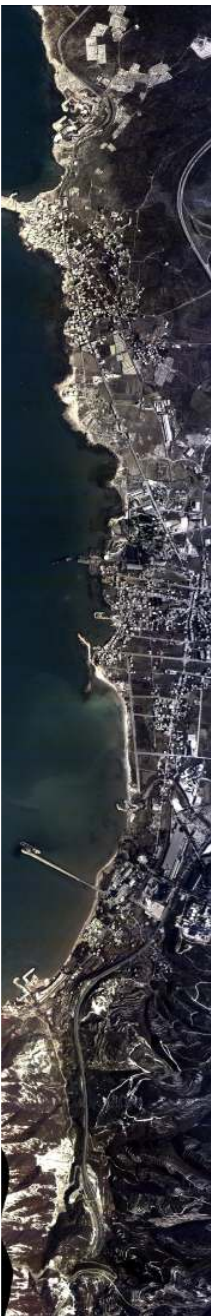
Raw data Image

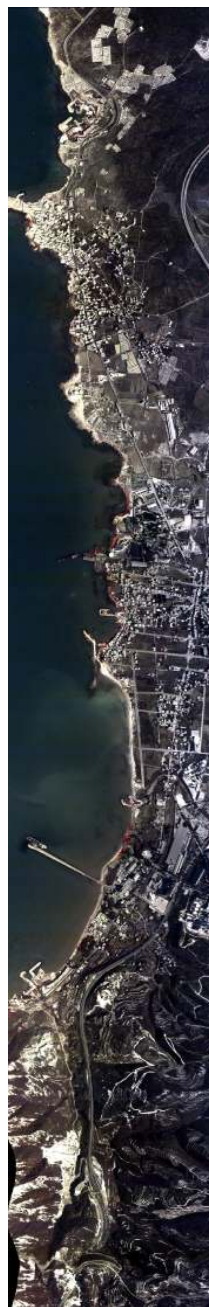
Processed Image

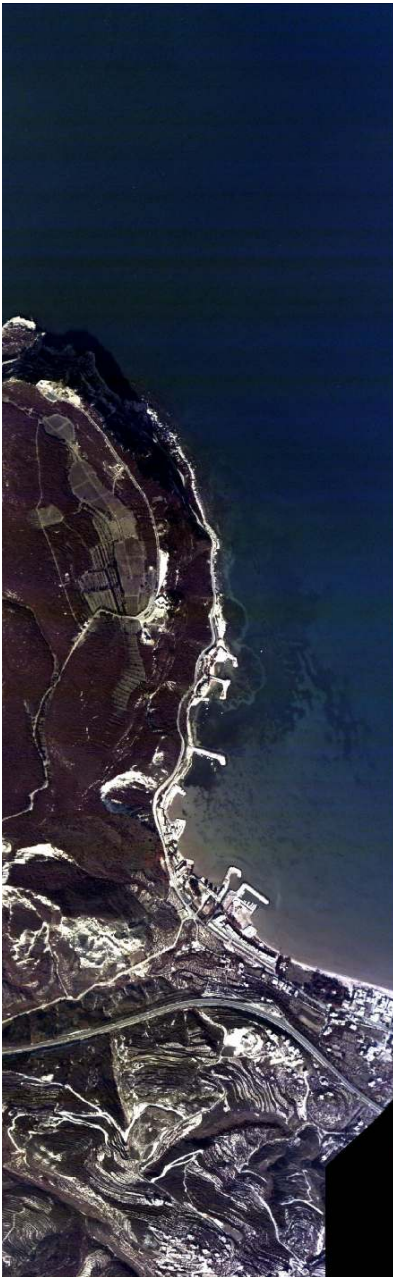
Raw data Image

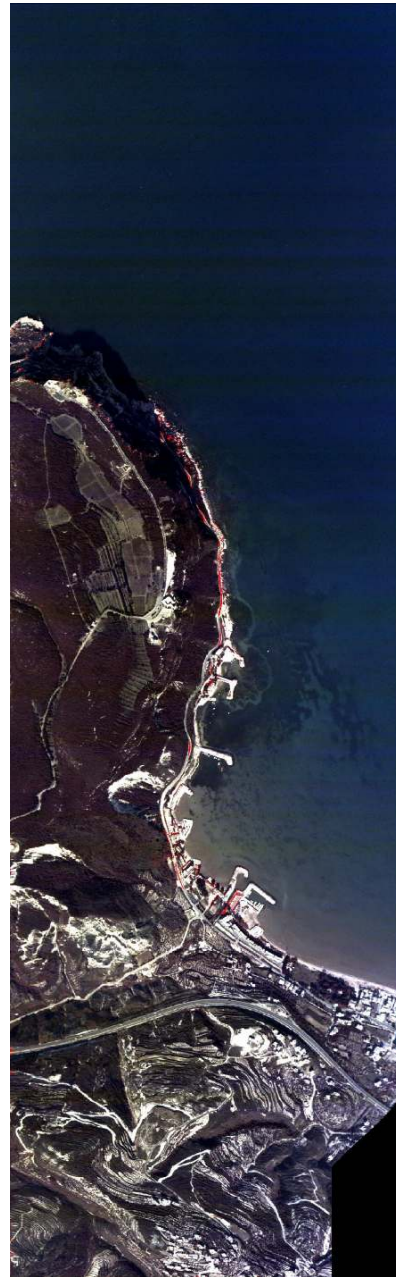
Pprocessed Image

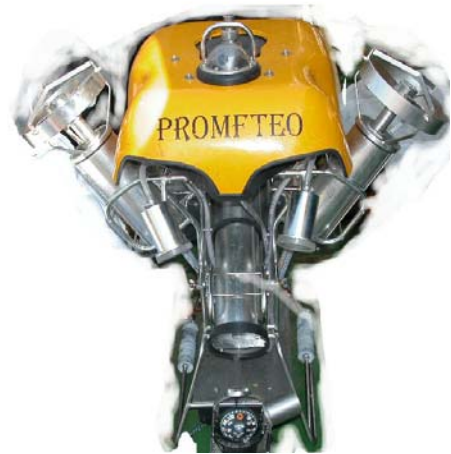
CABLE DRIVEN ROV PROMETEO

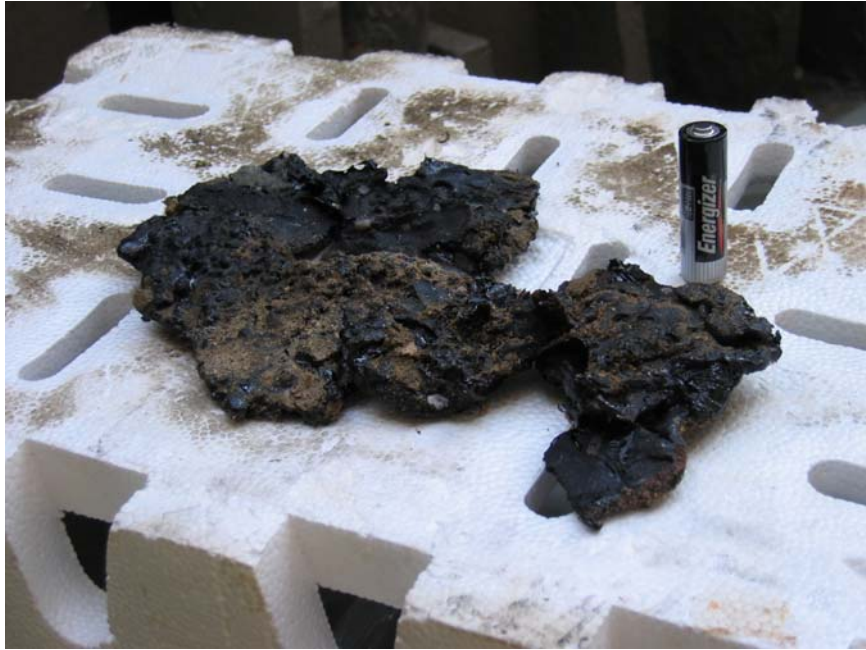
**Figure 3– Semi–solid residues**

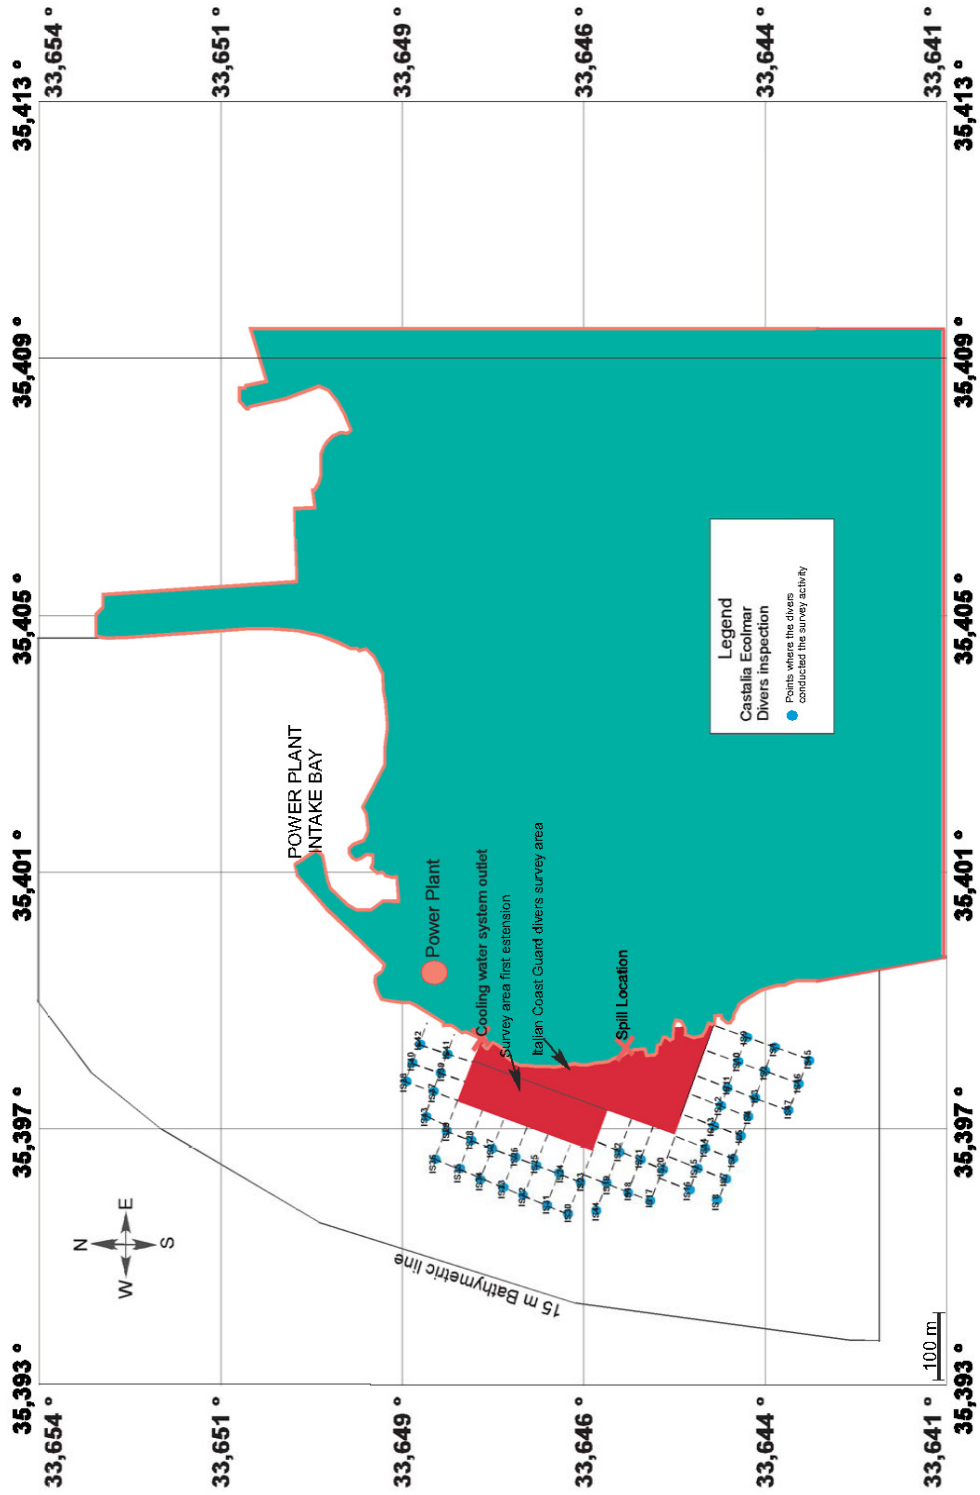
MAP 16

The period from the 11th to the 13th October 2006 has been dedicated to the divers verification of the presence of hydrocarbons covered by sand on the the areas represented in map 4.

MAP OF AREAS SURVEYED BY DIVERS

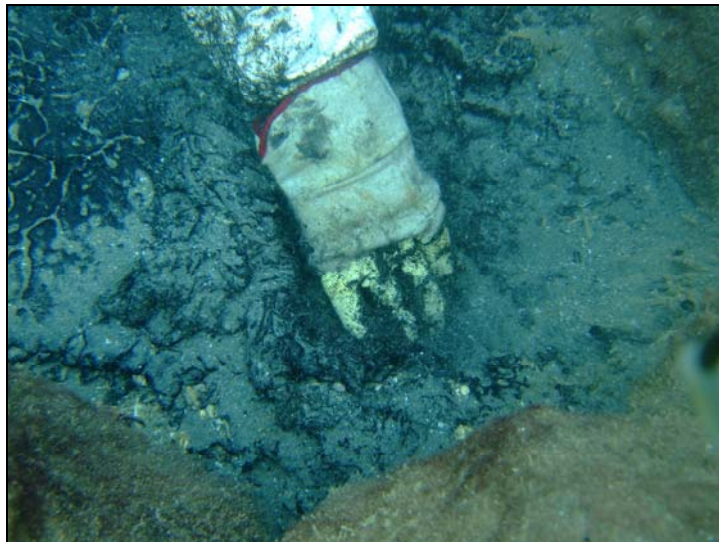
**Figure 6: semi-solid product**

- the third, almost liquid consists in a viscose liquid solution.

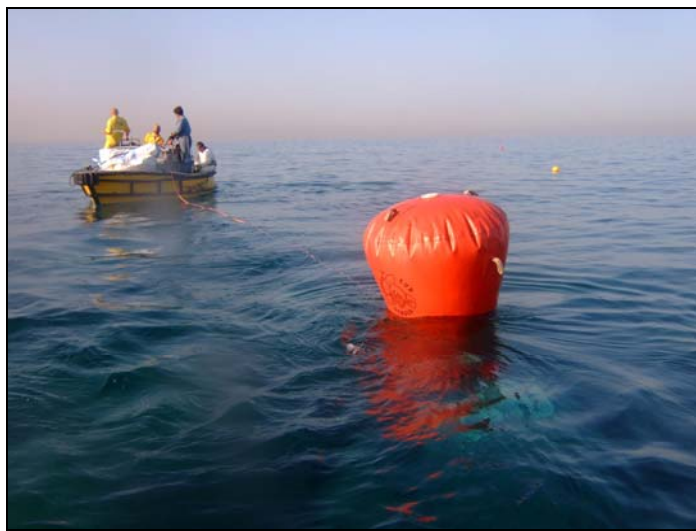
**Figure 8**

In the first step of the operations, in the area near the outlet of the power plant's cooling system and in the area in front of the tanks, the pollutant has been manually removed by the divers with the support of S/V Tito's tender. The activities have been conducted always at a certain distance from the coastline where the NGO BAHAR LUBNAN operations were already running.
