Italian Coast Guard - APAT/ARPA - ICRAM

# **Italian Ministry of Environment Mission in Lebanon**

## **Activity Report**

**September-November 2006**

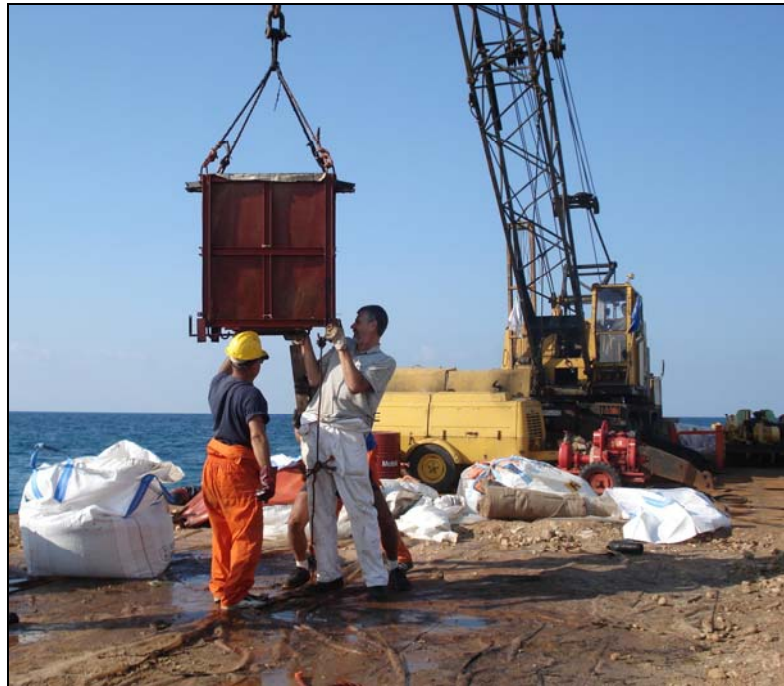
**Figure 9**

This system has been made with metal baskets of proportioned dimensions with the restraint and storage system available (1m<sup>3</sup> big bag with a breaking strength of 1000Kg) covered with geotextile in order to drain the exceeding water.

The baskets were equipped with extendable doors on the bottom in order to unload the collected products inside the big bags.

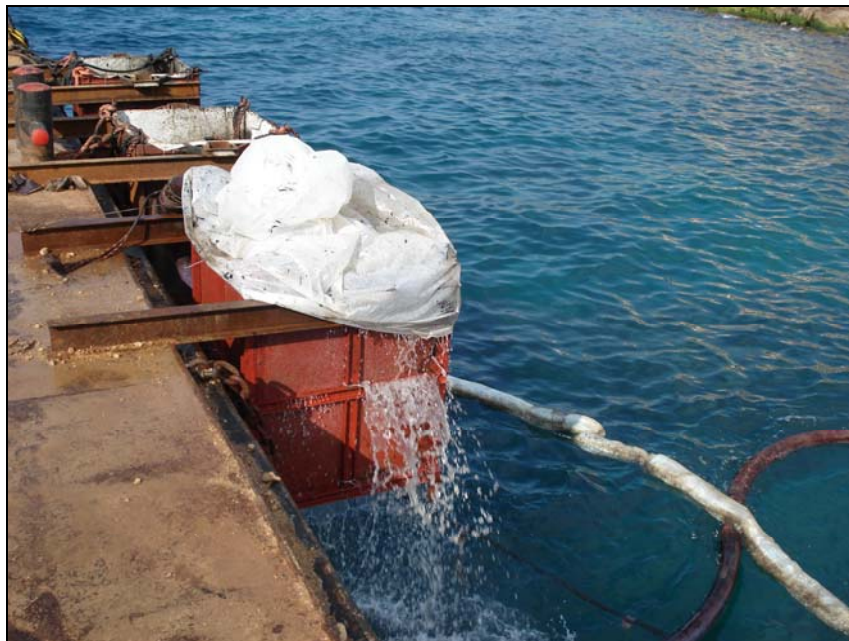
**Figure 10**

After few extraction tests two handy air suction pumping systems have been built in situ.

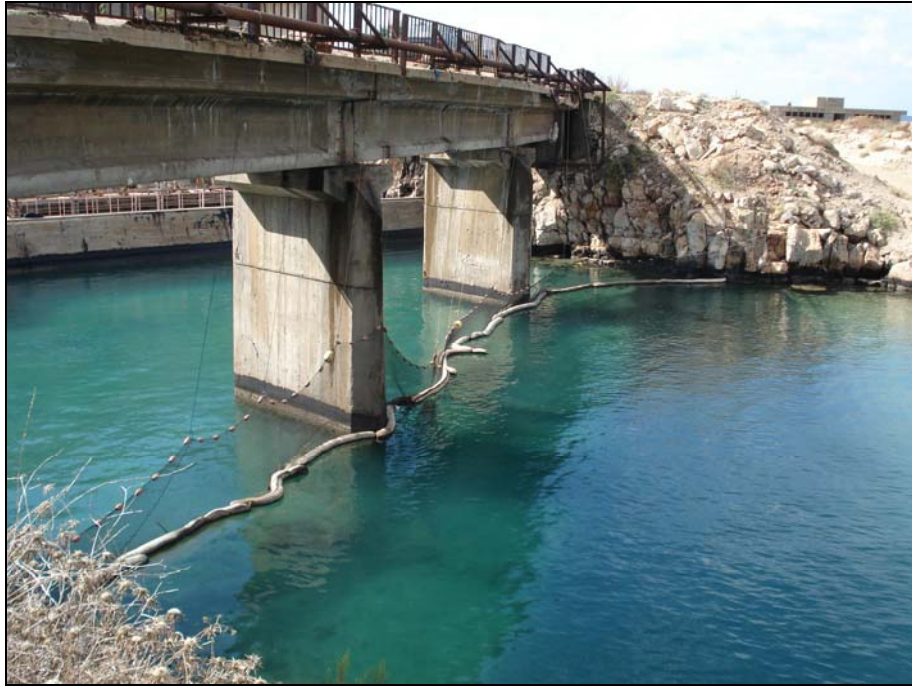
**Figure 11**

In order to protect the power plant's water intake area, the small bay has been closed by a vertical net and sorbent booms anchored to the bottom with weights to contain the possible floating pollutants.

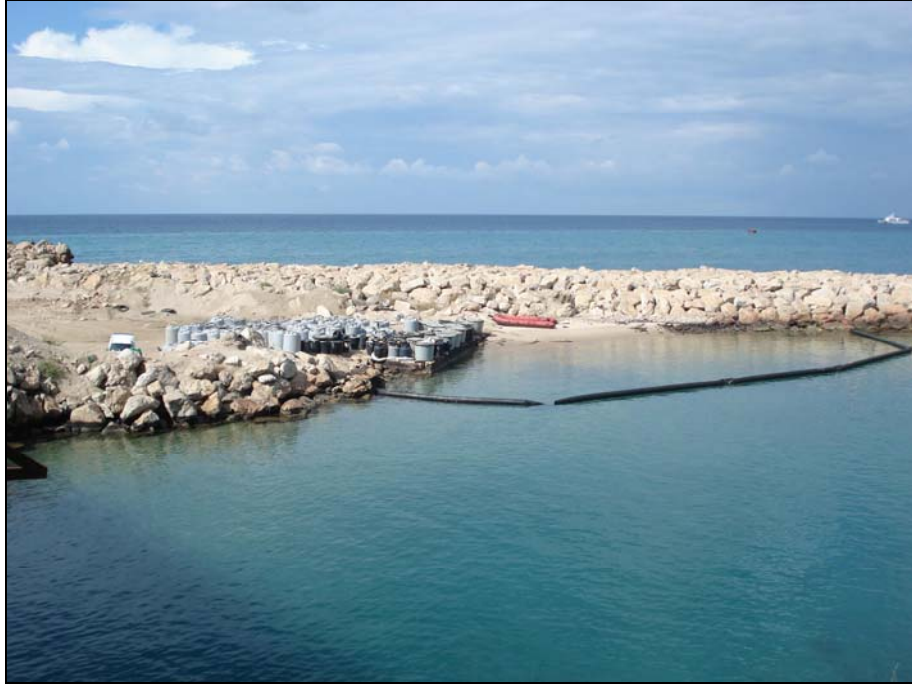
**Figure 12**

Moreover two coastal booms sections have been placed to protect the sea from possible spilling coming from the area where was stored the product collected by NGO BAHAR LUBNAN divers.

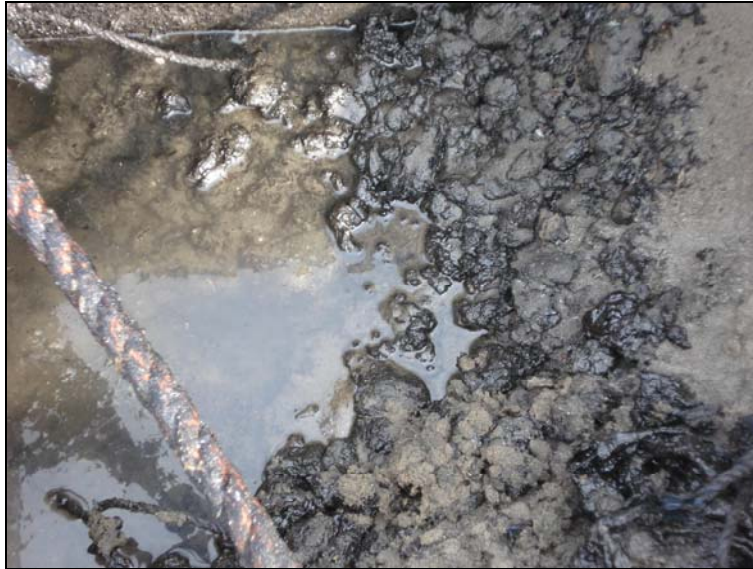
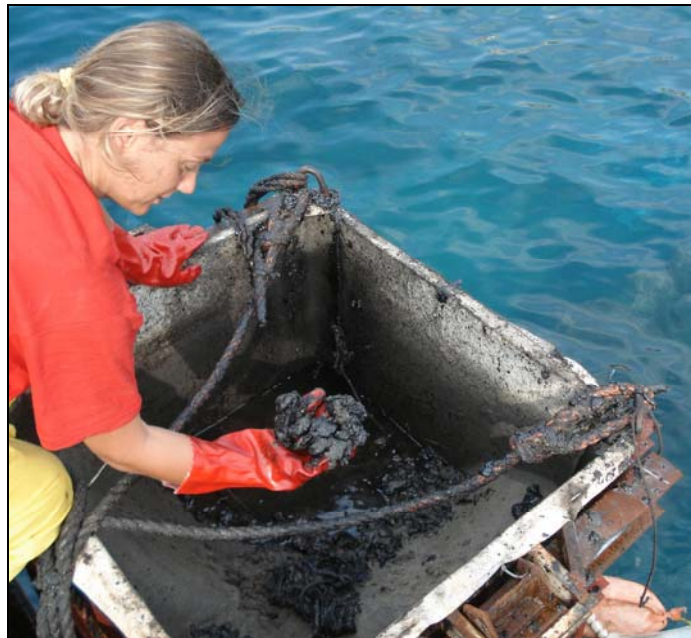
- The semi-solid product is suitable to be recovered with the air suction pump. This technology has been employed in the cells 5C, 6C 7C, 7B and 8B with satisfying results. The application of this technology has been applied only in the areas with significant presence of semi-solid product. Once concluded the activity on sectors C, the pumpable product with the utilized criteria, remained concentrated in few areas near to the shoreline (cells 7B-8B and S4-S5) with consequent limitations for manoeuvring and anchorage of the pontoon. On the above mentioned areas the operations have been conducted with the air suction pump when the weather conditions were favourable.

**Figures 15a -15b: aspirated semi-solid product**

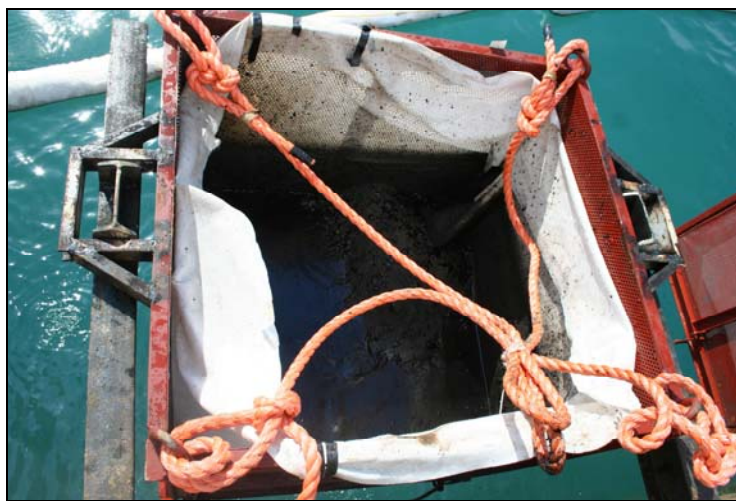
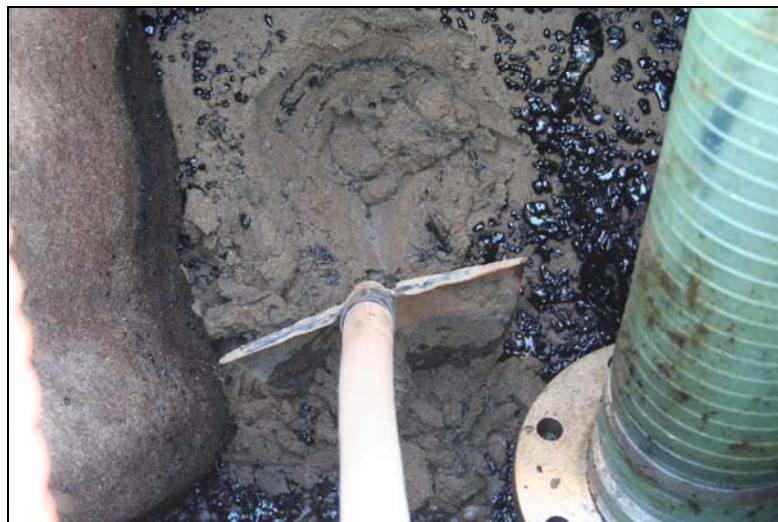
- The semi-liquid product was impossible to be manually removed because of its consistency. The 8C and 9C areas, in fact, have been treated with the air suction pump.

**Figures 16a -16b: aspirated semi-liquid product**

This remaining product could be removed in a second step of the remediation activities with air suction or with the use of cohesive materials (as fine-knit nets) able to adhere with the product.

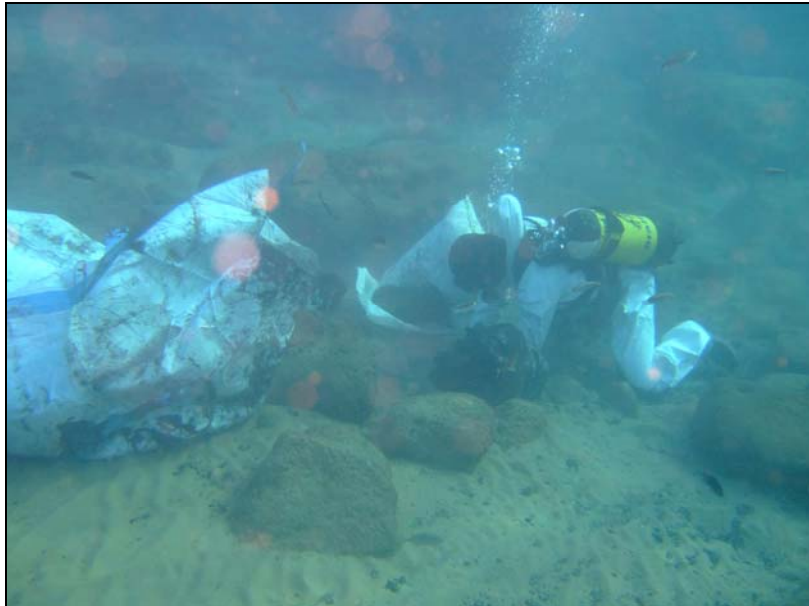
**Figure 17: Manual Recovery Activities**

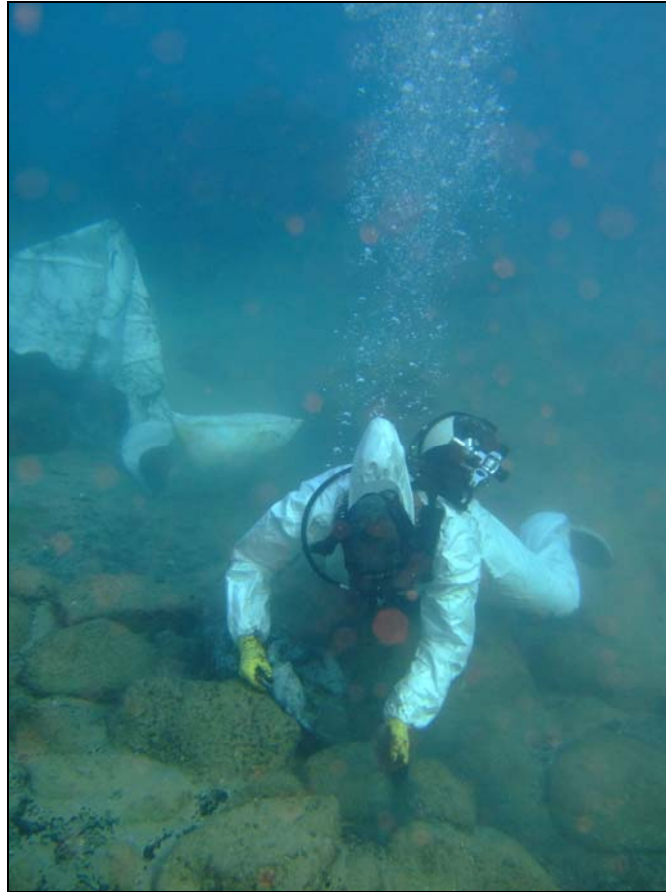
**Figure 18: Manual Recovery Activities**

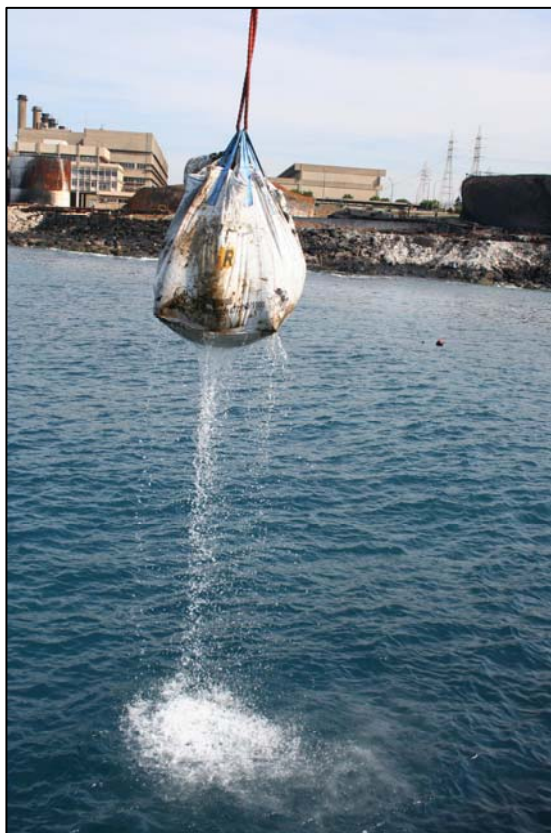
In the first period, before the pontoon arrival, the divers operated with the support of the tender of the S/V Tito. The product manually recovered on the sea bottom was stored in canvas bags on the sea bottom itself and then on big bags. At the end of each day the big bags were transported with the aid of floating balloons to the S/V Tito and lift on board with the crane. During the lifting operation the material was drained of the water in excess.

**Figure 19: drainage of excess water**

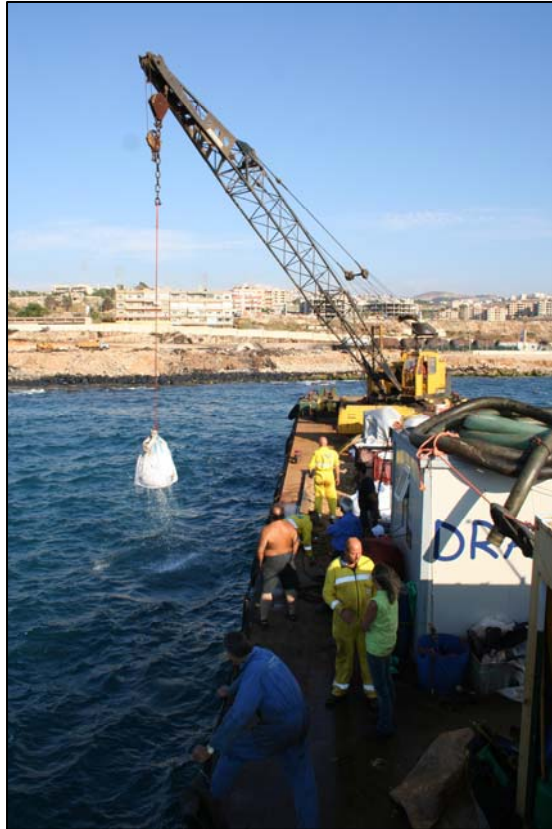
**Figure 20**

After the pontoon arrival the big bags resulting from the manual recovery were directly lifted onboard with the pontoon's crane and given to the truck service provided by the Lebanese Ministry of Environment at the end of the activities.

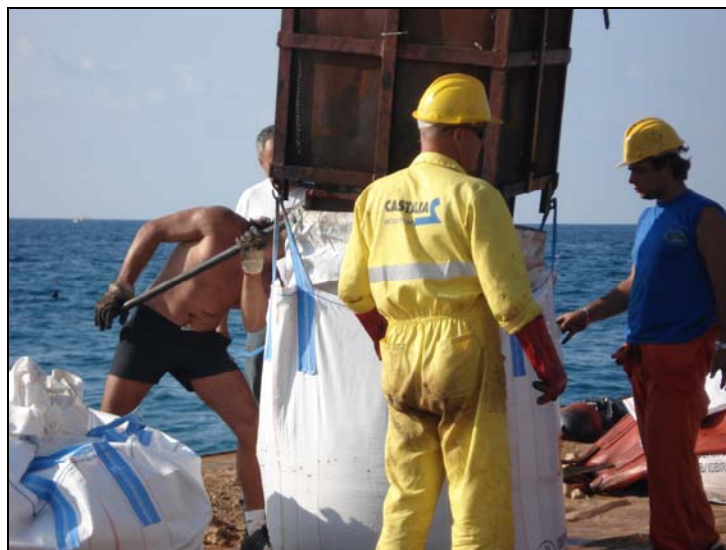
**Figure 21**

For the operations conducted with the air suction pump the material recovered into the baskets, once drained from the water in excess, was unloaded into the big bags.

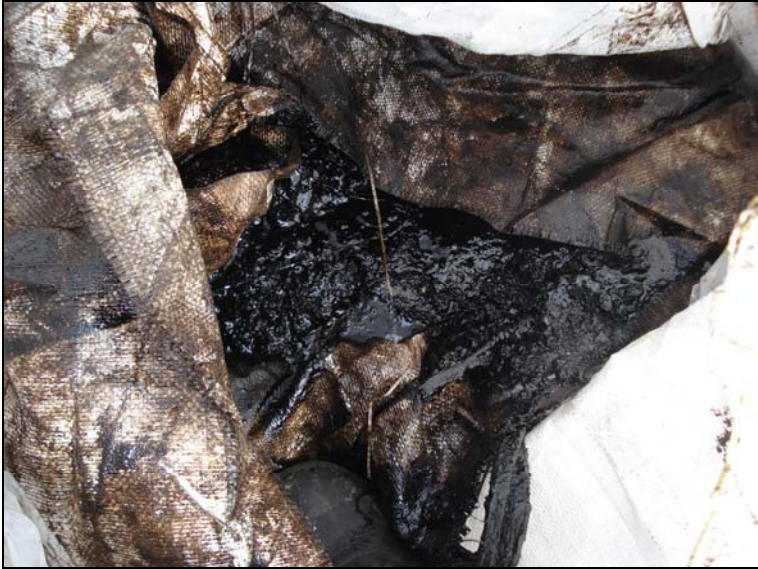
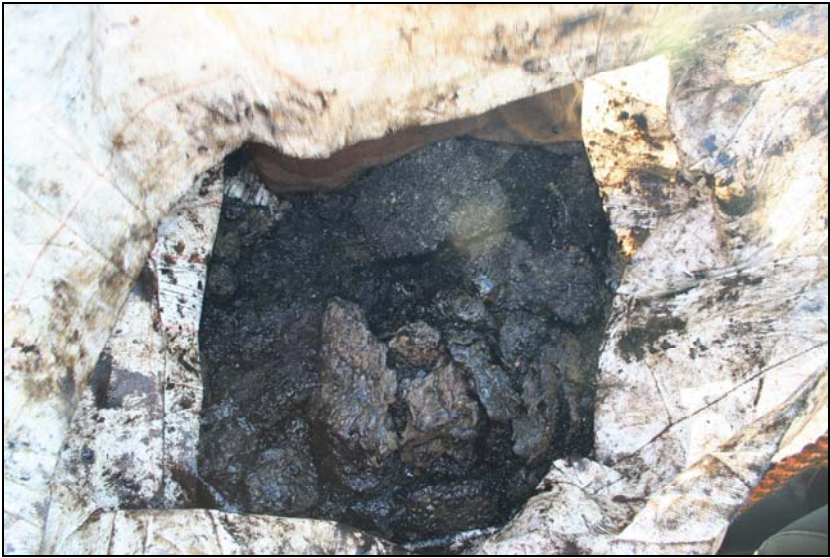
The total quantity of the material recovered (about 31,5 m<sup>3</sup>) is constituted for the 80% of almost pure hydrocarbons product deriving from the manual collection.

**Figures 22a -24b: big bags with manually collected products**

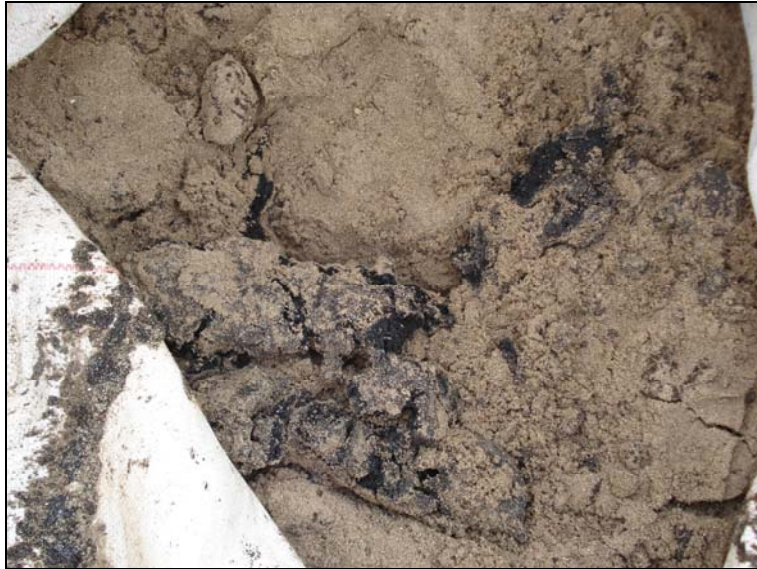
About 7,2 m<sup>3</sup>, recovered with mechanical means, are characterized by product mixed with sand. The estimation of sand quantity in the mixture is of about 60 %.

**Figure 23: big bag with aspirated products mixed with sand**

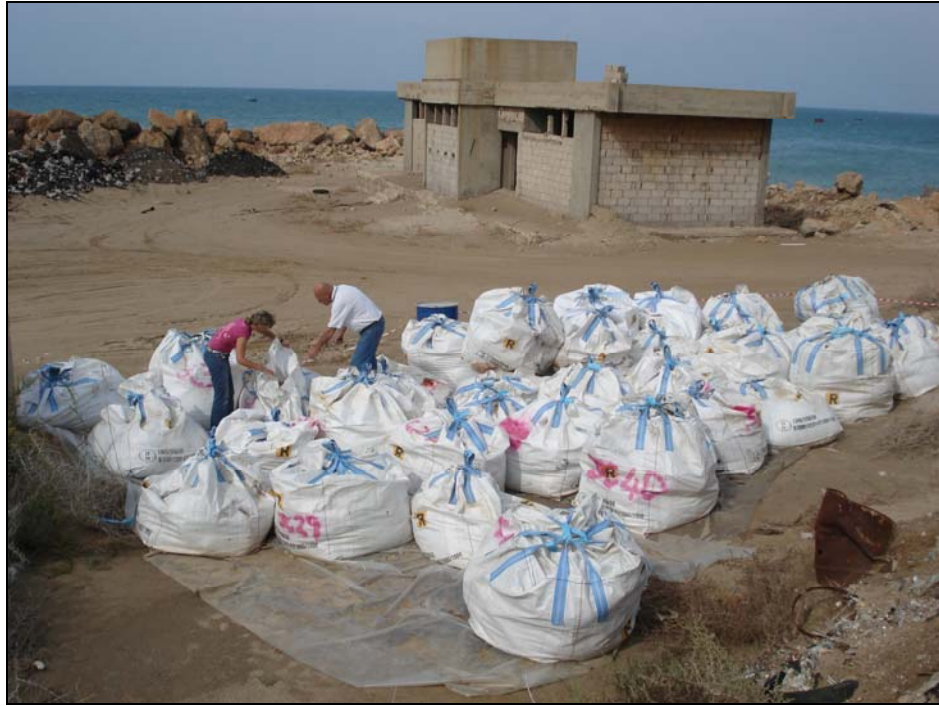
During the activities have been moreover produced waste like sorbent booms (72 sections), oily overall, oily gloves, oily ropes, etc. that have been stored in separated big bags.

**Figure 24: temporary storage area**
