## GROUND CRACKS

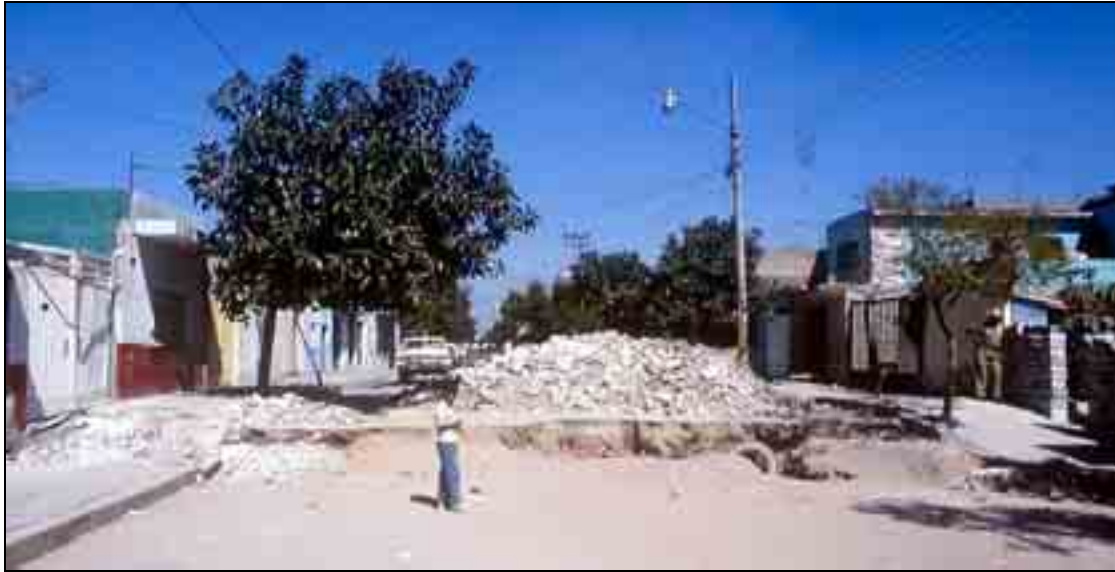
**Figure A3.21** – September 19, 1985 Michoacan (Mexico) earthquake ( $M_s$  8.0): scarp due to differential compaction in Mexico City. Photo E. Vittori.

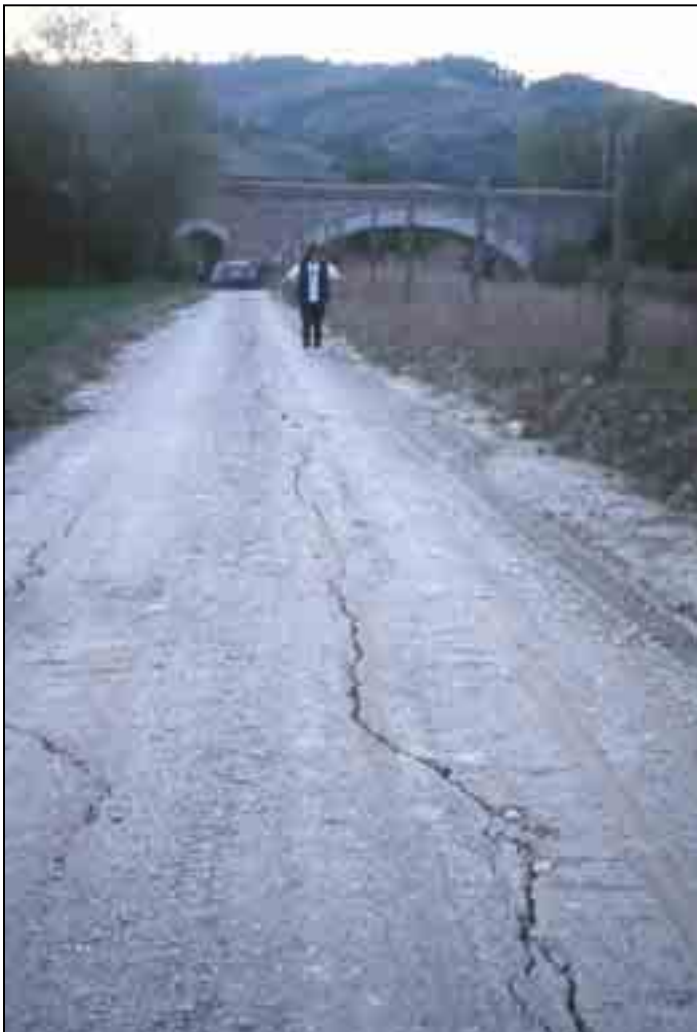
**Figure A3.22** – Ground cracks affecting a dirt road in a flat area near Isola (Umbria region), caused by the 1997 Umbria-Marche (Central Apennines) earthquake ( $M_w$  6.0) (Esposito et alii, 2000; Vittori et alii, 2000). Photo S. Porfido.

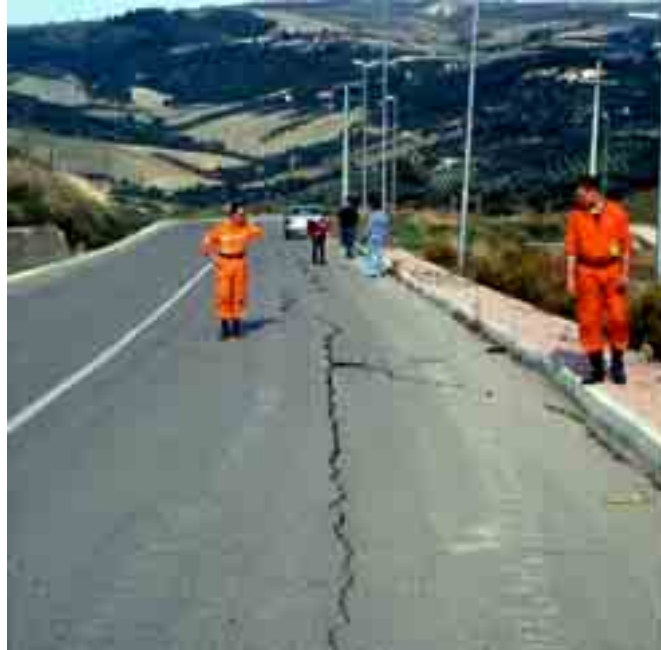
**Figure A3.23** – Ground cracks of debated origin affecting a paved road near San Giuliano (Molise region), caused by the 2002 Molise (Southern Apennines) earthquake (MI 5.4). Photo E. Esposito.

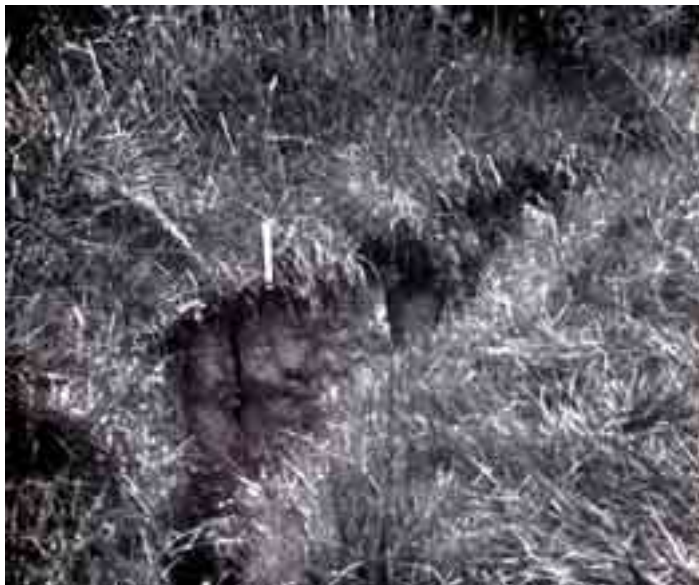
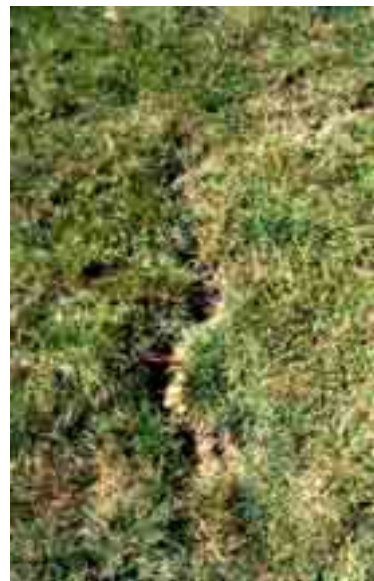
**Figure A3.24** – Ground cracks that can be followed for tens of meters in grass fields occurred during the 1976 Friuli, north-eastern Italy, earthquake, Ms 6.5 (left, from Cavallin et alii, 1977), and the 1997 Umbria-Marche earthquake (right, photo E. Vittori).
