## LIQUEFACTION AND COMPACTION

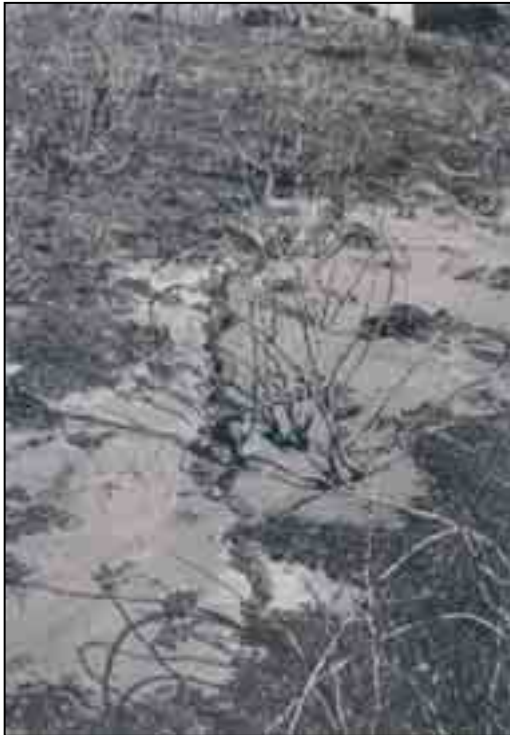
**Figure A3.25** – Small liquefaction cones along fissures near the Belice River bridge, on the road for Montevago (Belice alluvial plain), produced during the 15 January 1968 Belice earthquake sequence ( $M_s$  5.9); Michetti et alii, 1995. The preliminary estimate of the Inqua EEE Intensity would be around VIII. Photo courtesy of M. Casirati.

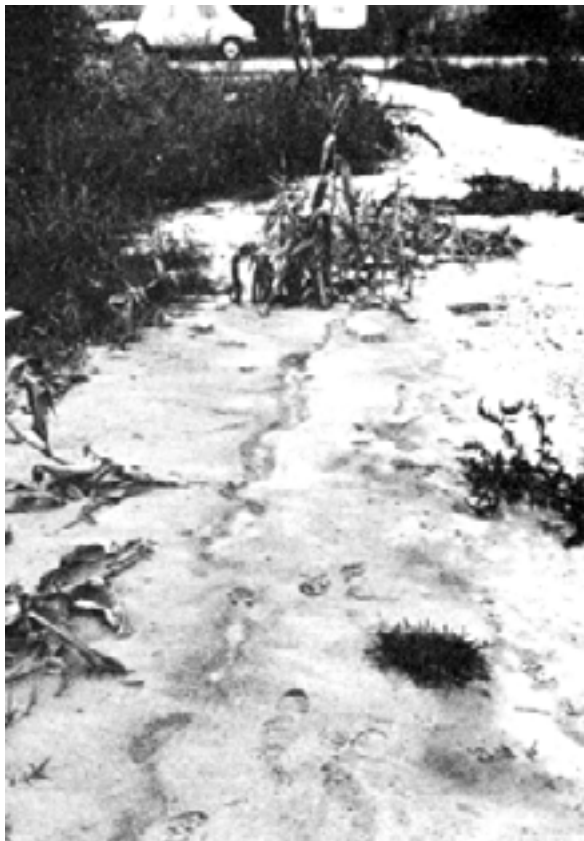
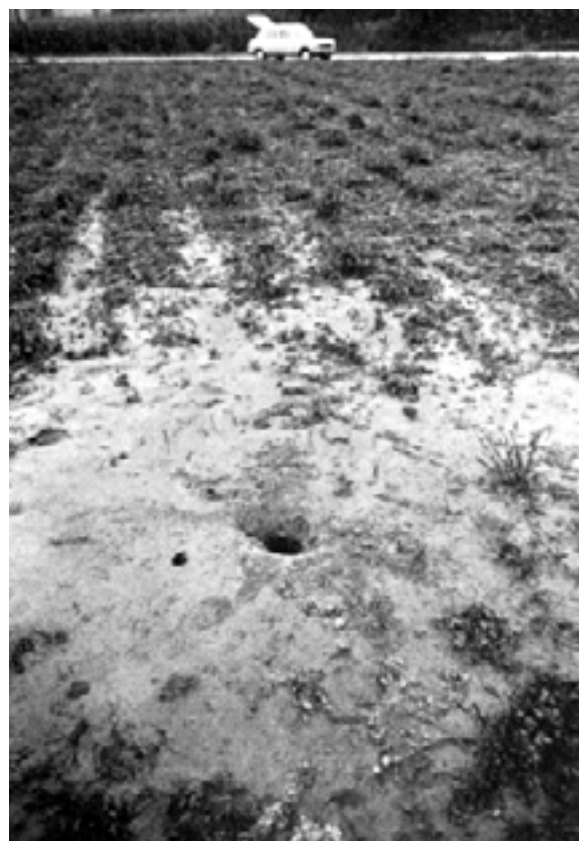
**Figure A3.26** –liquefaction features in farmed land occurred during the 1976,  $M_s$  6.5, Friuli earthquake in northeastern Italy (from Siro, 1977). The preliminary estimate of the Inqua EEE Intensity would be close to the degree IX.

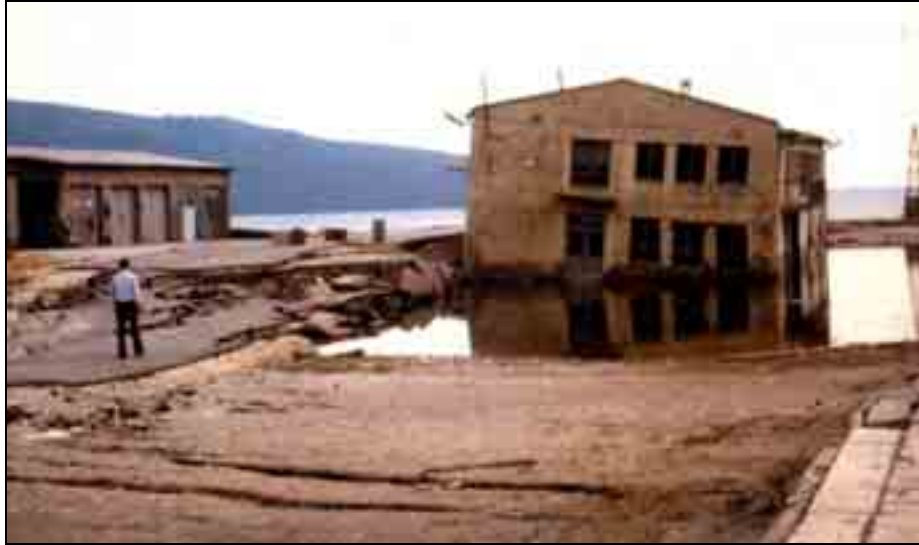
**Figure A3.27** – Ground failure (liquefaction of artificial embankment) along the seacoast during the 15 April 1979 Montenegro earthquake ( $M_w$  6.9). The preliminary estimate of the Inqua EEE Intensity is X. Photo E. Iaccarino.

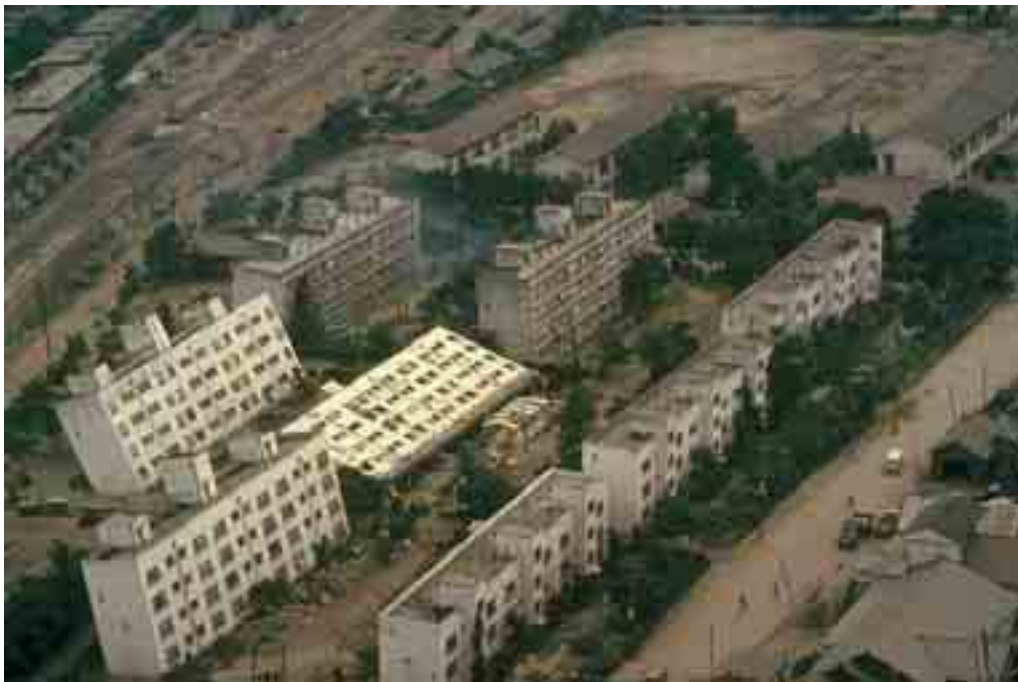
**Figure A3.28** – Tilt of buildings at Kawagishi-Cho due to liquefaction following the June 16, 1964 Niigata (Japan) earthquake ( $M_s$  7.5). The preliminary estimate of the Inqua EEE Intensity is XI.  
Source: <http://cee.uiuc.edu/sstl/education/liquefaction/>

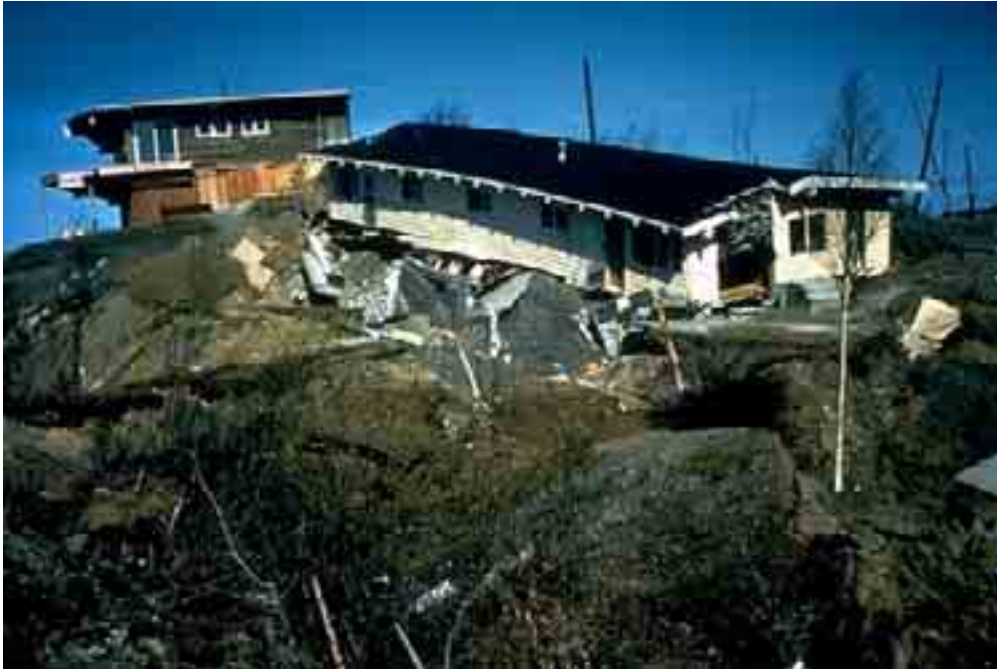
**Figure A3.29** – Liquefaction of soil and lateral spreading of saturated soft clay and sand in Anchorage during the Alaskan Earthquake of March 27 1964 (M 8.6). The ground dropped on the average of 11 meters and houses slid about 150 to 180 meters. This effect, which determined a widespread change of the landscape, can be evaluated of Intensity XII in the Inqua EEE Scale. Source: <http://cee.uiuc.edu/sstl/education/liquefaction/>

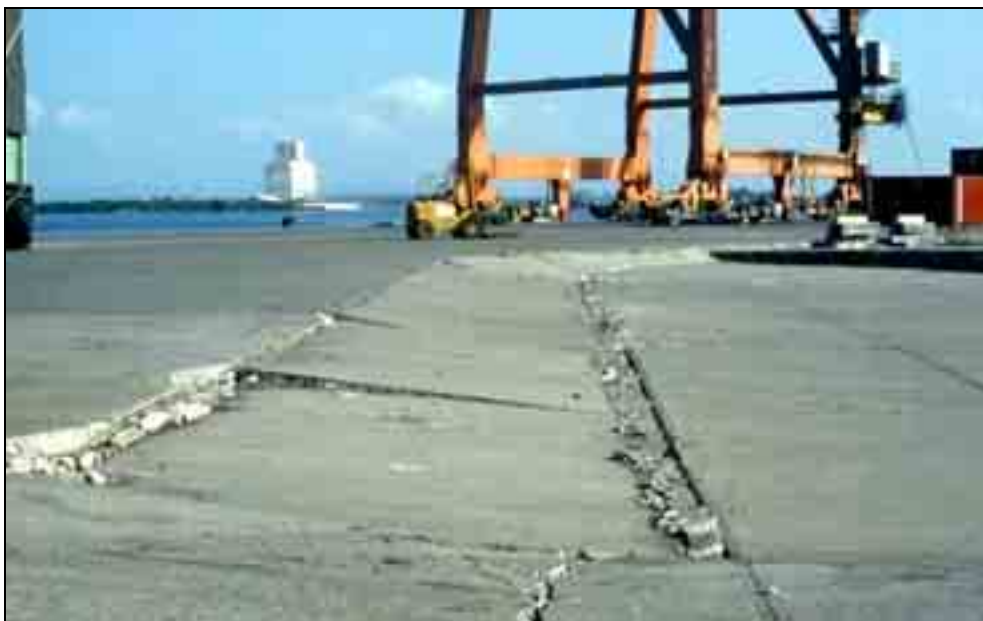
**Figure A3.30** – September 19, 1985 Michoacan (Mexico) earthquake (M<sub>s</sub> 8.0): backfill compaction in the harbour facilities of Lazaro Cardenas. The preliminary estimate of the Inqua EEE Intensity is VIII. Photo E. Vittori.
