**IDRAIM – stream hydromorphological evaluation,
analysis and monitoring system**

Illustrated Guide to the Answers

**Guidebook for the evaluation of stream morphological
conditions by the Morphological Quality Index (IQM)**

**Massimo RINALDI
Nicola SURIAN
Francesco COMITI
Martina BUSSETTINI**

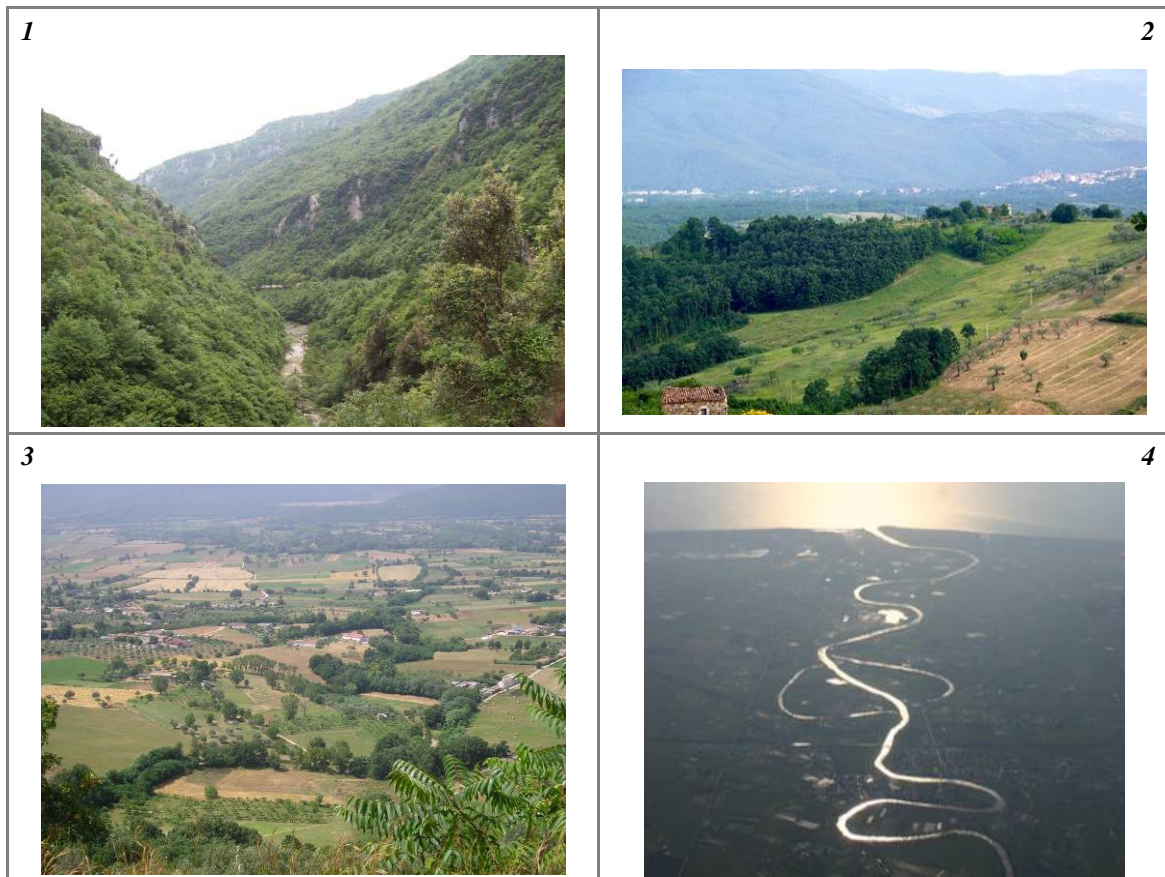
Figure 2 – Panoramic views of the physiographic units in the Voltorno River watershed. (1) Mountainous unit; (2) Hilly unit; (3) Intermontane unit; (4) Low plain unit.

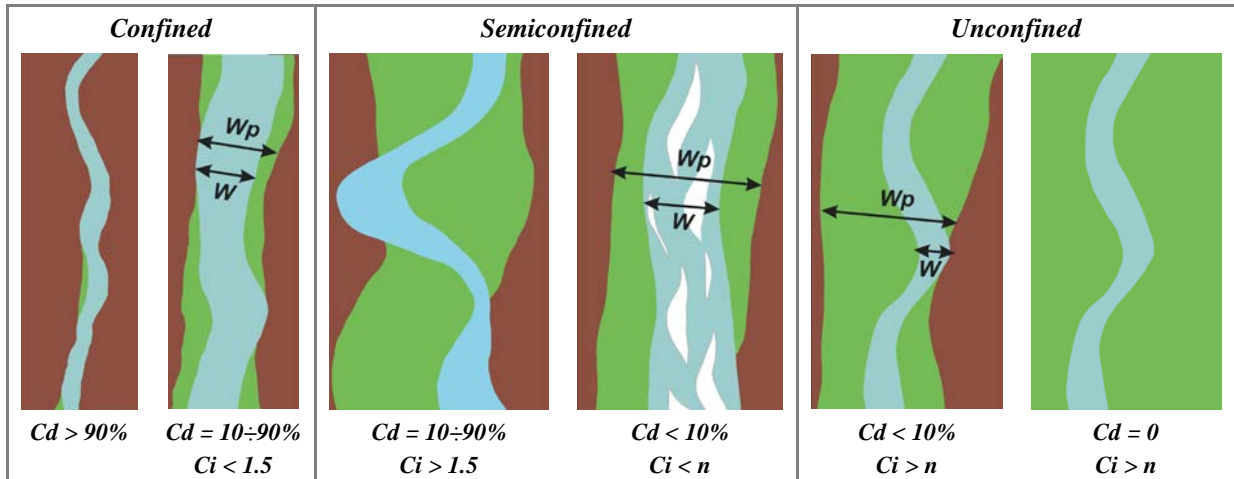
Figure 3 – Confinement classes. In green: alluvial plain; in brown: hillslopes (or ancient terraces). Cd : confinement degree; Ci : confinement index = Wp/W , where Wp : alluvial plain width (including the channel) and W : channel width.

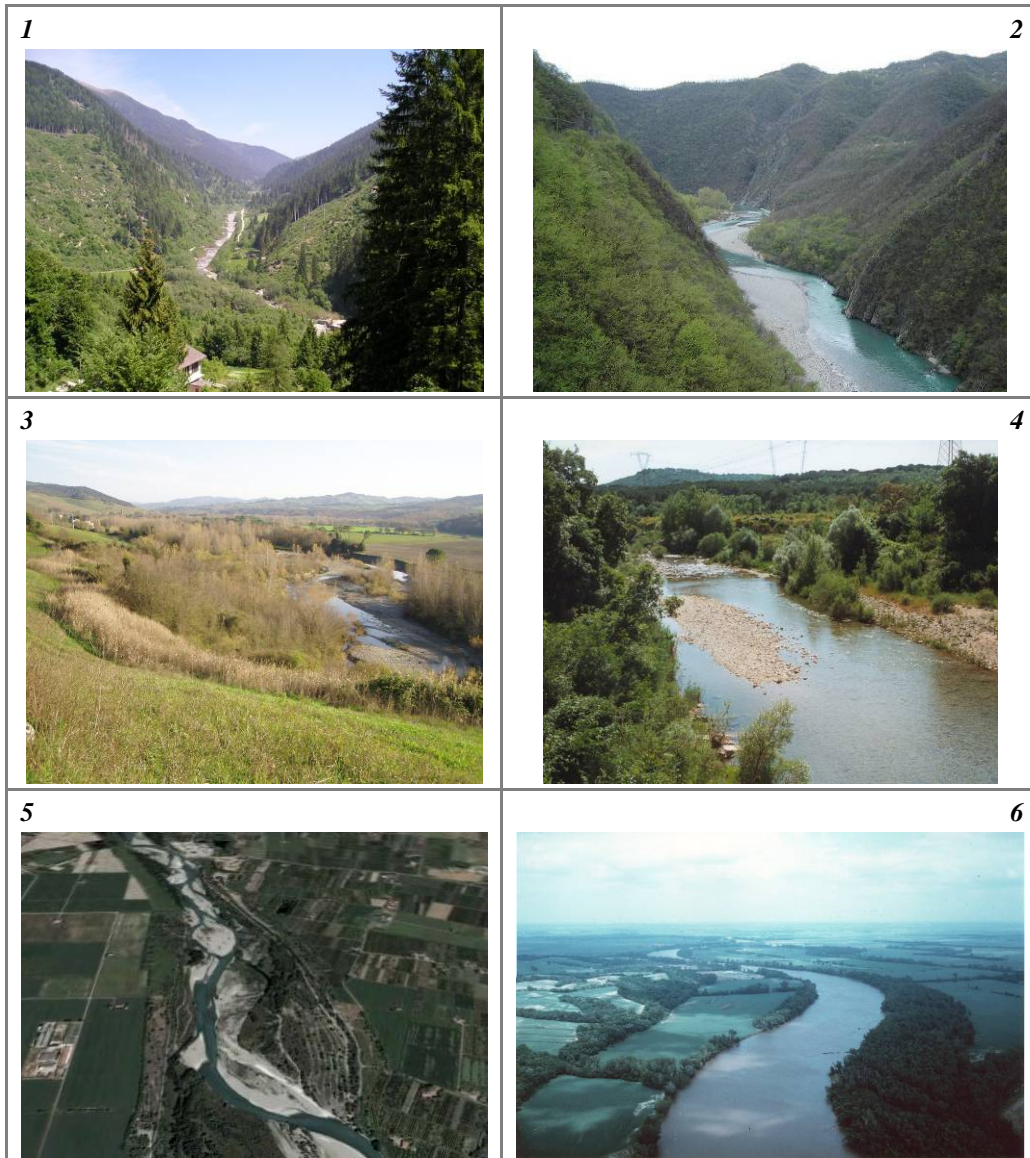
Figure 4 – Examples of different confinement classes. (1), (2) Confined channels; (3), (4) semiconfined channel; (5), (6) unconfined channels.

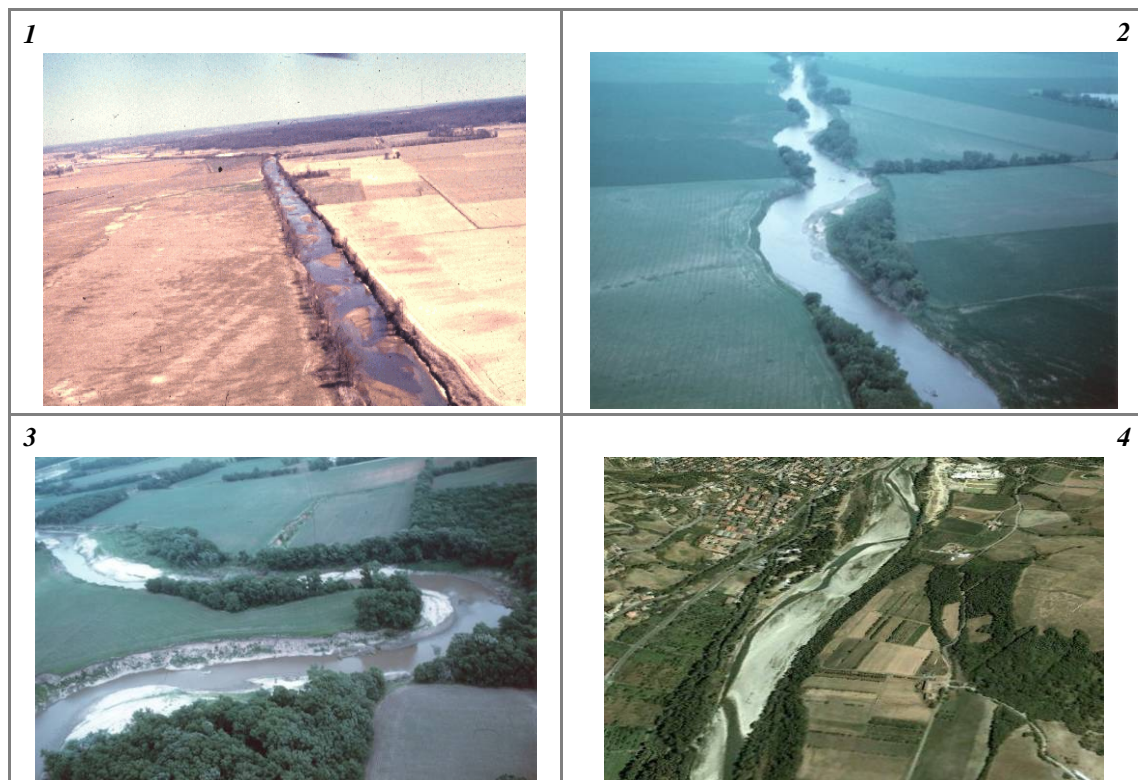
Figure 6 – Examples of morphologies of semiconfined and unconfined channels. (1) Straight; (2) sinuous; (3) meandering; (4) sinuous with alternate bars.

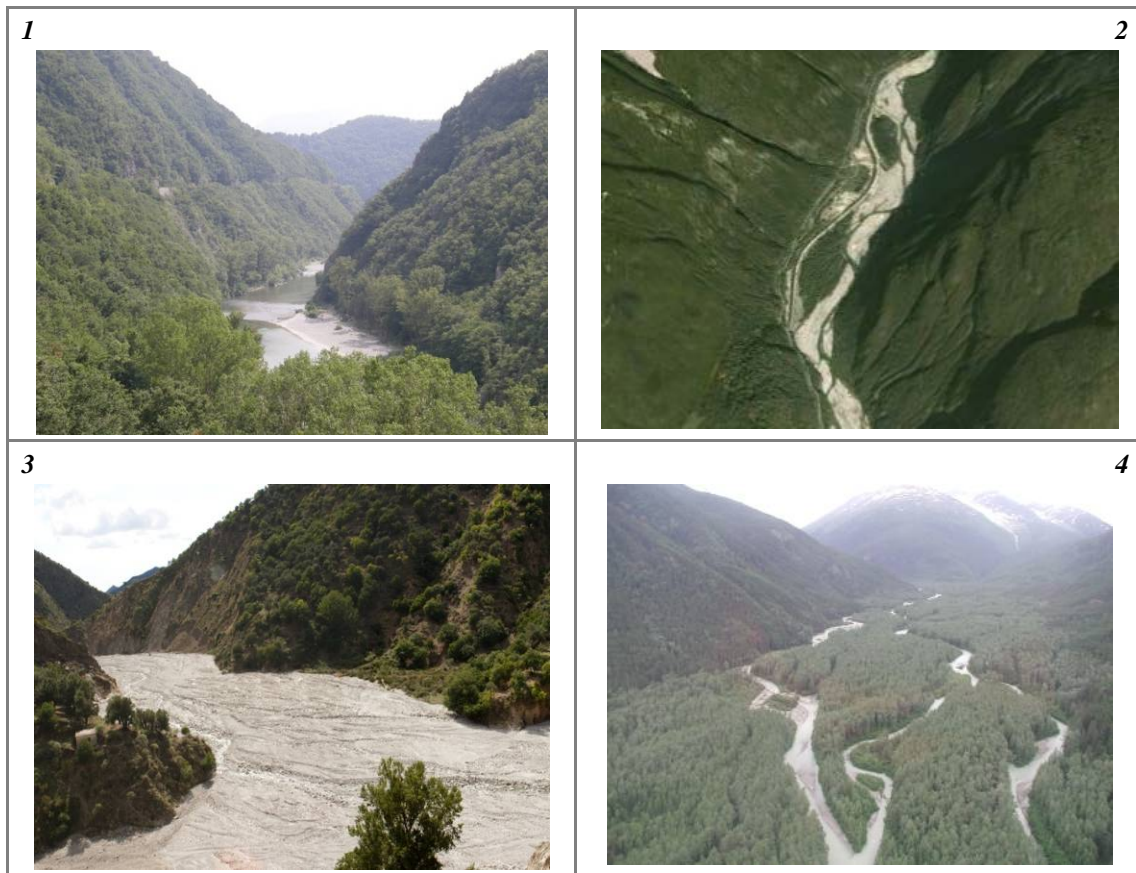
Figure 7 – Morphologies of confined channels. (1) Confined single-thread; (2) confined wandering; (3) confined braided; (4) confined anastomosed.

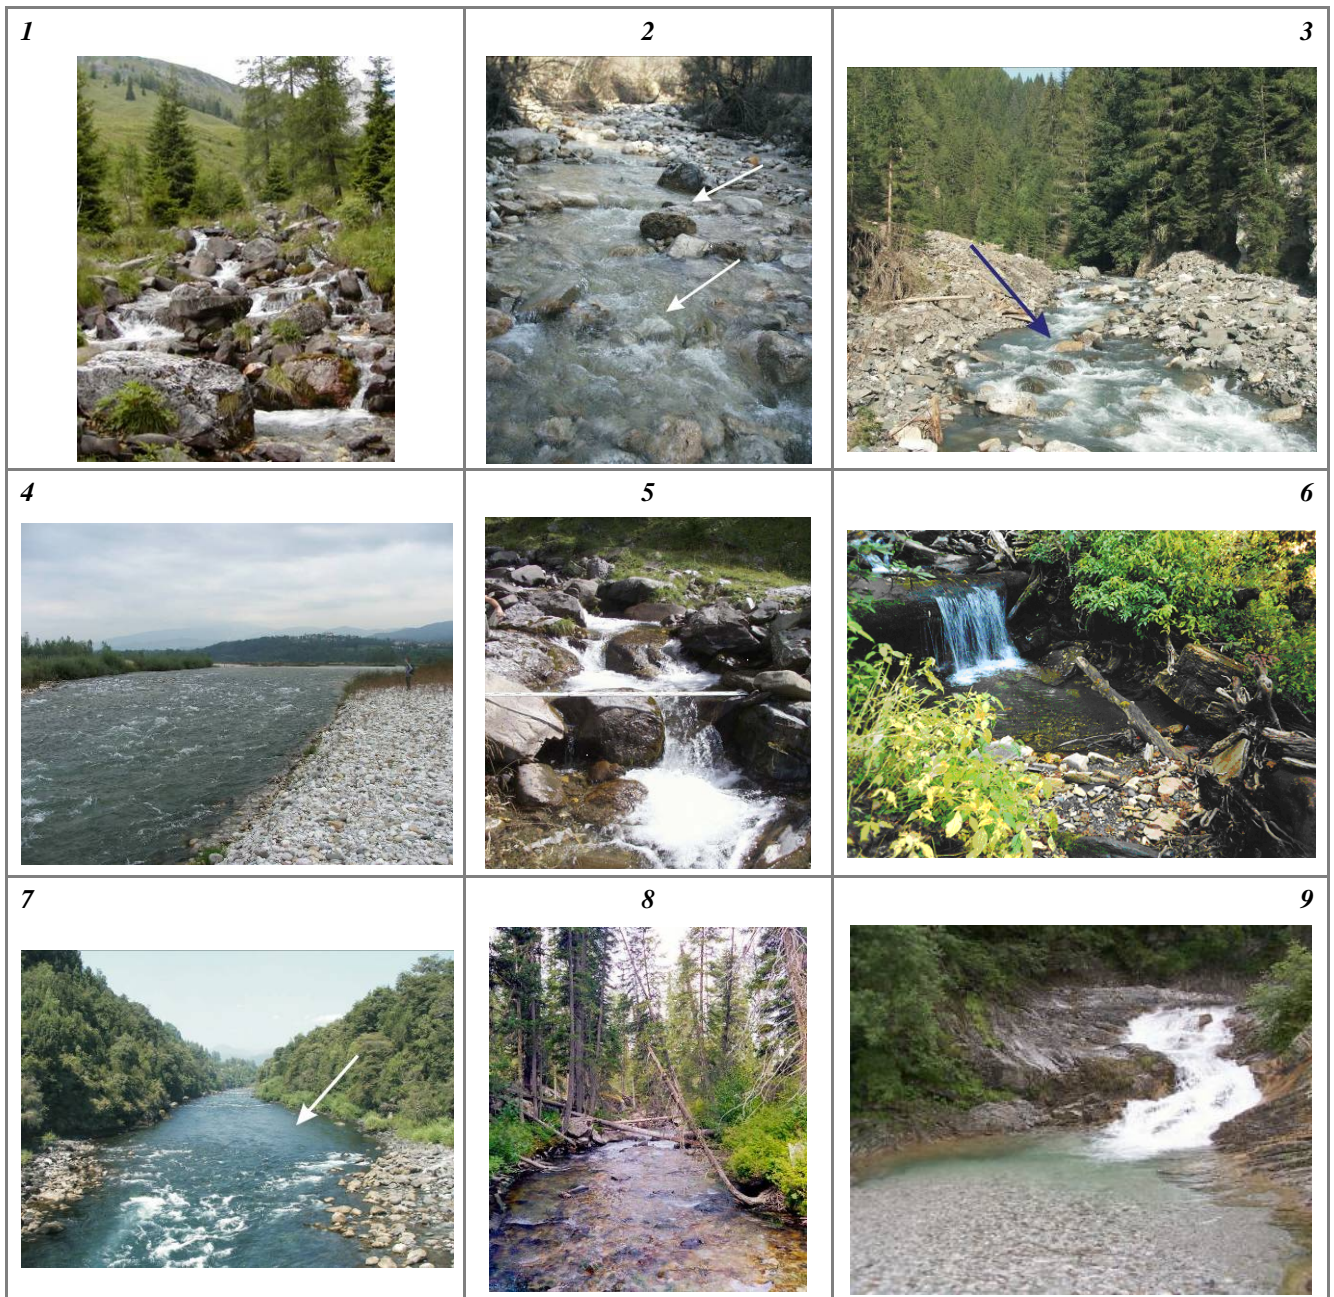
Figure 9 – Morphological units in mobile bed stream channels. (1) *Cascade*; (2), (3) *rapids* (some transverse ribs are indicated by the arrow); (4) *riffle*; (5) series of *steps* alternated with *pools*; (6) *log step*; (7) *glide* (indicated by arrow); (8) *glide*; (9) *pool* downstream a bedrock *cascade*.

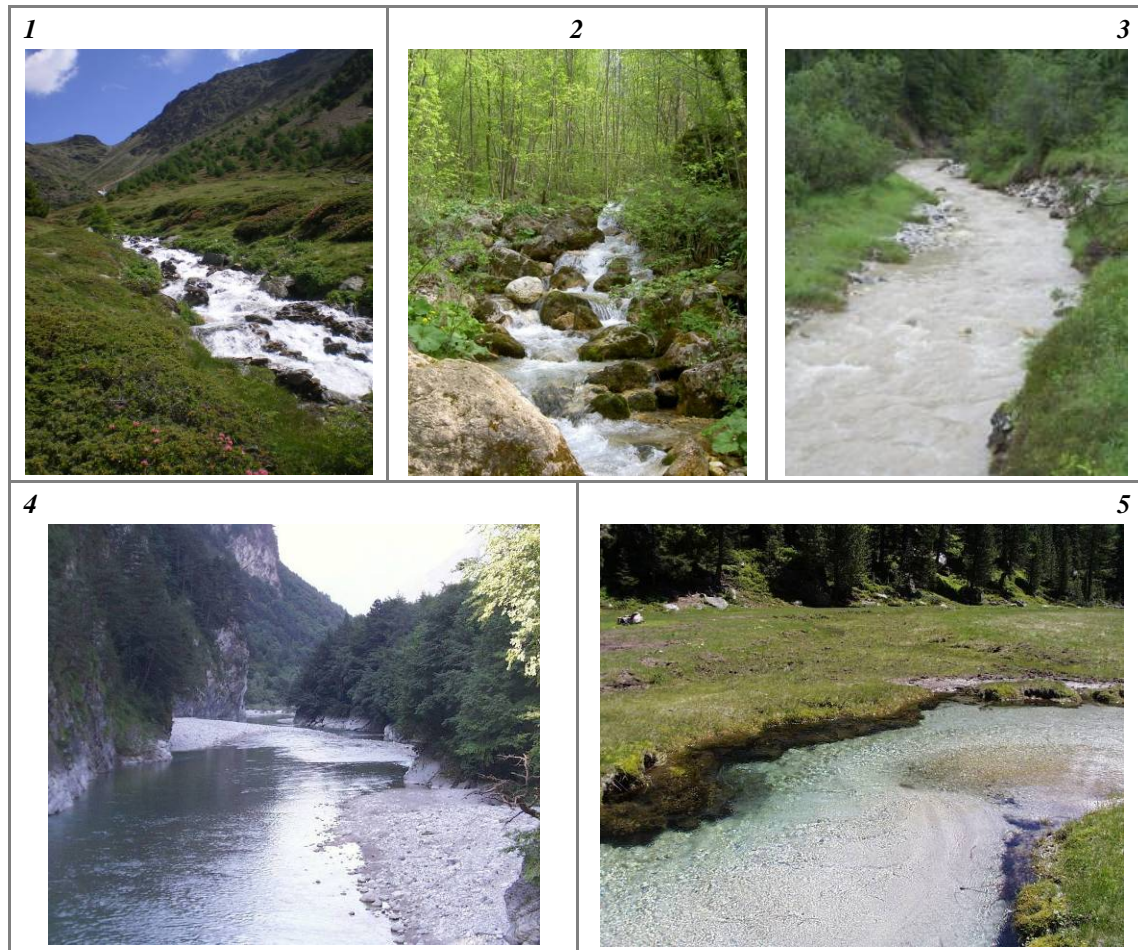
Figure 12 – Bed configurations at reach scale in mobile bed streams. (1) *Cascade*; (2) *step pool*; (3) *plane bed*; (4) *riffle-pool*; (5) *dune-ripple*.

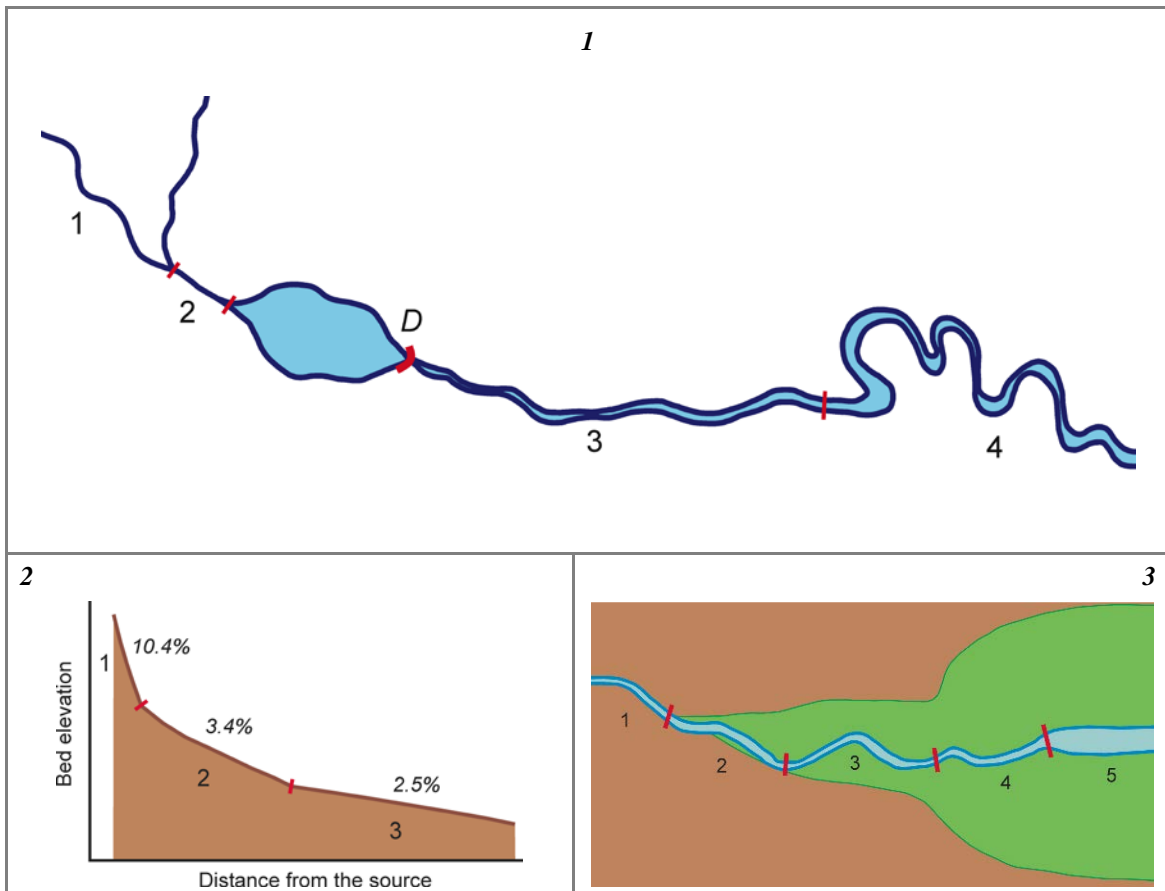
Figure 13 – Examples of discontinuities accounted for the final segmentation in reaches. (1) Hydrological discontinuity due to a relevant tributary (reaches 1 and 2); dam (D) (reaches 2 and 3: note that the reservoir is not considered as a river reach). The passage from reach 3 to 4 is instead due to a change in channel morphology (from sinuous to meandering: see previous step). (2) Discontinuity in bed slope (confined reaches). (3) Other discontinuities that can be used for river segmentation: the passage from reach 3 to the following reach is not motivated by a change in morphology (sinuous channel) but by a change in plain width and confinement index (from 3 to 4), and by a significant change in channel width (from 4 to 5).

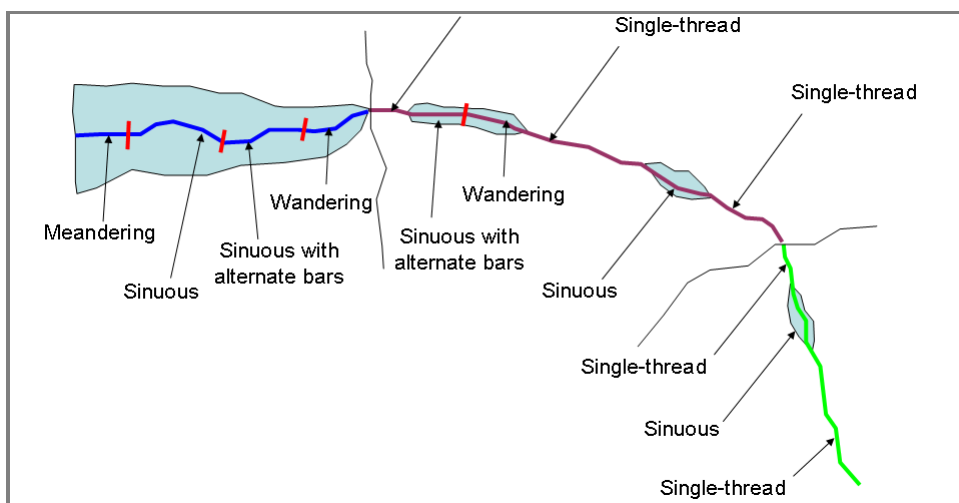
Figure 16 – Summary of the segmentation. STEP 3: channel morphologies are classified.

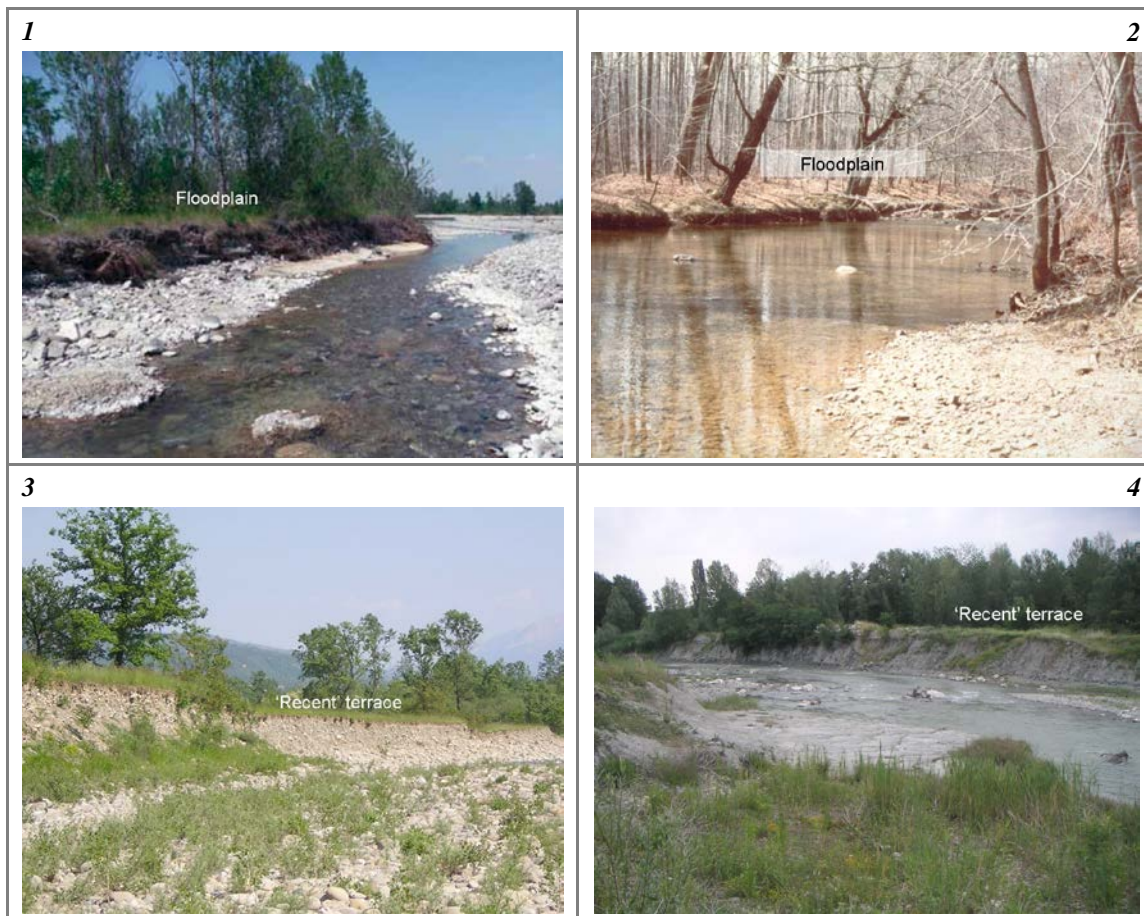
Figure 23 – Differences between floodplain and “recent” terrace. (1) and (2) Examples of modern floodplain (note the very limited differences in elevation with channel bars); 3: “recent” terrace generated by a bed incision of about 2÷3 m; 4: “recent” terrace generated by an intense incision (> 3 m).

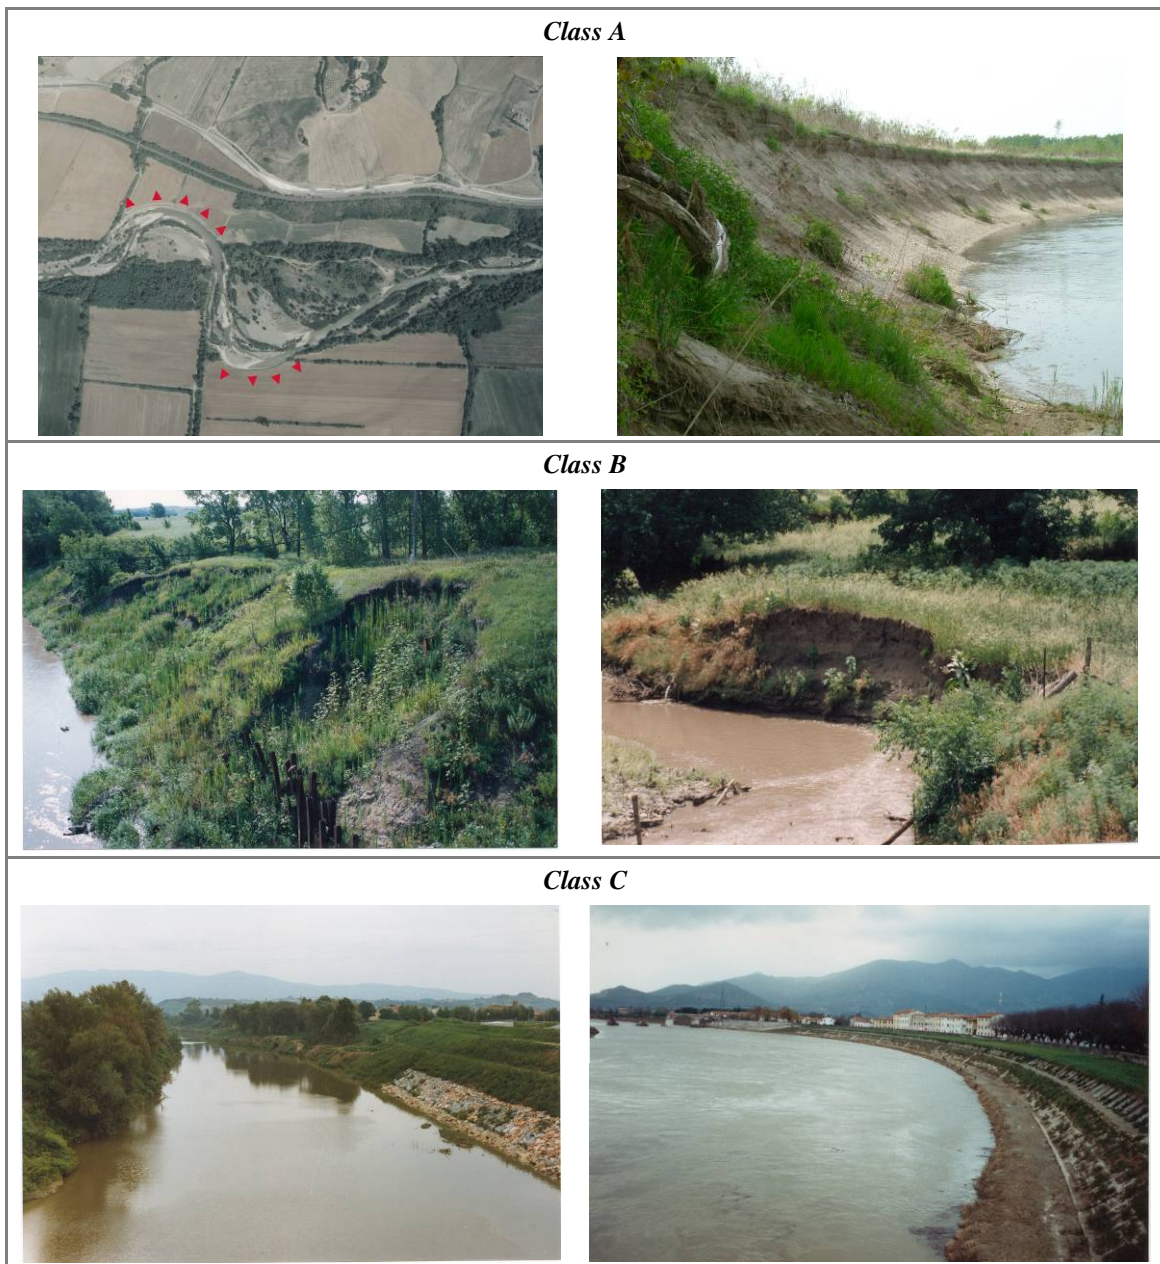
Figure 32 – Processes of bank retreat. *Class A*: frequent retreating banks, particularly along the outer side of bends (red arrows, photo on the left). *Class B*: this class includes reaches with bank erosion observed only locally. *Class C*: absence of eroding banks due to bank protections and/or absent channel dynamics.

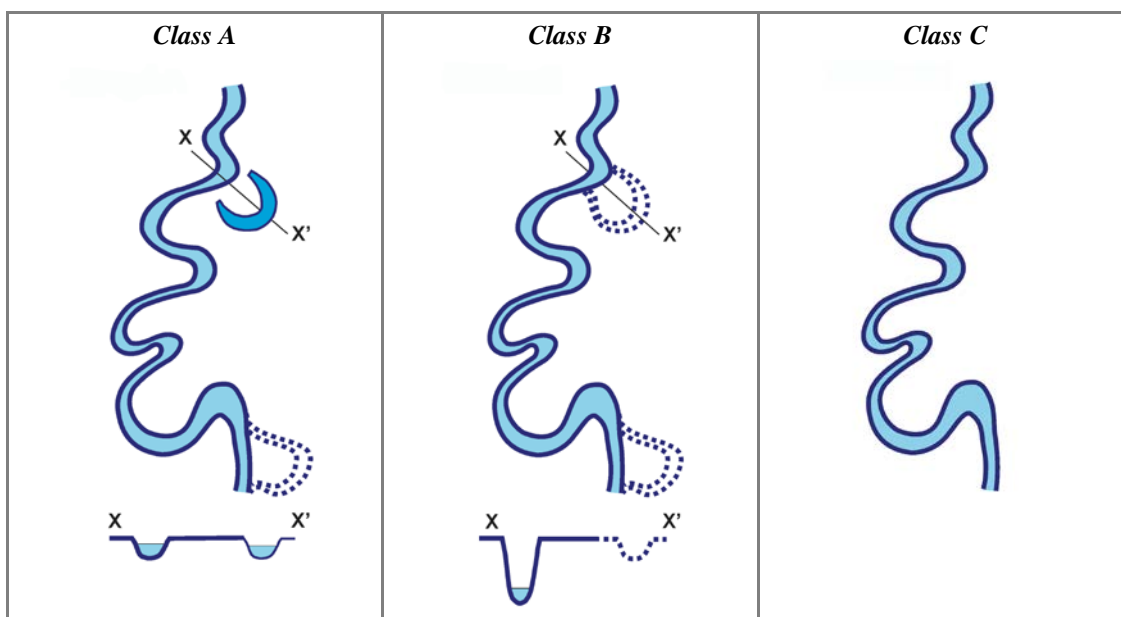
Figure 37 – Presence of typical fluvial forms in the alluvial plain. *Class A*: presence of natural fluvial forms (e.g. abandoned meander, oxbow lake). *Class B*: traces of fluvial forms, now disconnected by the channel due to incision, but with possible reactivation. *Class C*: complete absence of fluvial forms in the alluvial plain.

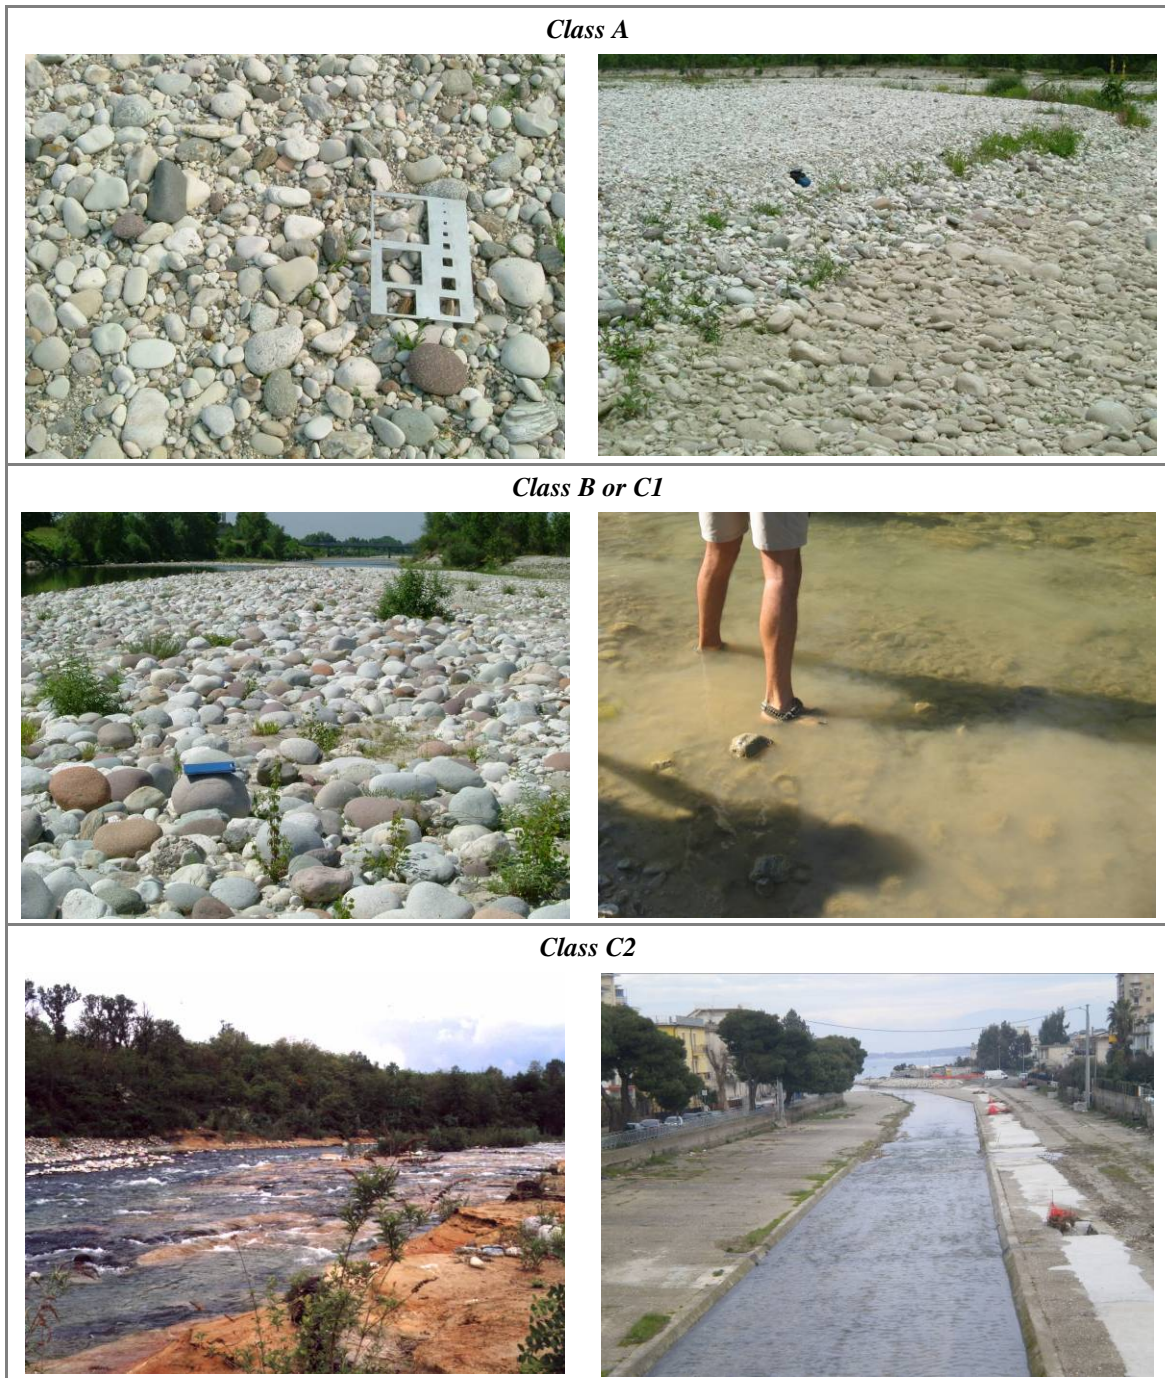
Figure 44 – Alterations of substrate in semi- and unconfined channels. *Class A*: natural sediment heterogeneity in an unconfined channel. *Class B* or *C1*: presence of armouring (photo on left) or clogging (photo on right) (assignment to *Class B* or *C1* will depend on the extension of armouring and/or clogging along the site). *Class C2*: bedrock outcroppings due to bed incision (photo on left) or completely altered substrate because of bed revetment (photo on right).

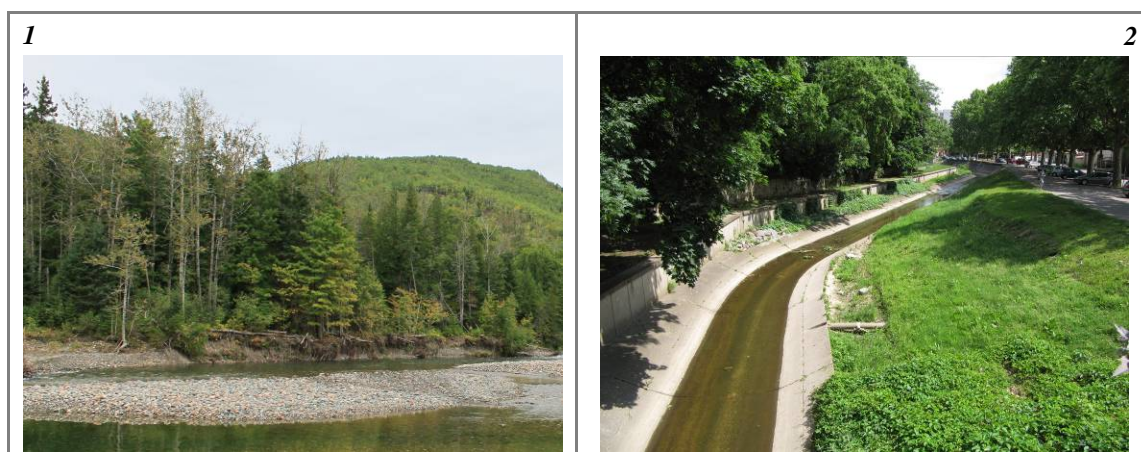
Figure 46 – Vegetation in the fluvial corridor. (1) Presence of vegetation connected with the channel in a semiconfined reach; (2) absence of vegetation (right) or vegetation disconnected by the stream channel because of the presence of walls.

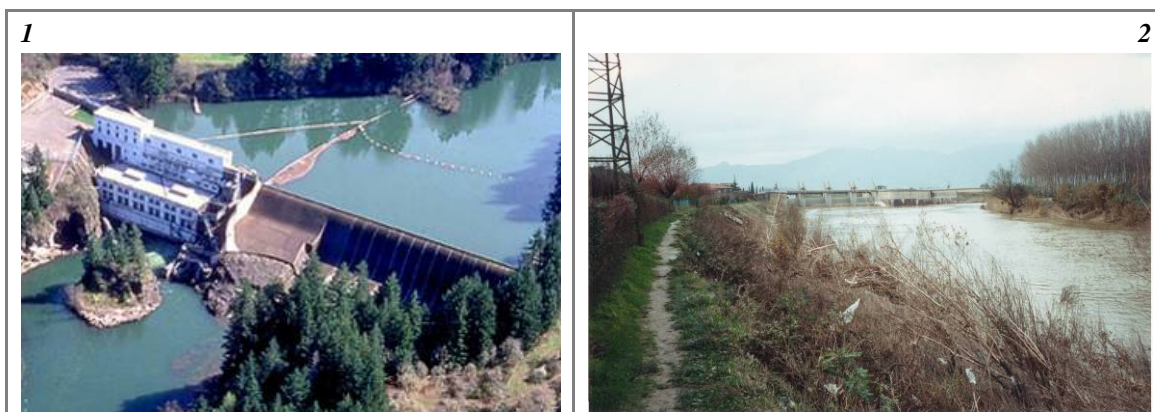
Figure 52 – Alteration of discharges. Typical alteration structures. (1) Dam; (2) spillway.

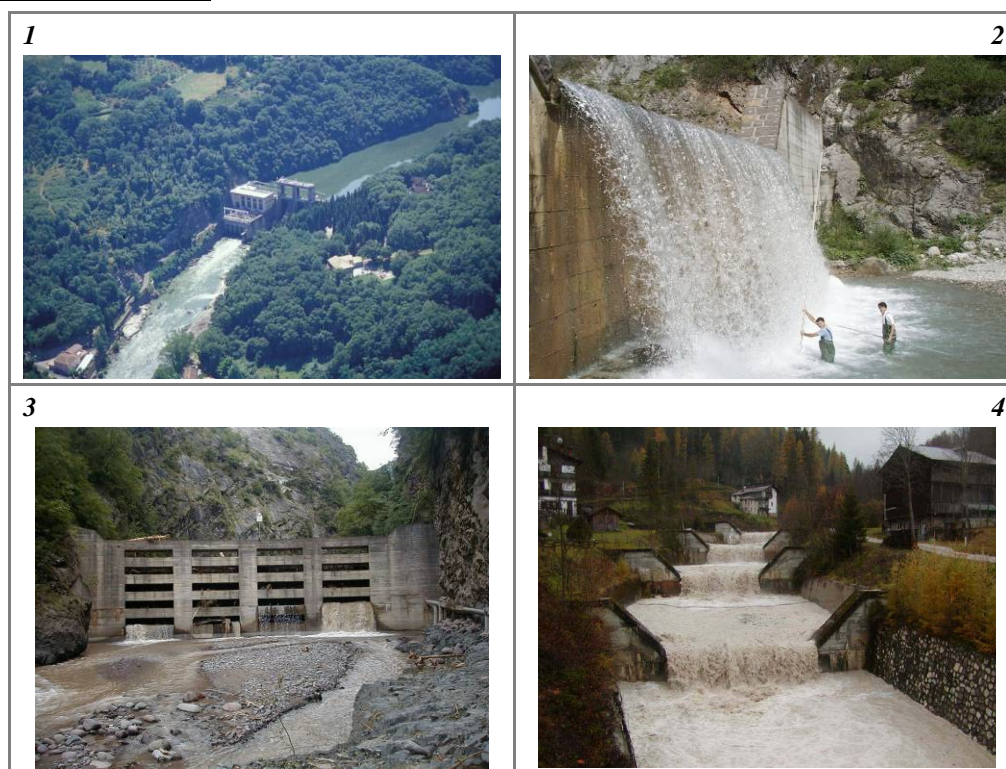
Figure 55 – Transversal structures of alteration of sediment discharges in mountain areas. (1) Dam; (2) retention check dam; (3) open check dam; (4) sequence of stepped consolidation check dams.

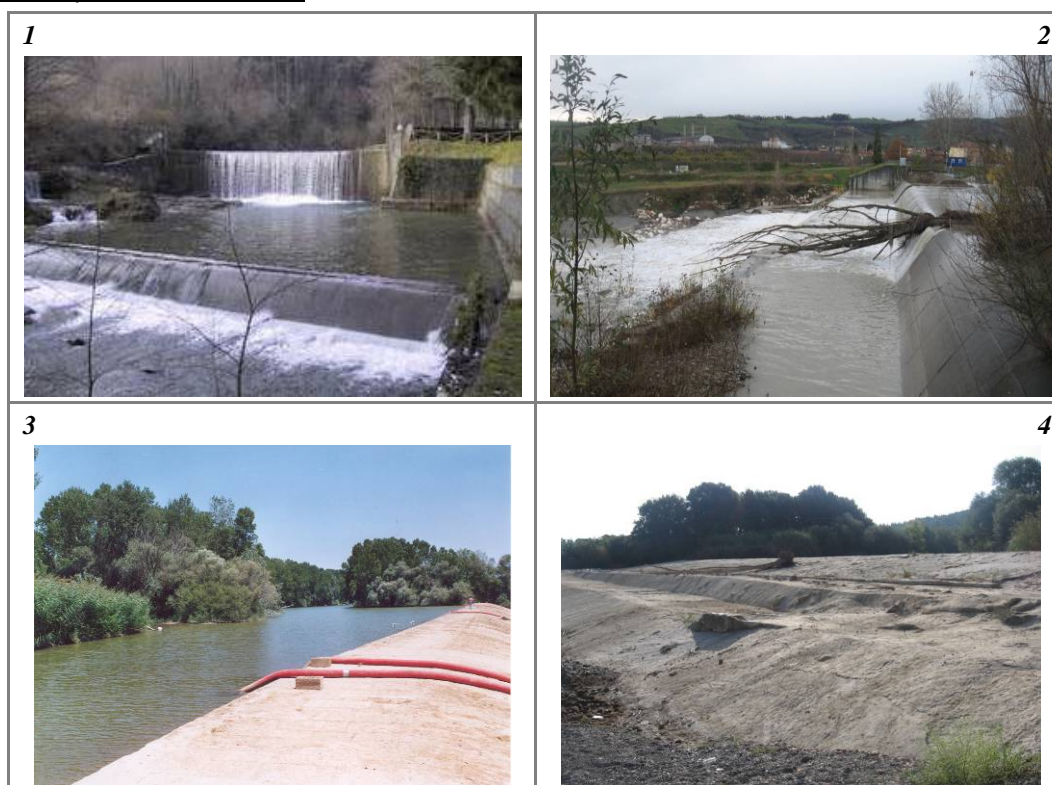
Figure 56 – Transversal structures of alteration of sediment discharges in hilly and lowland areas. (1) Consolidation check dam; (2) abstraction weir; (3) not filled abstraction weir; (4) filled abstraction weir.

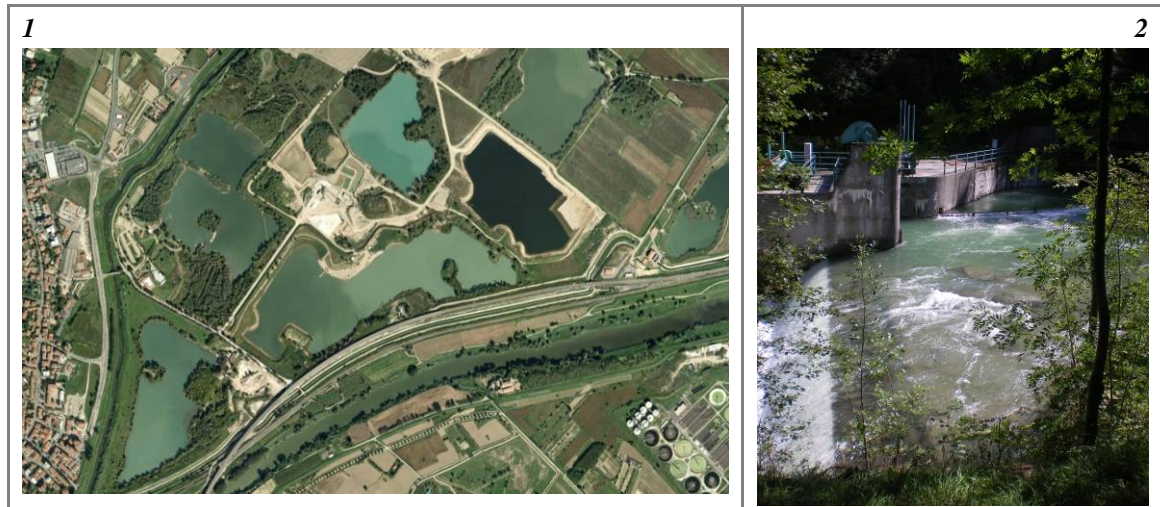
Figure 58 – Other structures (besides those defined for A1) that can cause an alteration of discharges within a reach. (1) Retention basins; (2) discharge abstraction.

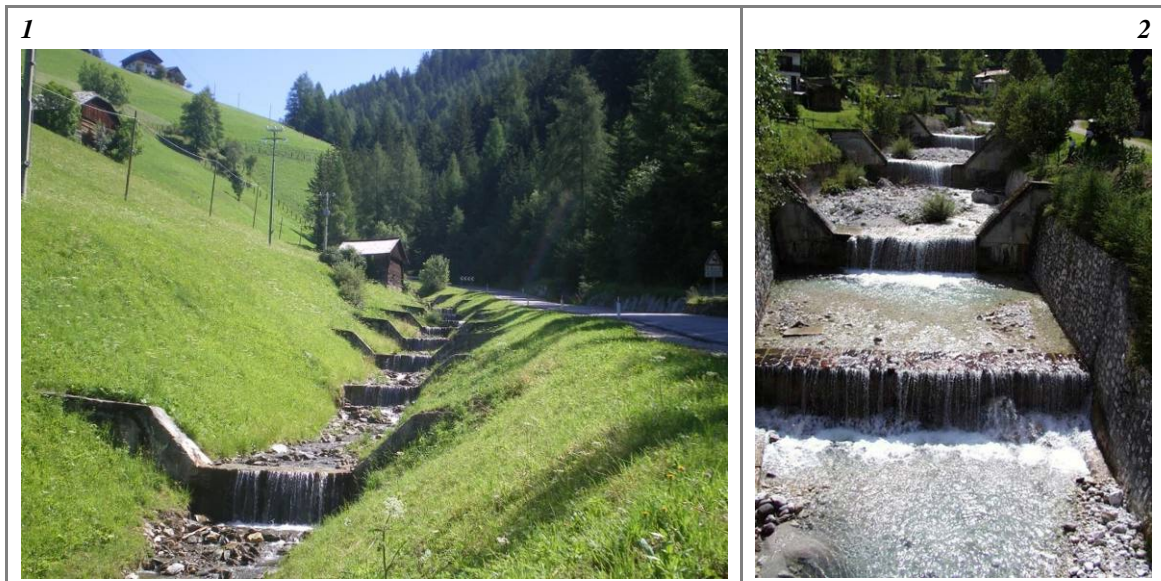
Figure 62 – Cases with very high density of transversal structures (> 1 every 100 m in mountain areas): an additional score of 12 is applied.

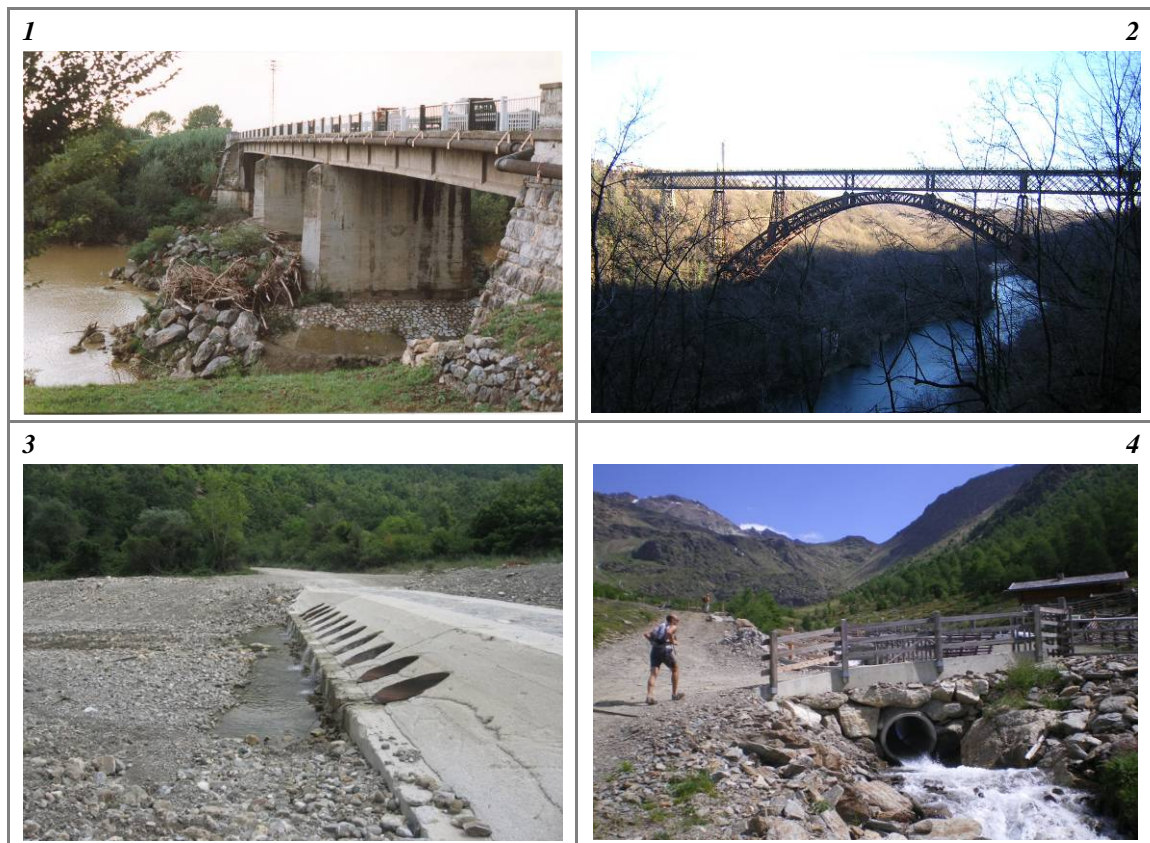
Figure 63 – Crossing structures. (1) Bridge with interference on fluvial dynamics; (2) crossing structure unrelated to the fluvial corridor; (3) ford with culverts; (4) culvert.

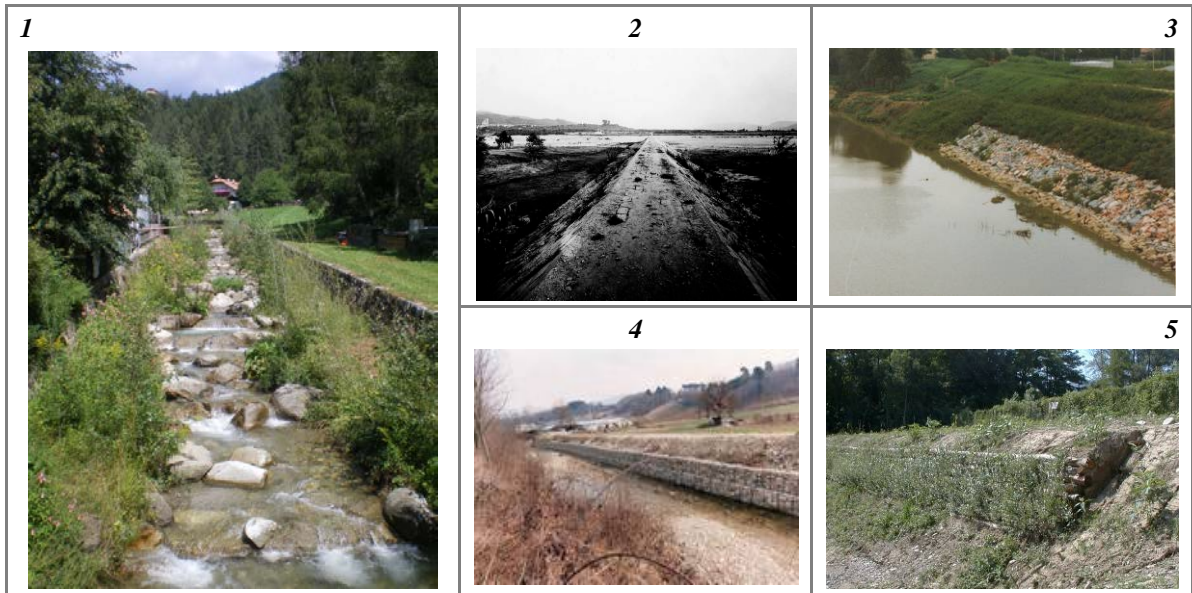
Figure 65 – Bank protections. (1) Bank walls (2) groyne; (3) rip raps; (4) gabions; (5) bioengineering bank stabilization.

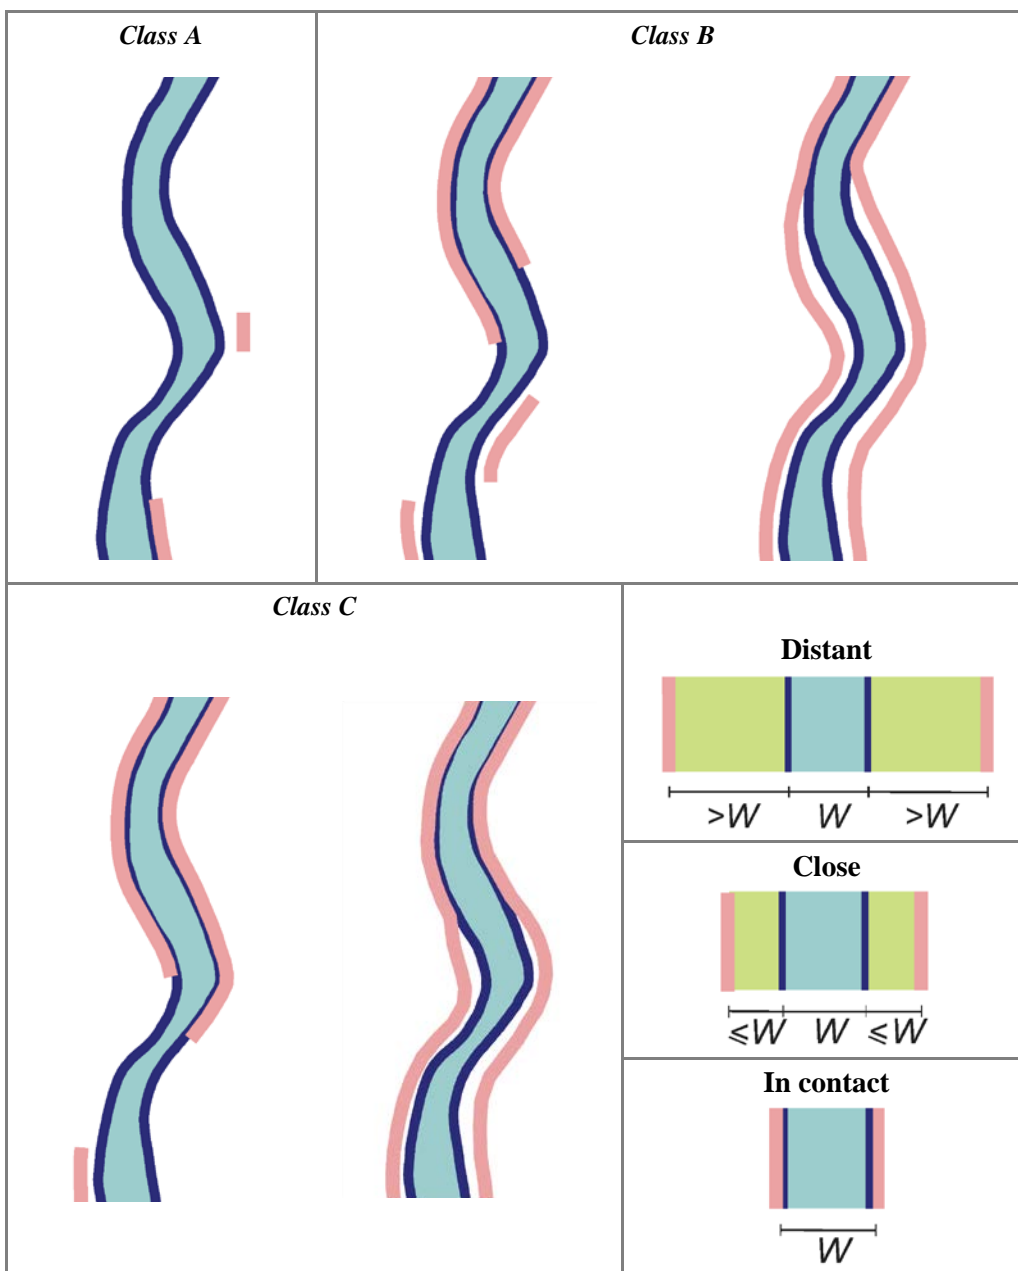
Figure 69 – Artificial levees. *Class A*: localized levees in contact or close (< 10%). *Class B*: the total sum of levees in contact and close is < 90%, with those in contact between 33% and 50% (left), or the total sum of levees in contact and close is > 90% but those in contact are < 33% (right). *Class C*: levees in contact are > 50% of the reach (left), or those in contact are between 33% and 50% but the total sum of levees in contact and close is > 90% (right). Bottom right: definition of distant, close and in contact levees.

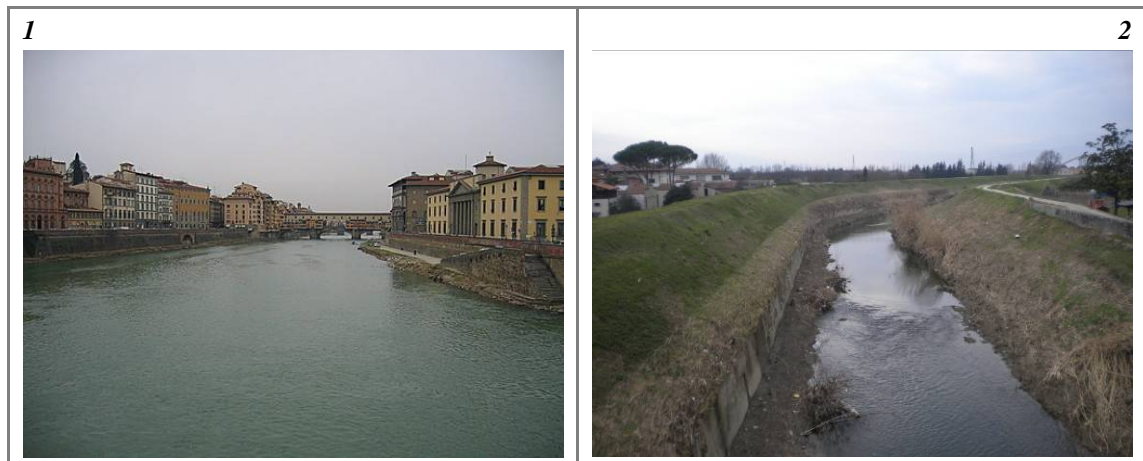
Figure 70 – Cases of bank protections plus levees in contact occurring for most of the reach (> 80%), for which a score of 12 is added.
