**IDRAIM – stream hydromorphological evaluation,
analysis and monitoring system**

Illustrated Guide to the Answers

**Guidebook for the evaluation of stream morphological
conditions by the Morphological Quality Index (IQM)**

**Massimo RINALDI
Nicola SURIAN
Francesco COMITI
Martina BUSSETTINI**

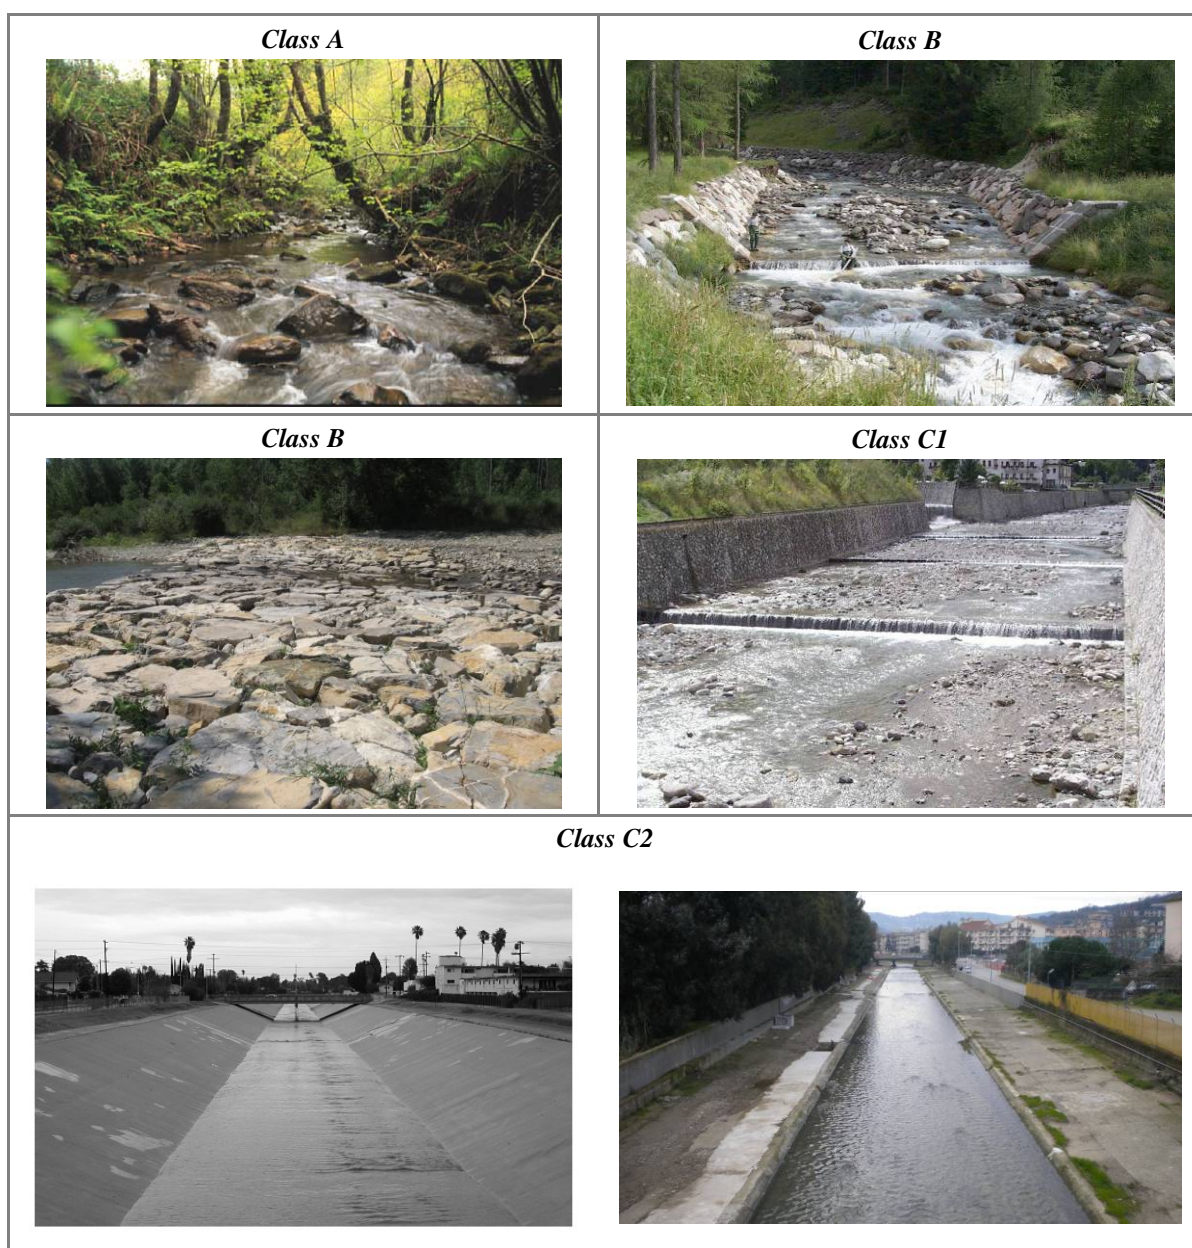
Figure 73 – Other grade control structures and revetments. *Class A*: total absence of other grade control structures or revetments. *Class B*: presence of sills (first row on right) or mass ramps (second row on left) with low density. *Class C1*: various sills and partial bed revetment. *Class C2*: total bed revetment with impermeable systems. If such revetments occur along most of the reach (> 80%), an additional score of 12 is assigned.
