The dying town of Civita di Bagnoregio and the killer landslide

G. Delmonaco, C. Margottini & C. Puglisi

ABSTRACT: Civita di Bagnoregio is a small village in Central Italy, located in the top of a volcanic hill and affected by continues landslides that are progressively reducing the urban area. The town was appealed as the dying town since, last century, it was believed that there were no chances to preserve this monumental landscape from destruction. The village, one of the most beautiful attraction of the region, was investigated in the last 10 years, to define a general comprehensive master plan for a restoration of town and cliffs, based on an approach capable to solve existing problems and minimizing the impact of interventions (sustainable mitigation) and continuously investigating the site as an open space geomorphological museum. Presently a small part of the cliff has been stabilized by means of new techniques from underground and a more exhaustive intervention is in progress. The present paper describe the morpho-evolutive processes of the cliff, the performed investigations, the monitoring data and the proposed solution, partially already realized.

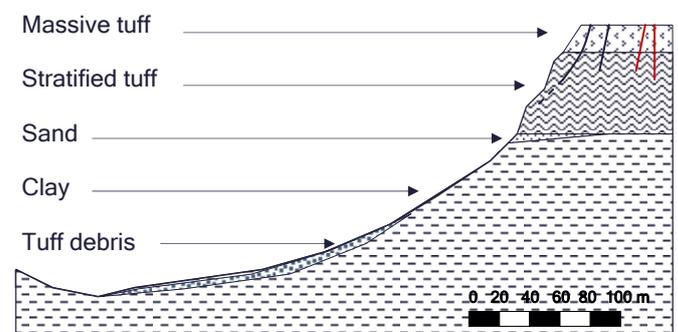
Figure 2. Geological profile of the study area

The cliff where lie Civita di Bagnoregio is composed of a 20-25 m top layer of jointed ignimbrite, underlain by intensively stratified pyroclastic formation; the Quaternary tuffs rest on a bedrock of a Plio-Pleistocene clayey succession which form the valley in the major area. The clays depth can be estimated in some hundreds meters, while the outcropping portion is about 150 and 200 m in the northern and southern valleys respectively. Due to the particular geological and morphological features, the town of Civita di Bagnoregio has suffered from large and frequent slope instability phenomena (Bandis et alii, 2000): in the clayey formation landslides are represented by mudflows, debris-flows and rotational slides, while in the upper portion of the volcanic cliff, due to a retrogressive mechanism of erosion, rock-falls, toppling and block-slides are the common landslide typologies. Historical phenomena have been detected since XV c., with an almost constant number of event in the last five centuries. An edict aimed at a correct management of agricultural practices in the Civita cliffs and surroundings was also recovered in 1373. In total, about 130 phenomena has been identified from historical sources.

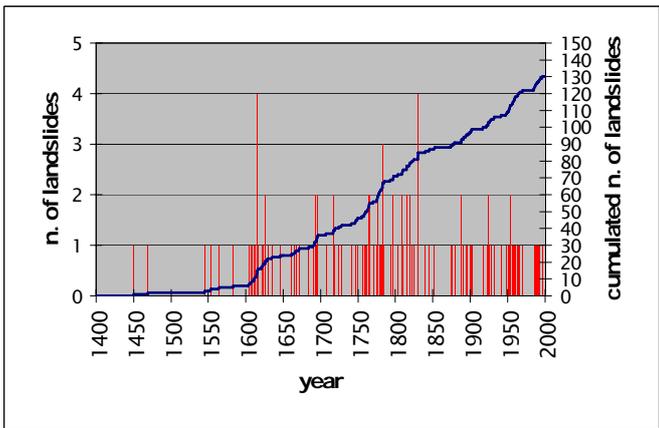
Figure 3. Historical landslide detected for the site of Civita di Bagnoregio in the period 1400-2000 A.D.

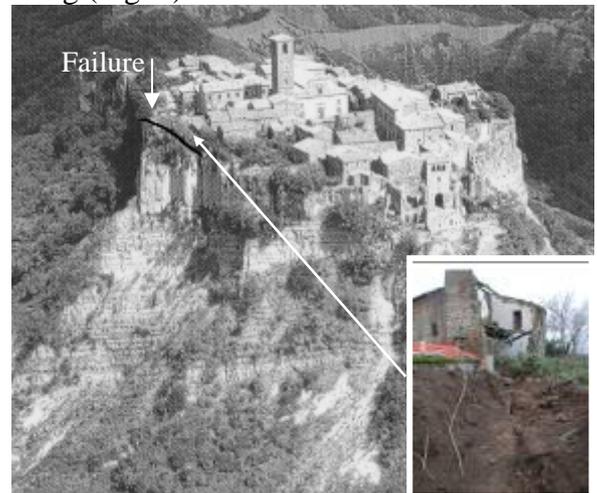
Figure 4. View of the northern side of the cliff and displaying of the large discontinuities.

both massive tuffs and part of the stratified pyroclastic materials, producing an average cliff retrogression of 6 m. During the previous months, in correspondence of the western side of the recently formed cliff border, an opened and lowered failure as well as local sinking were observed. Such failure represents the prosecution of the existing joint in *Piazza del Vescovado*, prolonged in W direction, under the damaged building (Fig. 4).

This discontinuity was monitored since 1992 and exhibited an opening behaviour in the last decade and present day stable situation (after changing of instrument).

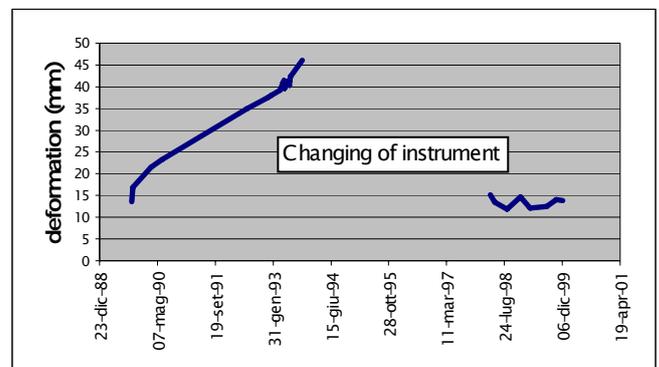
Figure 5. Deformation of the large discontinuities in the northern sector, widening in the period 1993-1998 and stable in the last two years (note, after changing instruments the "0" has been modified)

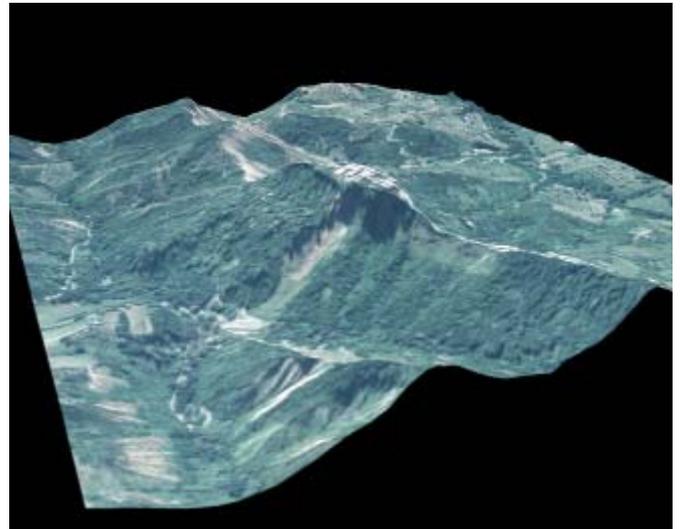
Figure 6. DEM of the area with superimposed an aerial photograph. In the left side it is possible to notice the toe of the large slide that, in 1114 A.D. moved the river from the natural linear behaviour towards the Civita cliff, Northern sector.

First trigger mechanism was probably a large events that occurred in front side of the valley, dated from 14C in a tree root about 1114 A.D..

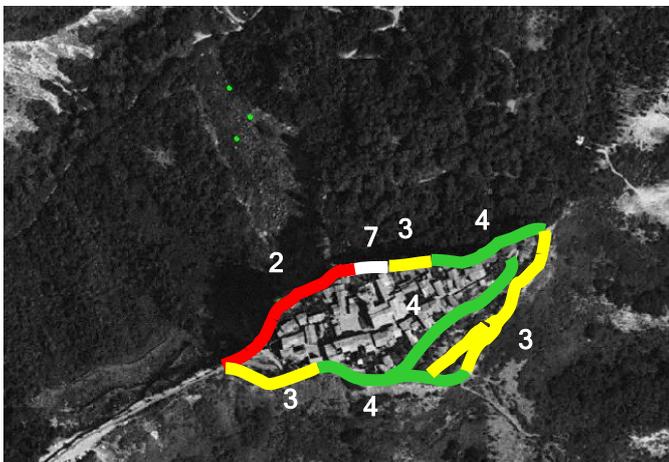
Figure 7. Hazard map of the Civita di Bagnoregio top cliff. Return period is based on Fell (1984) classification, slightly modified; 1 - Extremely high (1 per year), 2 - Very high (0.2 per year); 3 - High (0.05 per year); 4 - Medium (0.001 per year); 5 - Low (0.0001 per year); 6 - Very low (0.00001 per year); 7 - stabilized

Mainly based on historical data an hazard map of cliff scarp was produced, according to the return period proposed by Fell (1984).

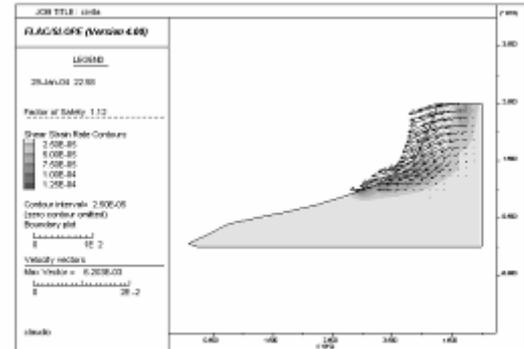
Figure 8. Shear strain rate contour and velocity vectors in a section passing through “Cavon Grande”

The Cavon Grande is now exhibiting a Factor of Safety (FoS) of about 1.12 for a critical surface placed at about 30 m from the cliff border (fig. 8).

In such a situation the plasticity state show a general tendency of a upper part to a tensional state and a lower part at a shear state. This situation it is not completely reliable since the existing discontinuities, spacing about 50-100 cm, define the cliff as discontinue material and not a continue one as requested by numerical code such as FLAC. Probably, collapse may occur in smaller sub set of the cliff, not greater than 5-8 m from the scarp, as already occurred in the past.

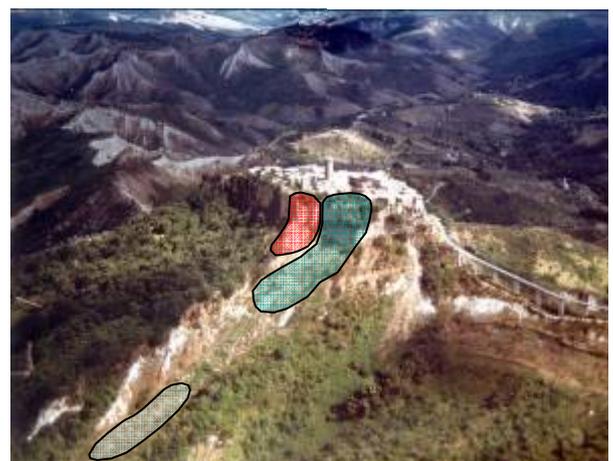
Figure 9. The three major areas of instabilities considered relevant for the future evolution of the cliff. From top-left “Casa Greco”, top-right “Cavon Grande”, bottom is the tuff debris.

The site of Casa Greco is almost at the limit equilibrium. The existing open discontinuity play a remarkable role in favour of collapse and a stabilisation work is strongly required.

In the lower part of the cliff, where the tuff debris is lying over the clay, stability conditions are related to the level of water table. For a Ru ratio (height of material/height of saturated zone) greater than 0.35 the lower part of the cliff is capable to generate debris flow.

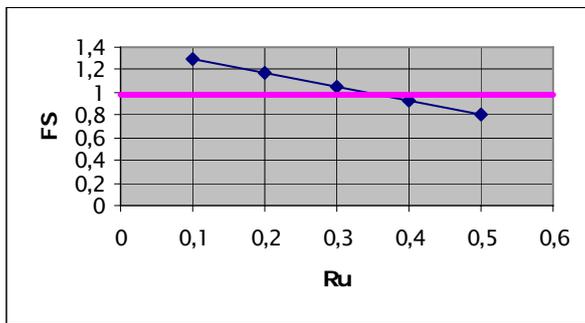
Figure 10. Factor of safety in the tuff debris for different Ru factors (Thickness of debris/width of water table).

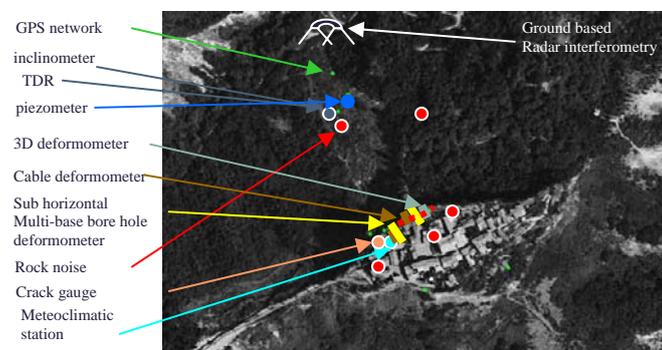
Figure 11. The realised monitoring system

Considering the rapid morphological evolution of the area, the Italian Minister of Education, University and Research, funded a project for the monitoring of Civita di Bagnoregio and than to provide a technological support to the consolidation strategies aimed at preventing a dramatic collapse of the cliff. The monitoring system was mainly focused to the northern cliff where majority of the problem exists. They include: 1 inclinometers (equipped with TDR), 1 piezometer, 1 3D extensometer, 2 sub-horizontal multi base bore-hole extensometer, 3 cable extensometer, 1 crack gauge, 1 meteo-climatic station, GPS network, rock noise measurement and, finally, even ground based radar interferometry. The monitoring system was installed in March 2002.

Since the installation of the monitoring network no relevant displacement has been detected by the instruments. Major deformation occurred in the period 1990-1995 with the large rock slid of 1993, September 3rd.

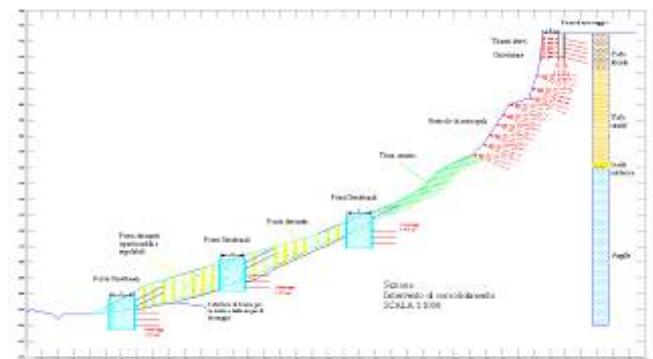
Figure 12. Typology section of the proposed intervention.

1. Anchoring the upper part of the volcanic cliff (massive tuff) by means of traditional passive anchors but realised from large wells located about 6-10 m from the scarp;
2. consolidation stratified tuffs with an irregular net of micropoles (e.g. "Pali radice");
3. protection the erosion of upper clay outcrop by means of reinforced earth;
4. Stabilisation of the tuff debris by means of large wells composed by a ring of several 1 m poles; these large wells are serving against potential deep sliding and for drainage of the debris;
5. realisation of drainage wells (sand wells and open) for the lowering of the water table;
6. maintenance of river bed;

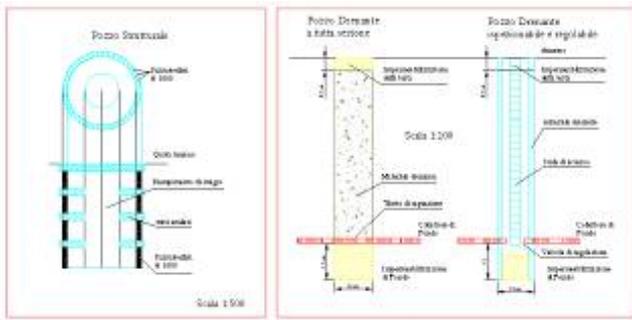
Figure 13. Detail of the proposed sand wells and open wells for the drainage of the tuff debris (redrawn from Bianco & Beligni, 1985)

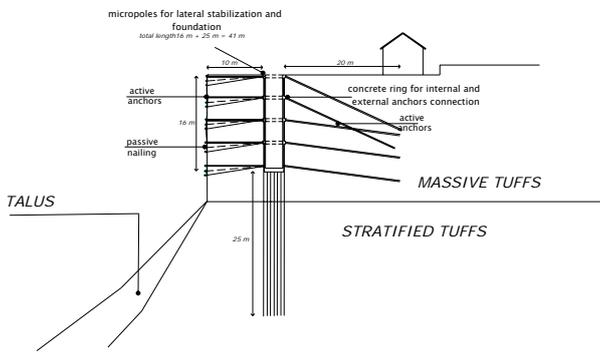
Figure 14. Detail of the already developed techniques for anchoring the upper massive tuff (Bandis et alii, 2000).

According to the approaches mentioned above, a first step was already realized and reported in Bandis, (2000). The result was quite satisfactory and the mean way correctly underlined.
