Dipartimento Difesa del Suolo
Servizio Geologico d'Italia

**GEOLOGICAL EFFECTS INDUCED BY
THE L'AQUILA EARTHQUAKE (6 APRIL 2009, MI = 5.8)
ON THE NATURAL ENVIRONMENT**

PRELIMINARY REPORT

Roma, May 2009

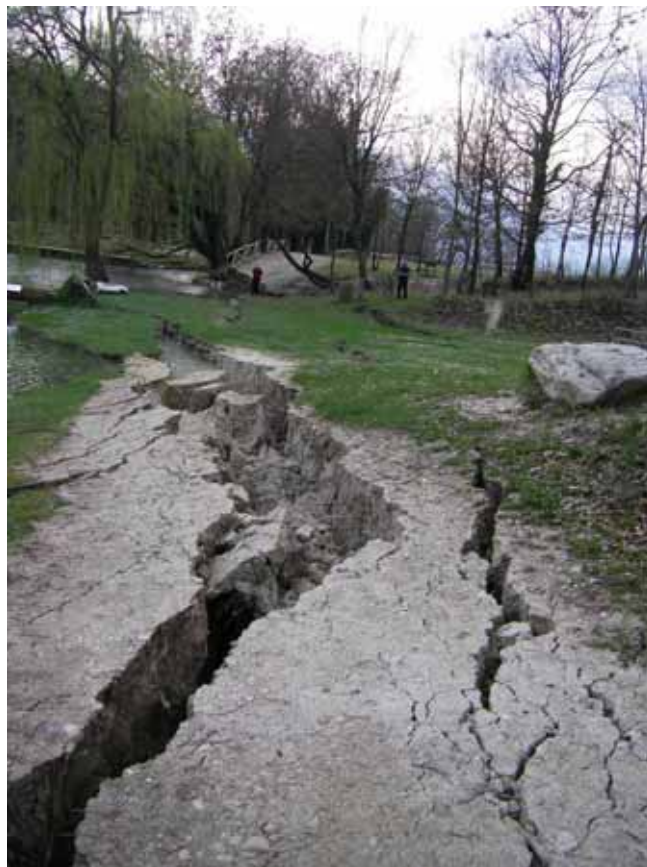
Front Cover: ground failures along the shores of the Lake Sinizzo, near San Demetrio ne' Vestini.

Around the Lake Sinizzo, near San Demetrio ne' Vestini, very impressive ground failures along the whole shoreline were observed (see front cover and Fig. 36). Their post-seismic evolution was very high. In the other sinkholes of the area (generally empty of water) no remarkable effects were found.

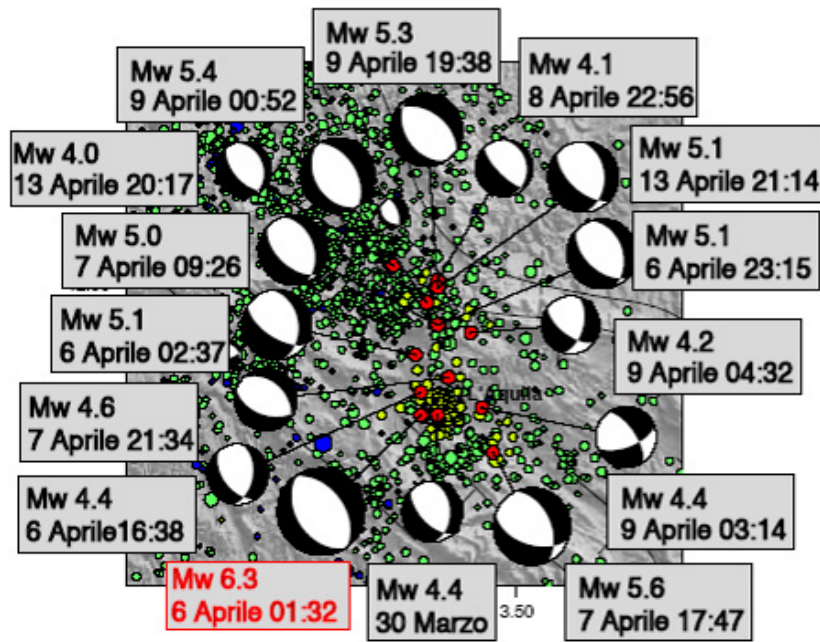
The seismic sequence has affected an about 30 km long, NW-SE trending, zone. The focal mechanisms of the sequence (Fig. 2) clearly define a NW-SE trending normal faulting mechanism. The focal depths are generally within 10-12 km, but the 7 April shock, which is slightly anomalous in terms of focal depth (about 15 km) and focal mechanism (a significant strike-slip component). While most of the main events appear to have occurred on southwest-dipping planes, according to INGV, the few aftershocks associable to the April 7 event do not clearly define a preferred nodal plane for the rupture.

Fig. 2 – Focal mechanisms of the most important events of the seismic sequence (source: INGV).

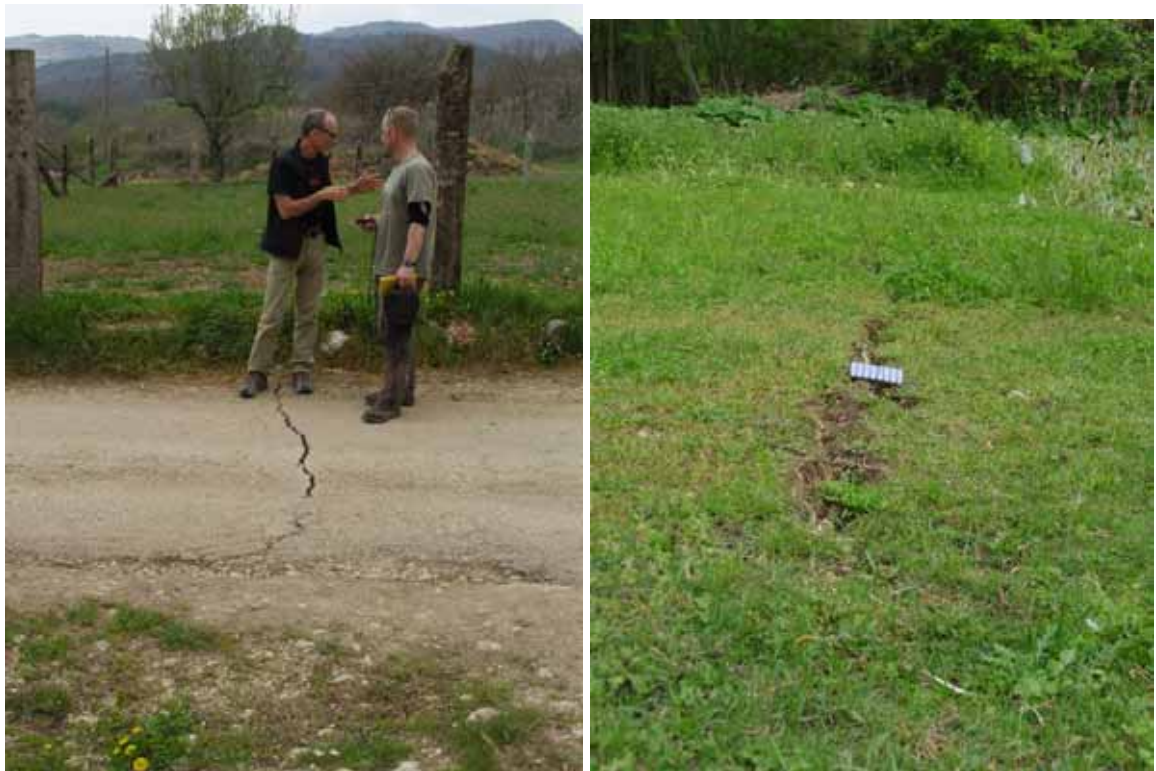
A set of discontinuous but well aligned ground ruptures was found in correspondence of the Paganica fault. These ruptures, trending between N120 and N140, could be traced for a length of about 2.6 km, reaching in some sites vertical offsets of 7-8 cm (see Figs. 8 – 18, from NW to SE). They could be easily observed on paved/concrete and often dirt roads and on other artificial surfaces, as well as on buildings and hard fences. Particularly evident was the pipeline rupture of the Gran Sasso aqueduct (see ahead). The same set of fractures was locally well evident also on natural/farmed soil.

Fig. 8 - Ground ruptures near Tempera, NW of Paganica

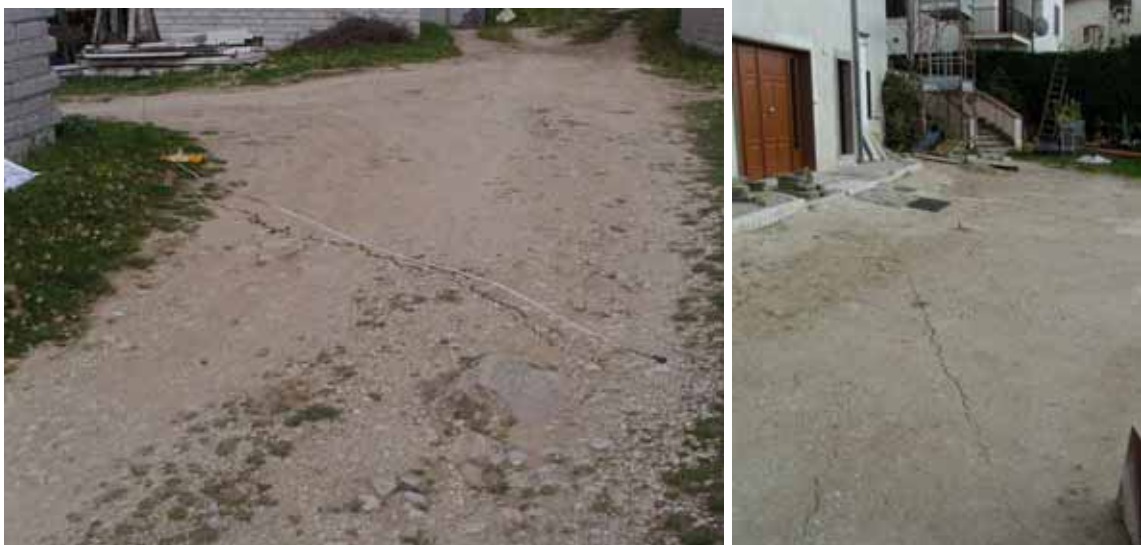
Fig. 9 - Ground ruptures between Tempera and Paganica

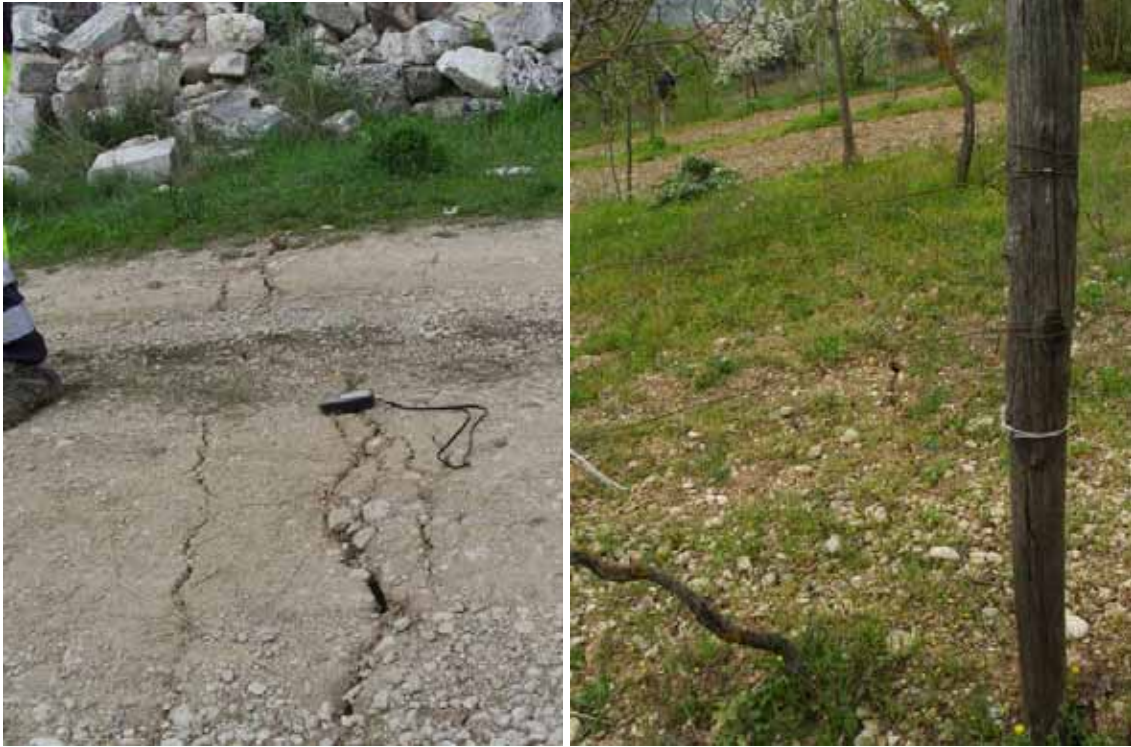
Fig. 10 - Ground ruptures in Paganica some tens of meters west of the broken aqueduct

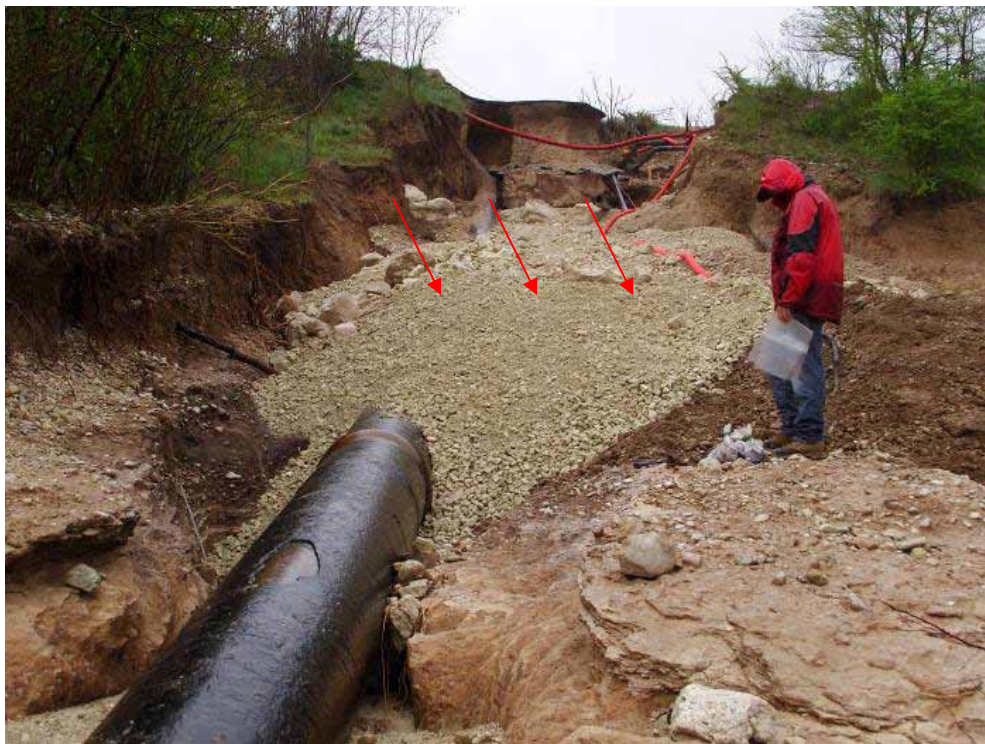
Fig. 11 - The site where the aqueduct was broken. The location of ground ruptures (before being covered) is pointed out by red arrows

The coseismic reactivation of the Paganica fault caused the rupture of the Gran Sasso aqueduct. The rupture of the aqueduct provided an extraordinary exposure of faulted sediments, clearly showing the occurrence of previous coseismic surface faulting events (Fig. 20).

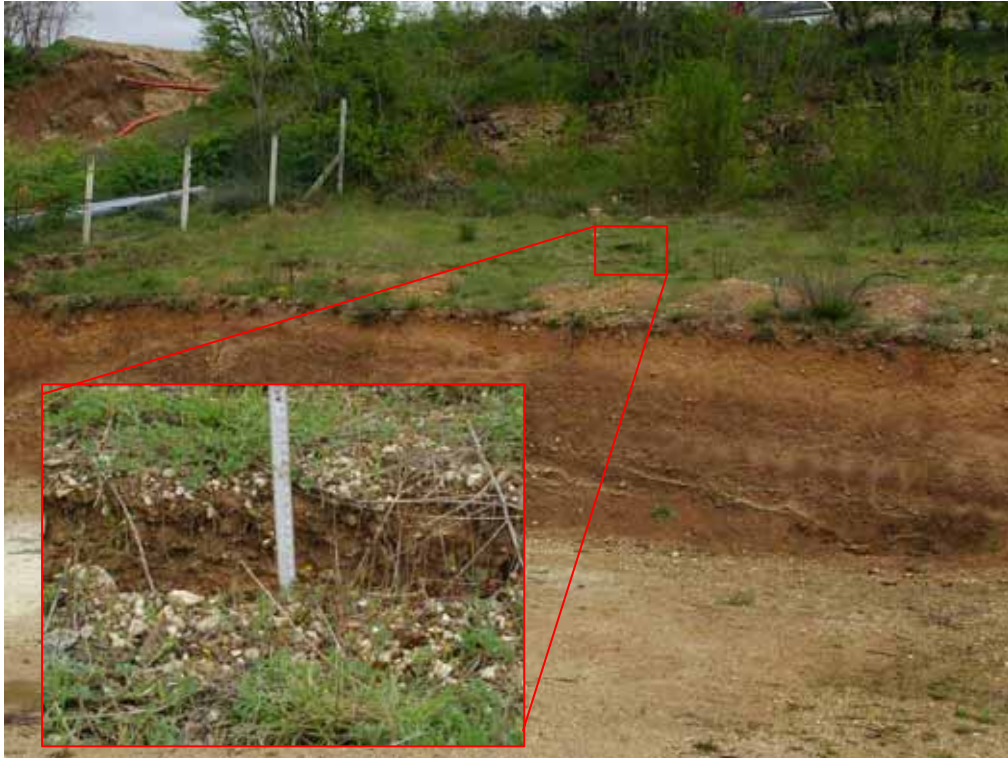
Fig. 12 - Ground ruptures in Paganica about 20 meters east of the broken aqueduct

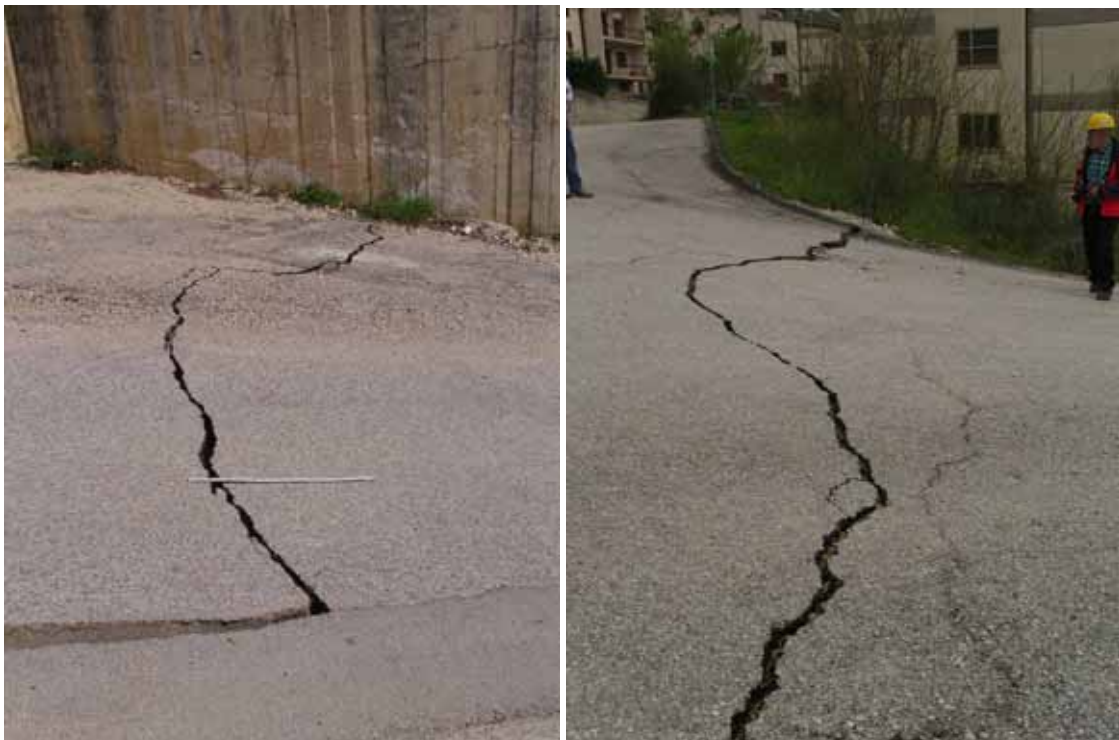
Fig. 13. Fractures in paved roads in Paganica some tens of meters east of the broken aqueduct

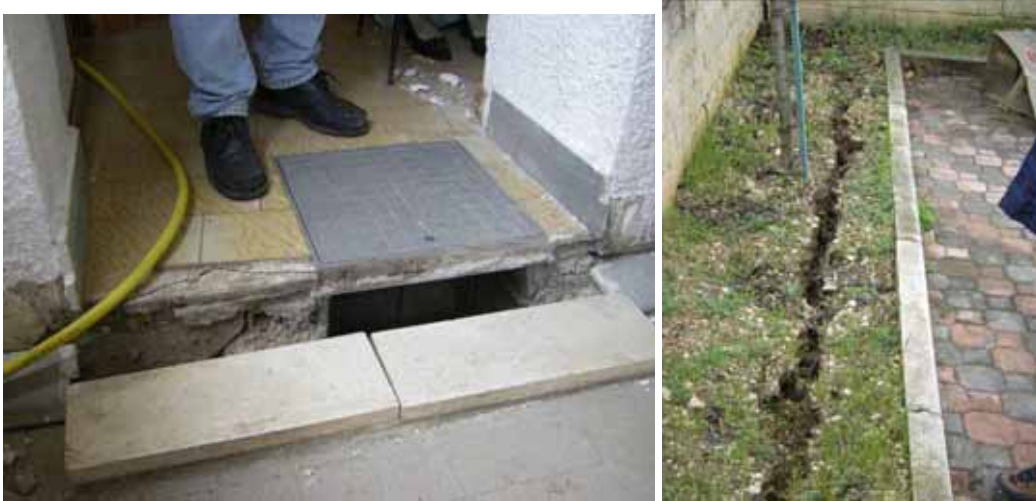
Fig. 14. Two ruptures affecting a modern building and a house-yard in Paganica

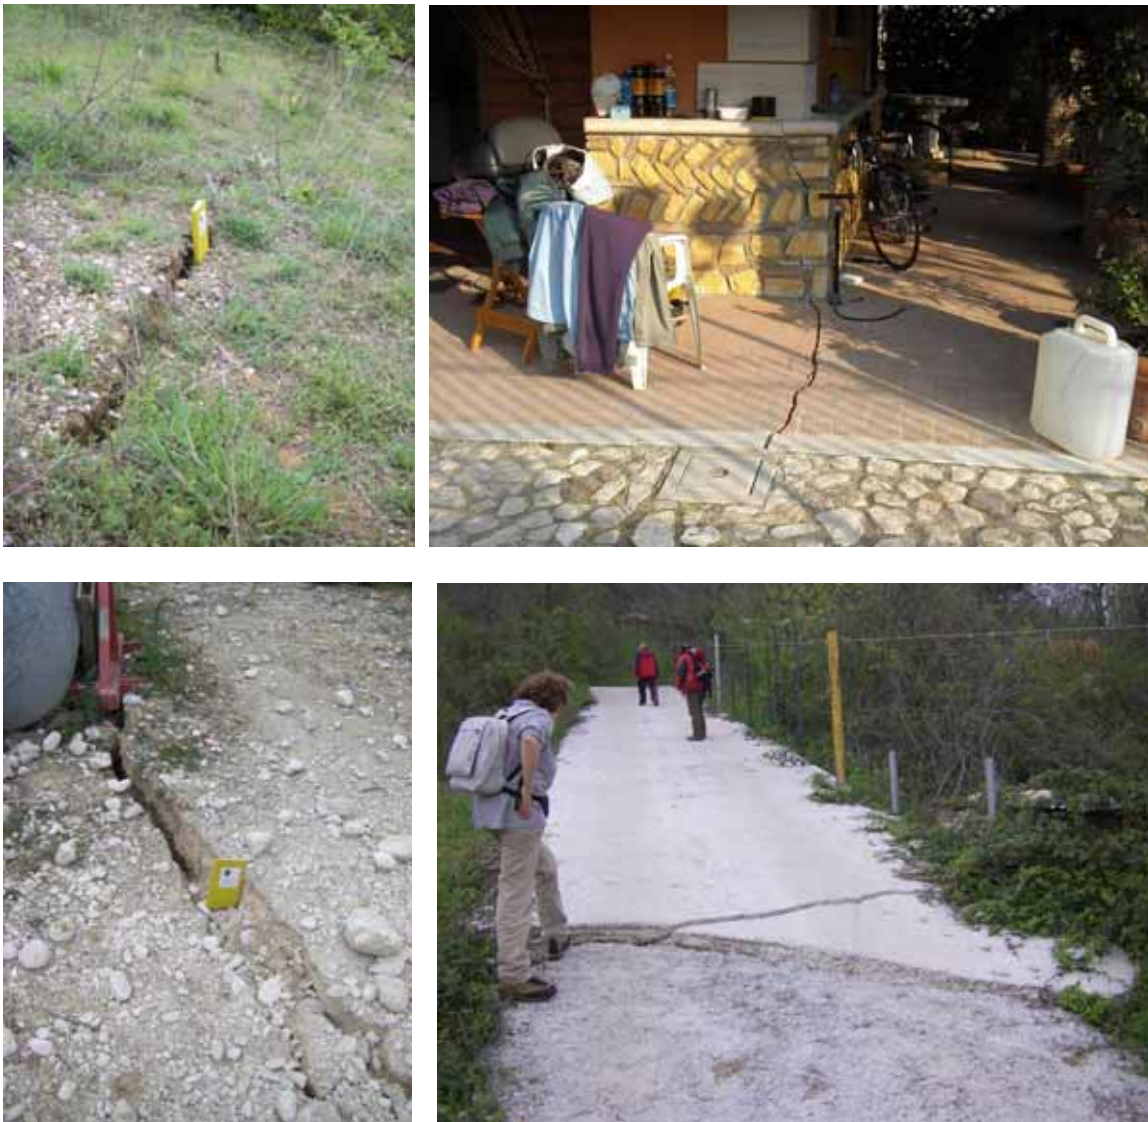
Fig. 15. The ruptures affected the ground, some buildings and concrete roads continuously for several hundreds of meters with offsets up to 7-8 cm.

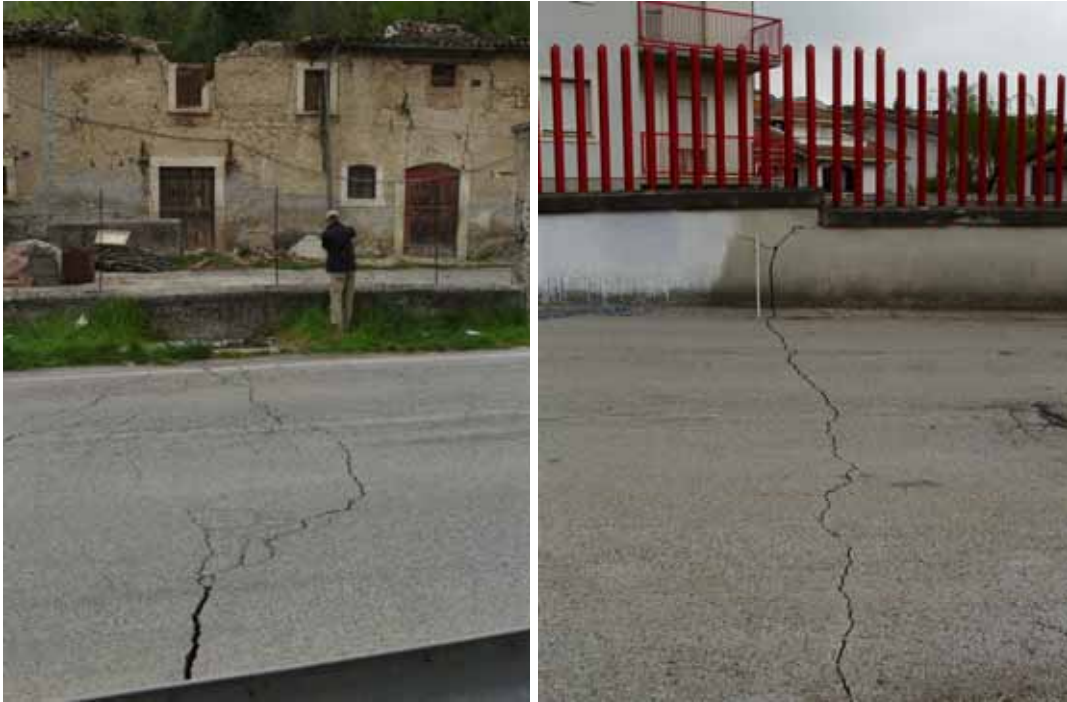
Fig. 15. The ruptures were clearly visible also on the road from Paganica to Camarda.

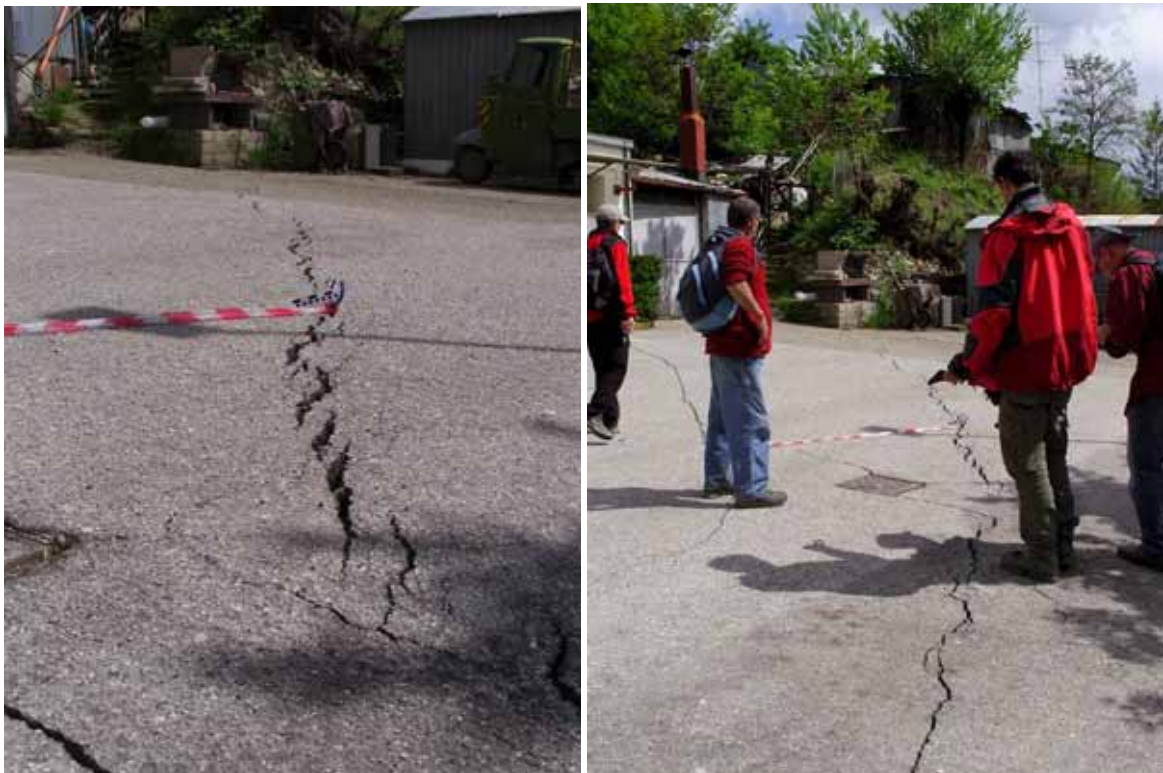
Fig. 16. Fractures in paved roads at Paganica, Via del Caldarello

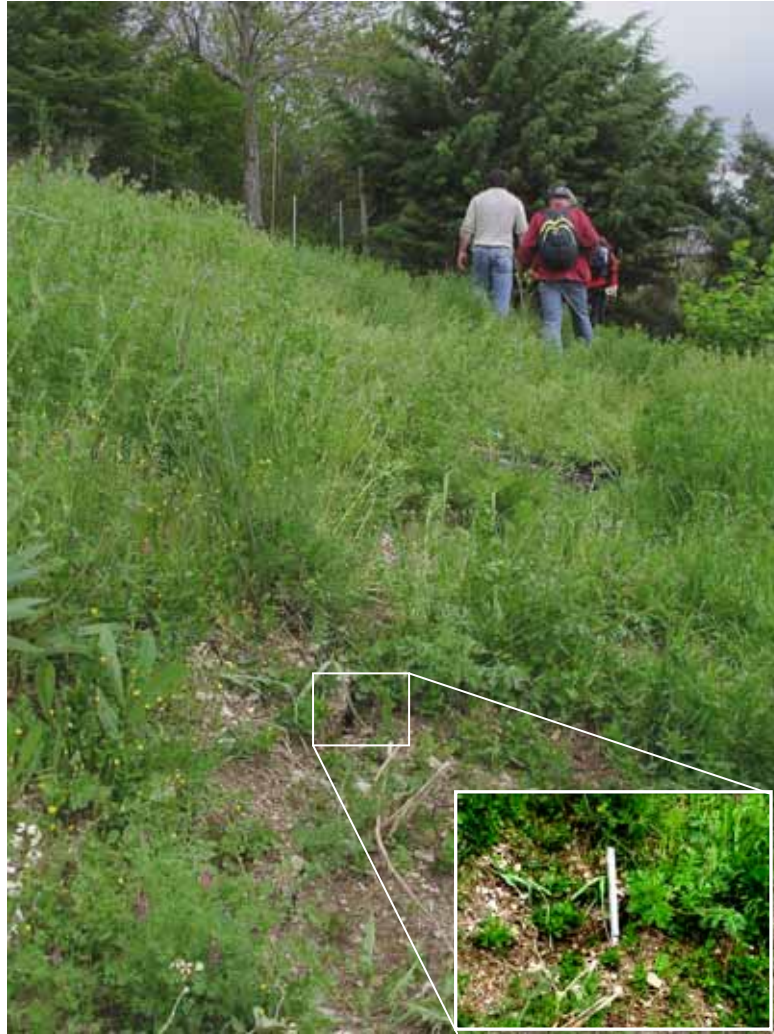
Fig. 17. Ground ruptures with centimetric offset at Paganica, Via Rodrigo De Paulis.

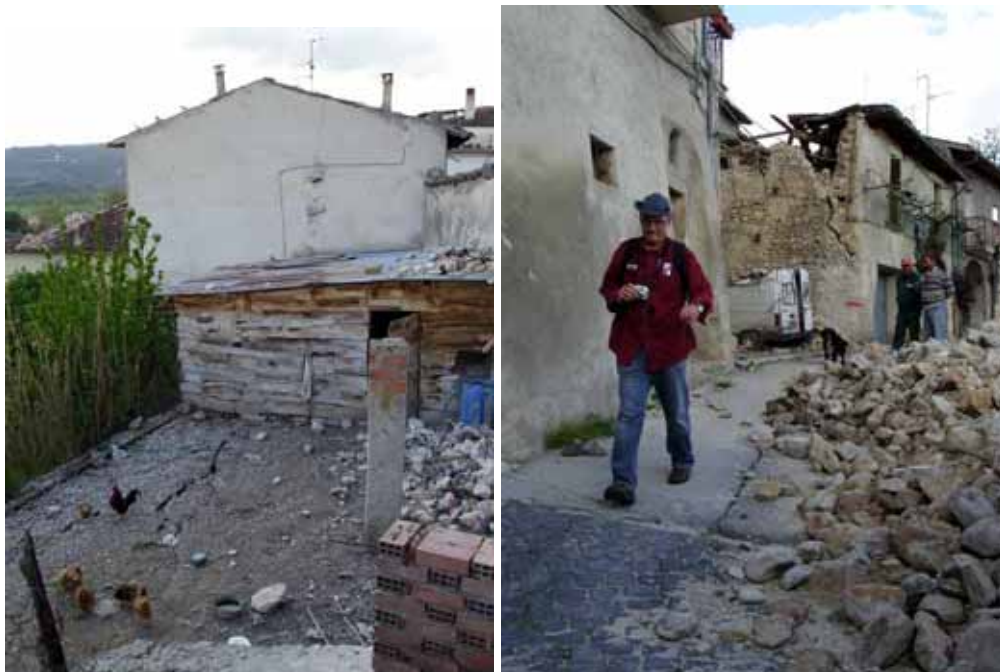
Fig. 18. Fractures in buildings and paved road at Paganica, Via delle Volpi.

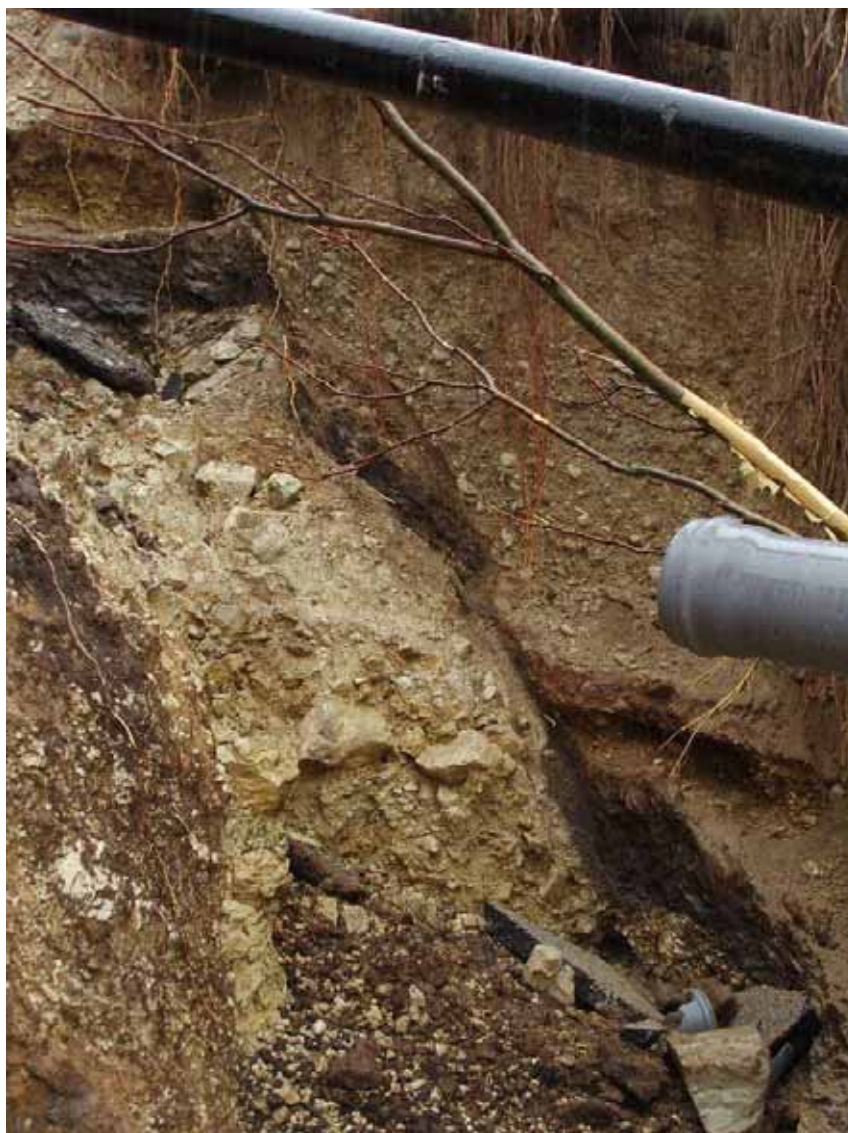
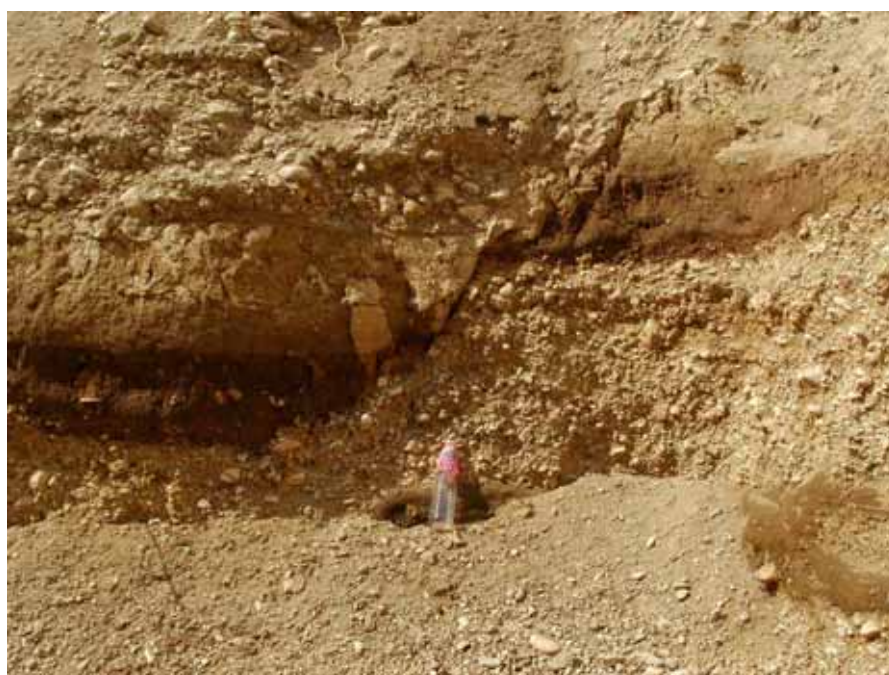
Fig. 20 – Paleoseismic evidences near the broken aqueduct

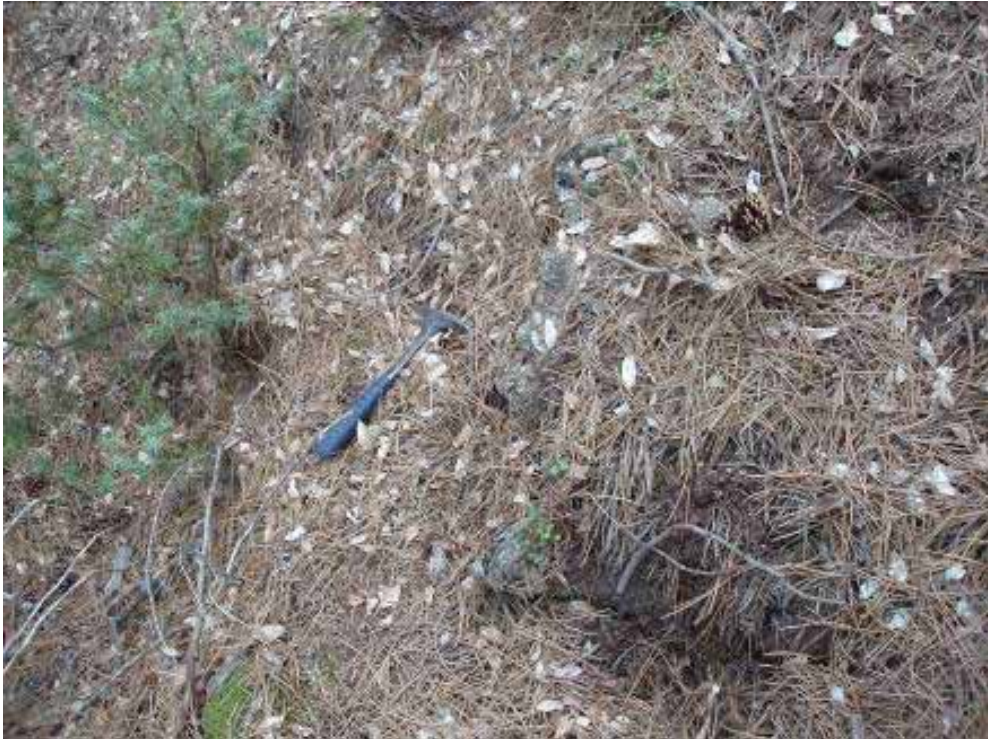
Along the Pettino fault only local ground ruptures, some tens of meters in length with offsets up to 10 cm were found (Figs. 21-22). This evidence is very discontinuous and cannot be interpreted as proof of actual surface faulting.

Fig. 21 - Pettino fault. Ground crack with about 10 cm offset pointed out by the uplifted leaf blanket

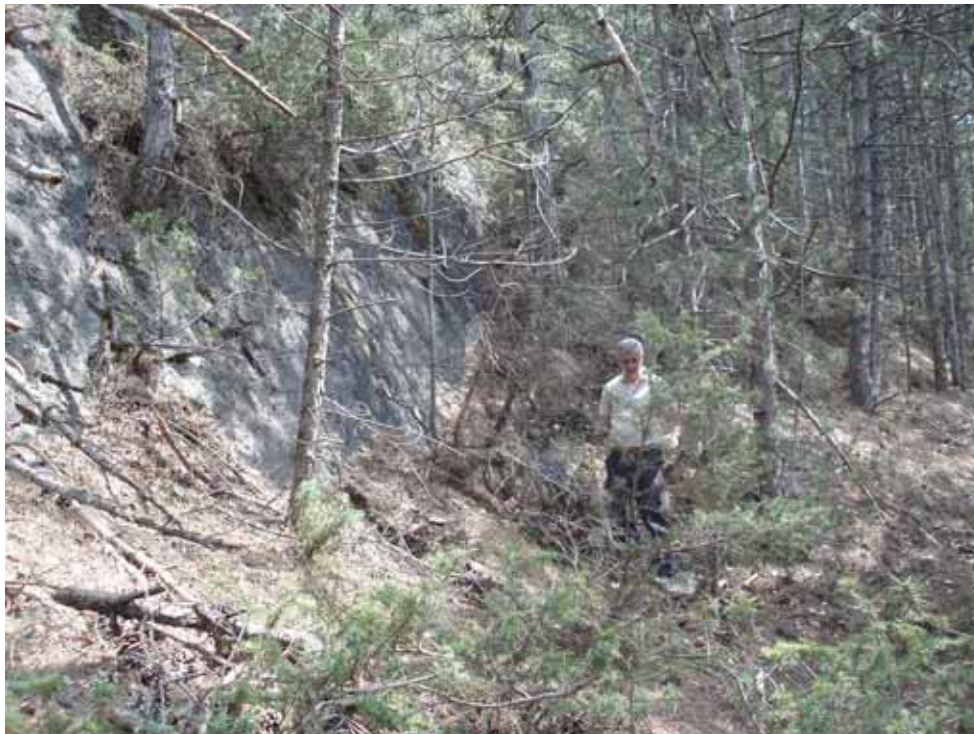
Fig. 22. - Pettino fault. Free face about 10 cm high and a few meters long shown by displaced pine needles.

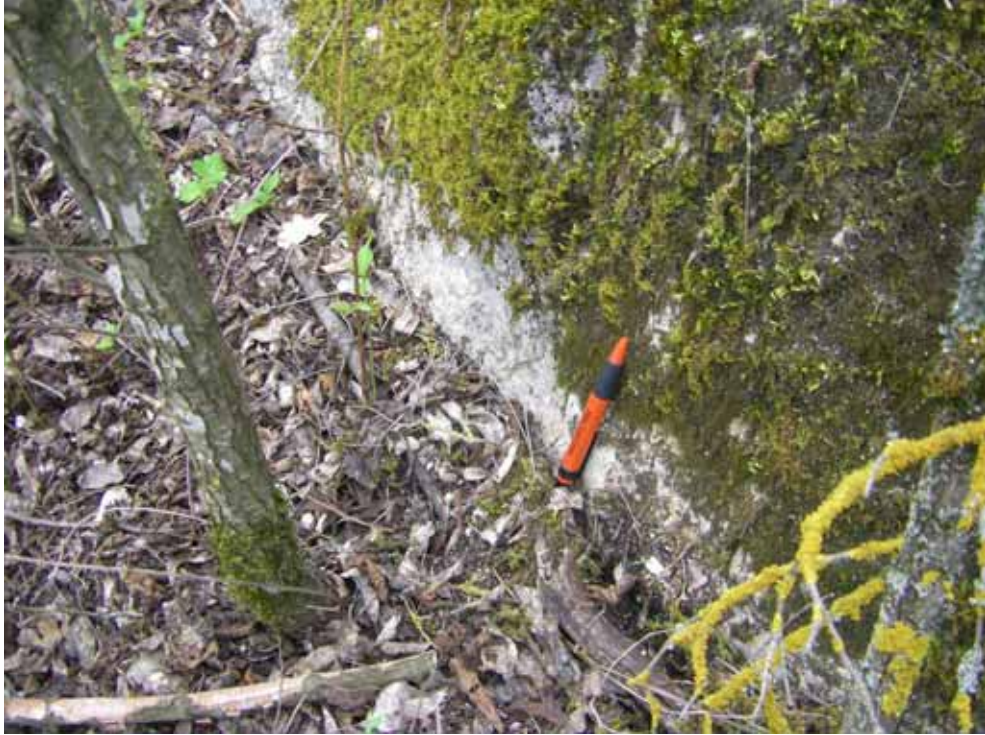
Along the Bazzano fault, which is a N310 trending normal fault antithetic to the Paganica fault, we observed a discontinuous free face with offsets locally up to 5-6 cm, marked also by the distribution of moss (Fig. 23). This evidence might be interpreted as a centimetric coseismic surface reactivation of the Bazzano fault together with a significant debris compaction, as shown by the irregular distribution of offsets.

Fig. 23 - Bazzano fault. Discontinuous free face, tens of meters to hundreds of meters long. Its thickness ranges from 2 to 8 cm

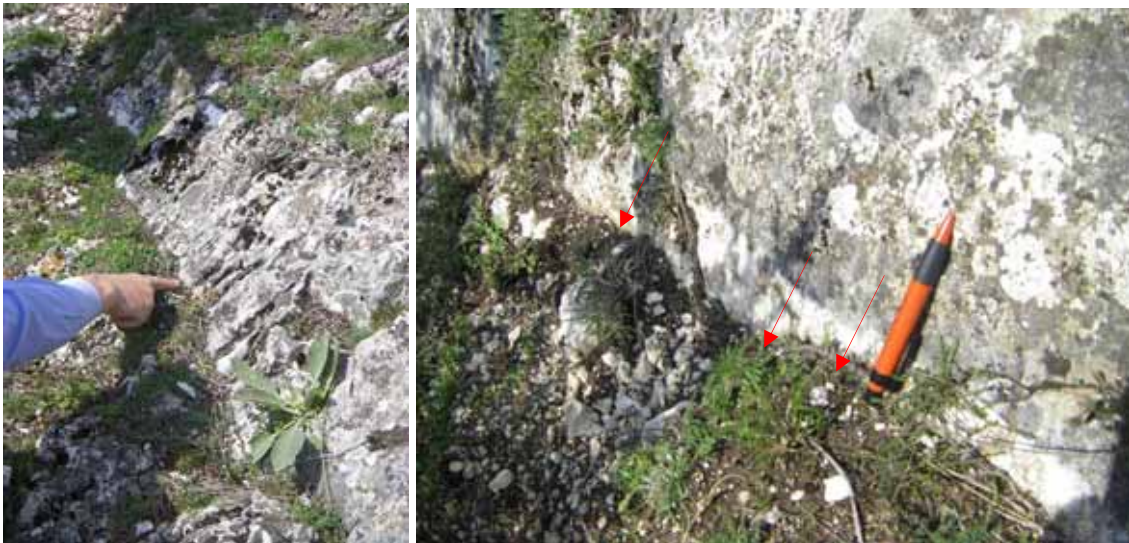
Another free face was found along the N125 trending Canetre fault not far from Roio (Fig. 24). A constant offset of about 1 cm was seen for at least 1 km. This effect was evident not only along debris-rock contacts but also along rock to rock contacts.

Fig. 24 - Canetre fault (Roio). Its potential reactivation is suggested by a continuous free face with constant offset of about 1 cm (shown by the red arrows) and length of at least 1 km. The free face was evident not only along debris-rock contacts but also along rock to rock contacts.

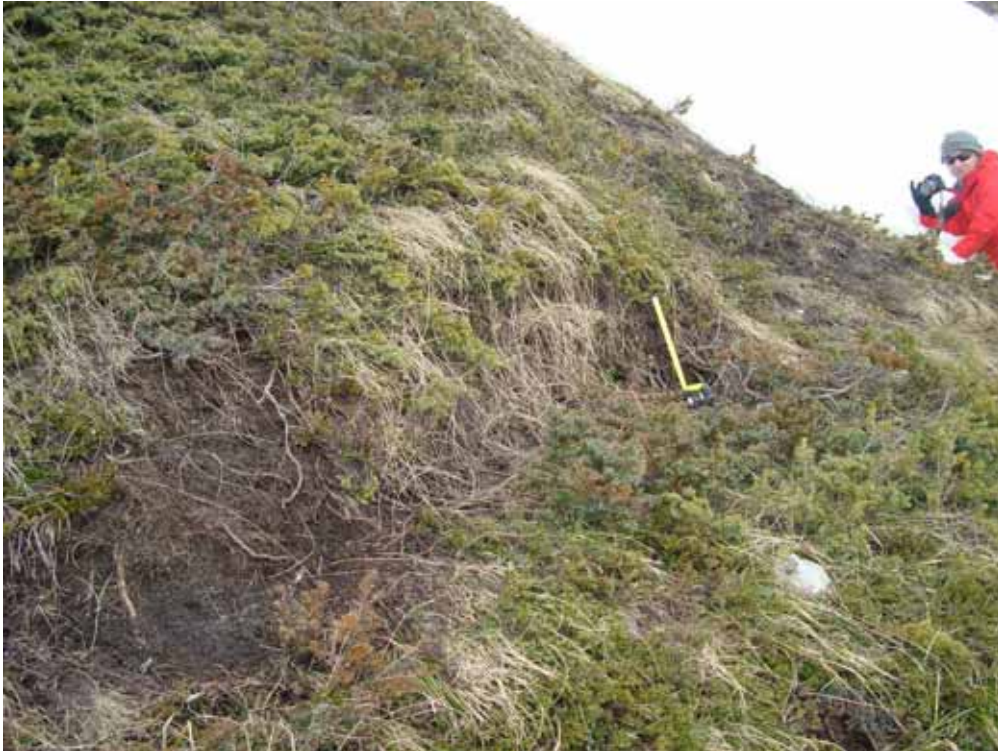
Another NW-SE trending ground rupture at least some hundreds of meters long and offsets up to 30 cm, was found by the Birbeck / University College of London along the Campo Imperatore active faults system (Fig. 25). A correct interpretation of this feature is not possible yet, since the area is partially covered by snow.

Fig. 25– Campo Imperatore fault. A 20-30 cm rupture exhuming the roots of juniper bushes was evident for at least 300 m (courtesy of G. Roberts)

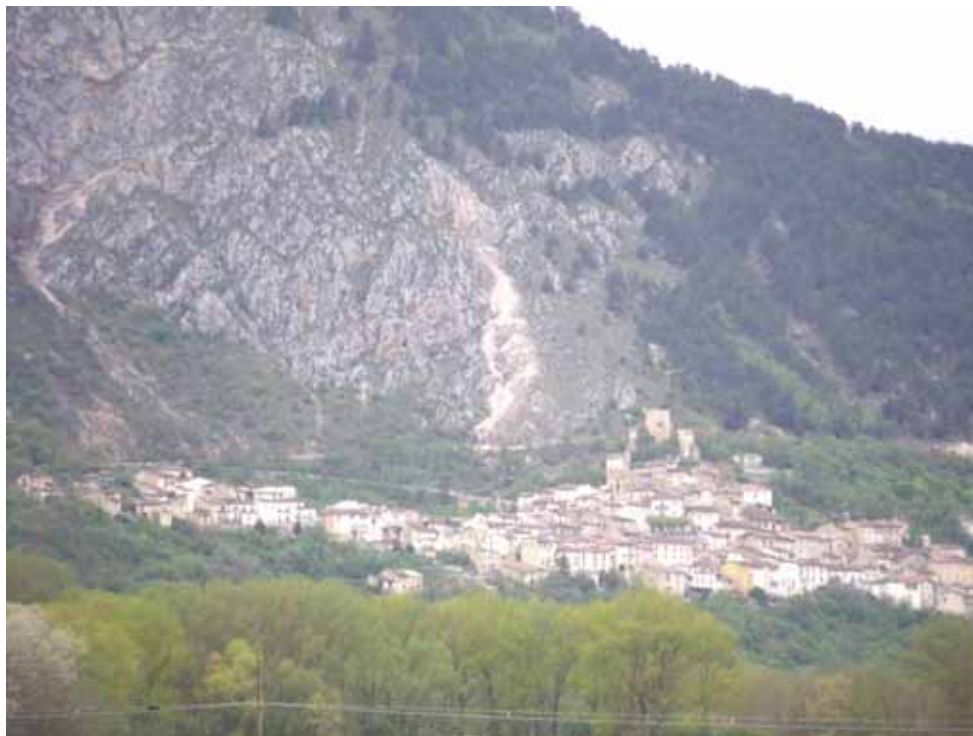
Numerous rock falls (78% of gravitational movements, Fig. 27) occurred especially from calcareous slopes. Among them, one of the most impressive took place above the village of Fossa, which was directly damaged by huge boulders (Fig. 28-29). The falling of blocks from the slope has continued for a long period also independently from the aftershocks, posing a significant residual risk for the area. Residual risk of rock falls has caused the temporary closure of some important roads like the SS17 (at San Venanzio Gorges, Fig. 30), the SS 696 (at San Potito, Fig. 31), the Paganica – Camarda road (at S. Maria d'Appari). and the access road to the Stiffe cave (Fig. 32).

Fig. 28 – Panoramic view of the rockfall above Fossa

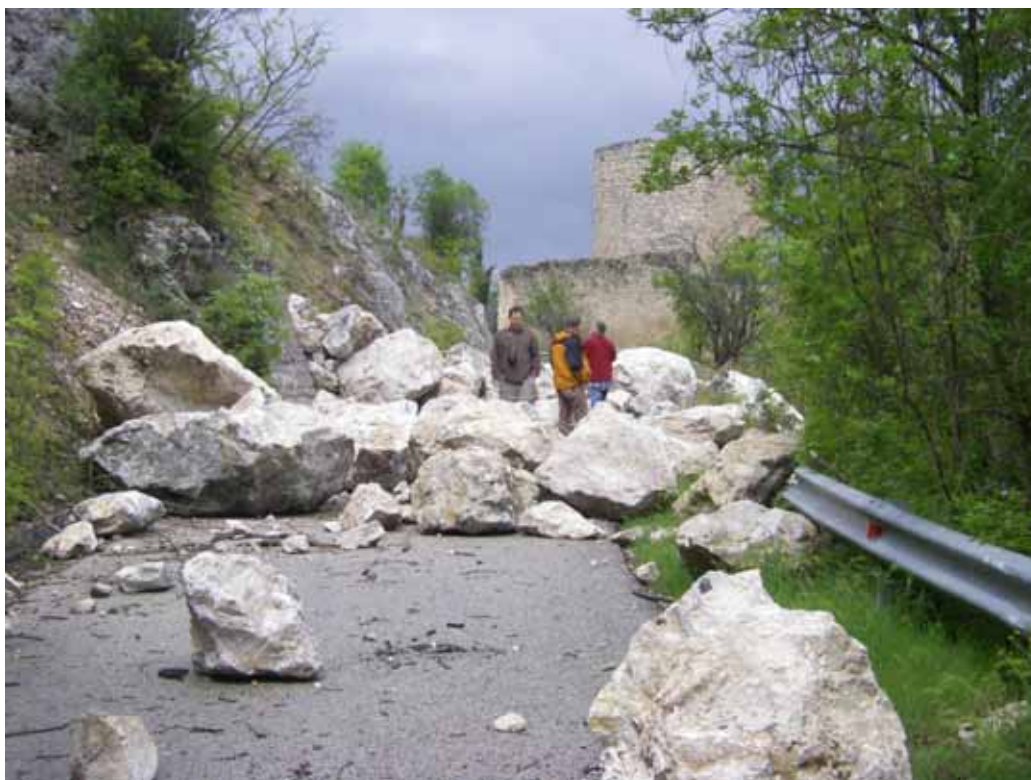
Fig. 29 – Fossa rockfall: huge boulders on a paved road.

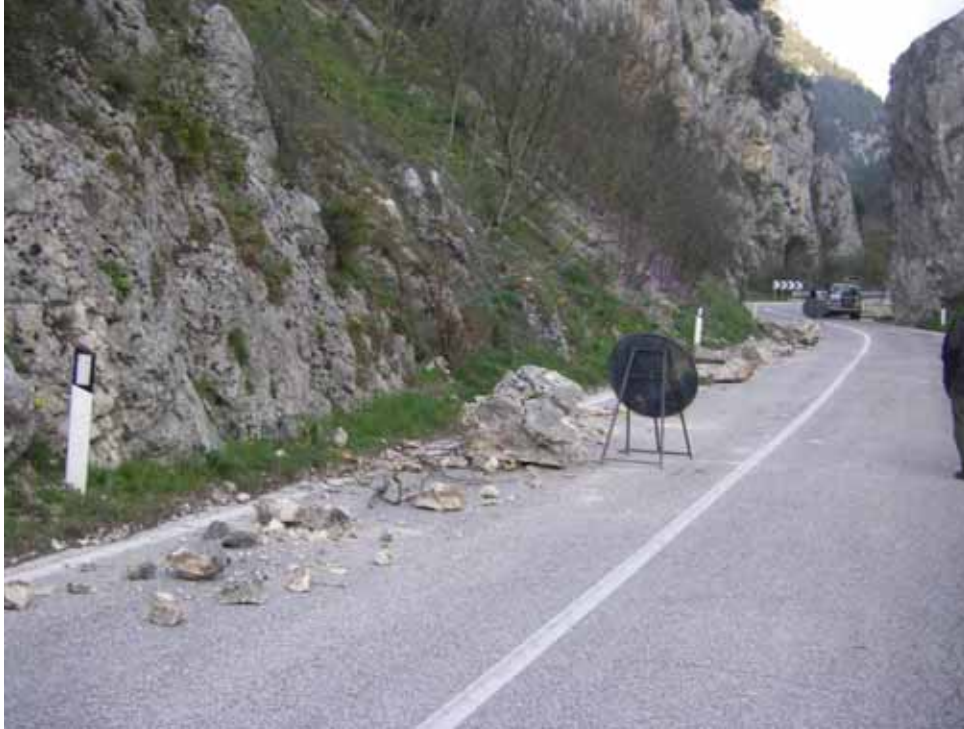
Fig. 30 – Rockfalls in the San Venanzo Gorges caused the interruption of the viability on the SS 17 Road.

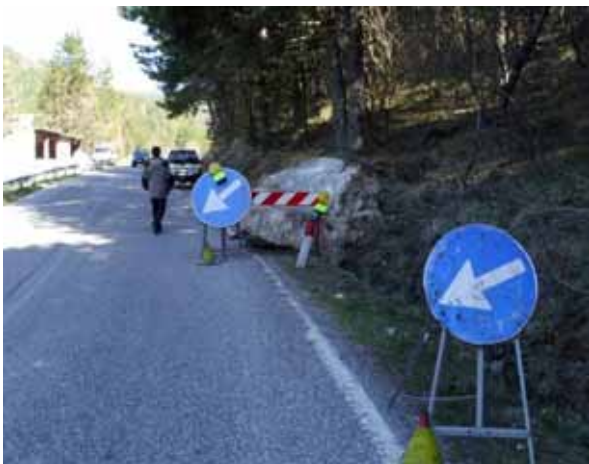
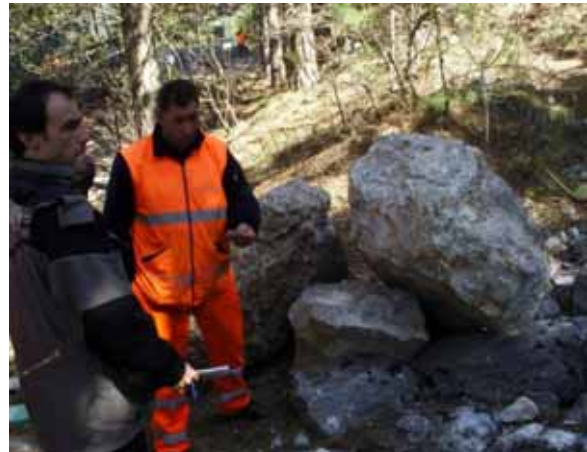
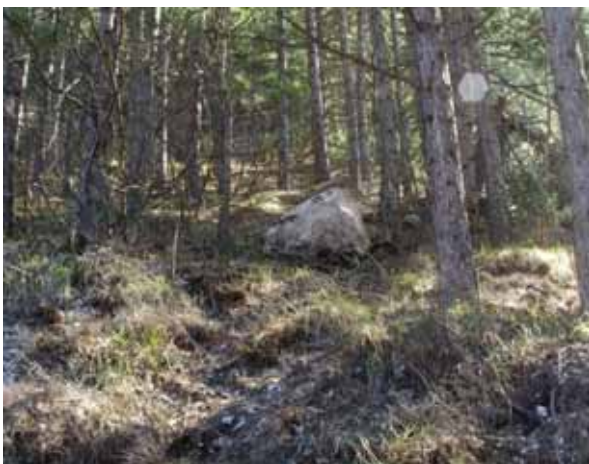
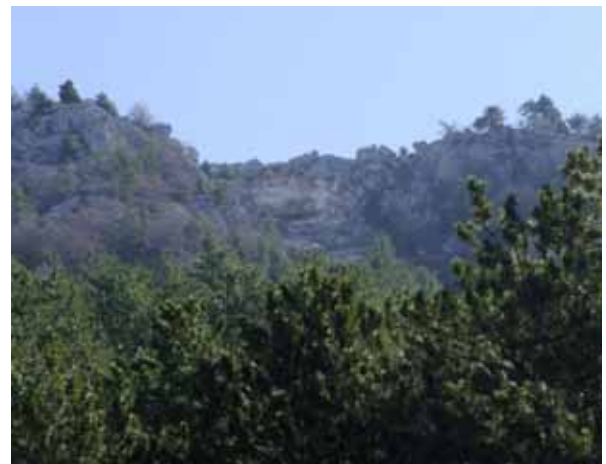
Fig. 31 – Boulders along the SS696 near San Potito. The presence of instable blocks on the steep slope caused the interruption of the viability for several days.

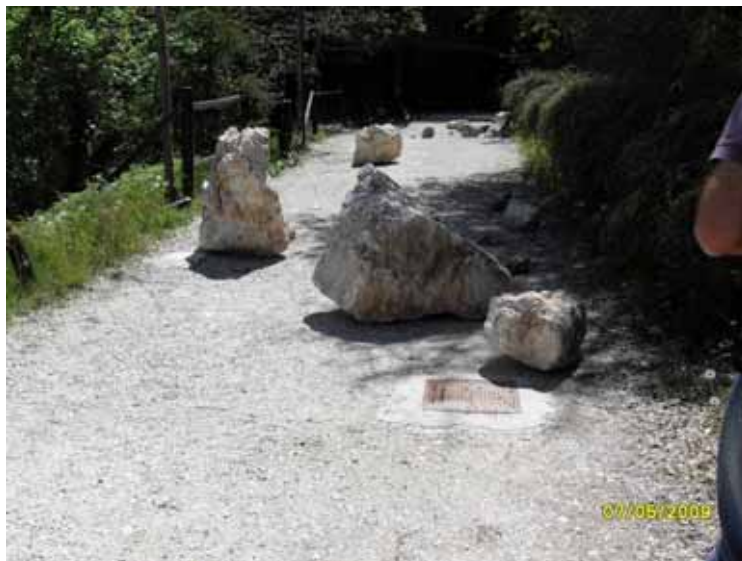
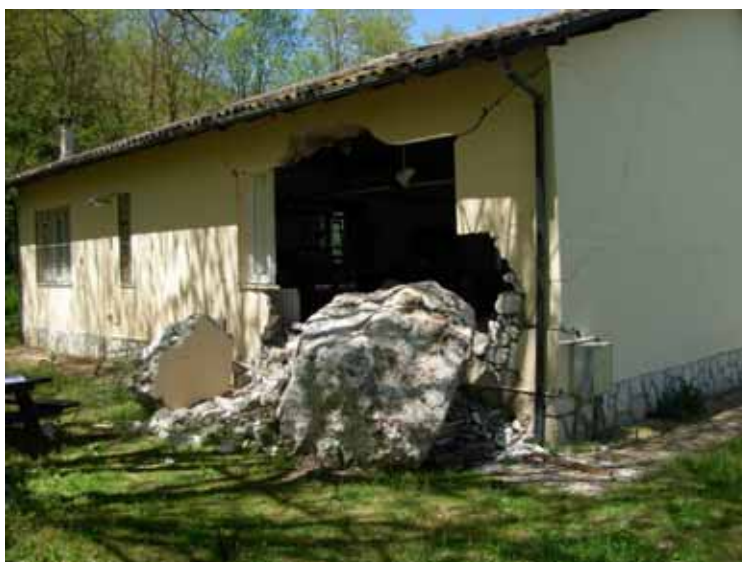
Fig. 32 – A huge block damaged the cafe near the entrance of the Stiffe Cave

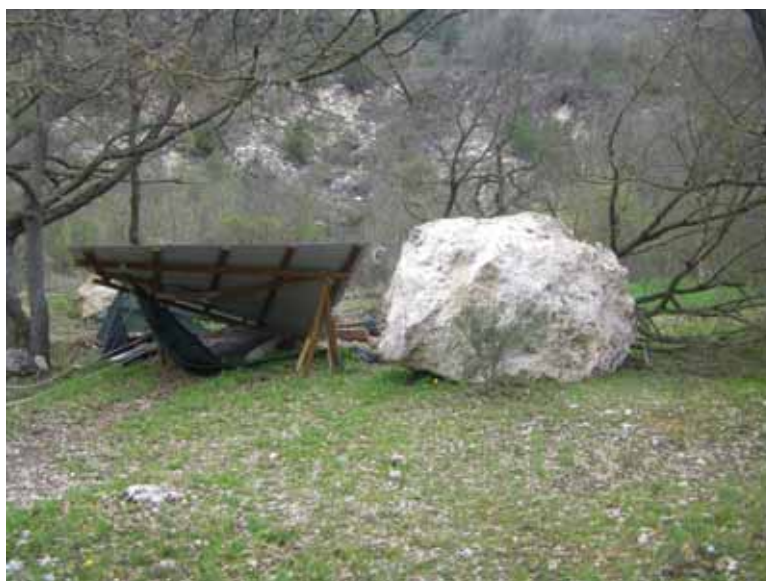
Other important rock falls have been surveyed within the Gran Sasso mountain range (rock avalanches), along the NE slope of Mt. Bazzano (several cubic meters in size, Fig. 33)

Fig. 33 – A huge block (about 7 cubic meters) fallen from the NE slope N of Mt. Bazzano
