Dipartimento Difesa del Suolo
Servizio Geologico d'Italia

**GEOLOGICAL EFFECTS INDUCED BY
THE L'AQUILA EARTHQUAKE (6 APRIL 2009, MI = 5.8)
ON THE NATURAL ENVIRONMENT**

PRELIMINARY REPORT

Roma, May 2009

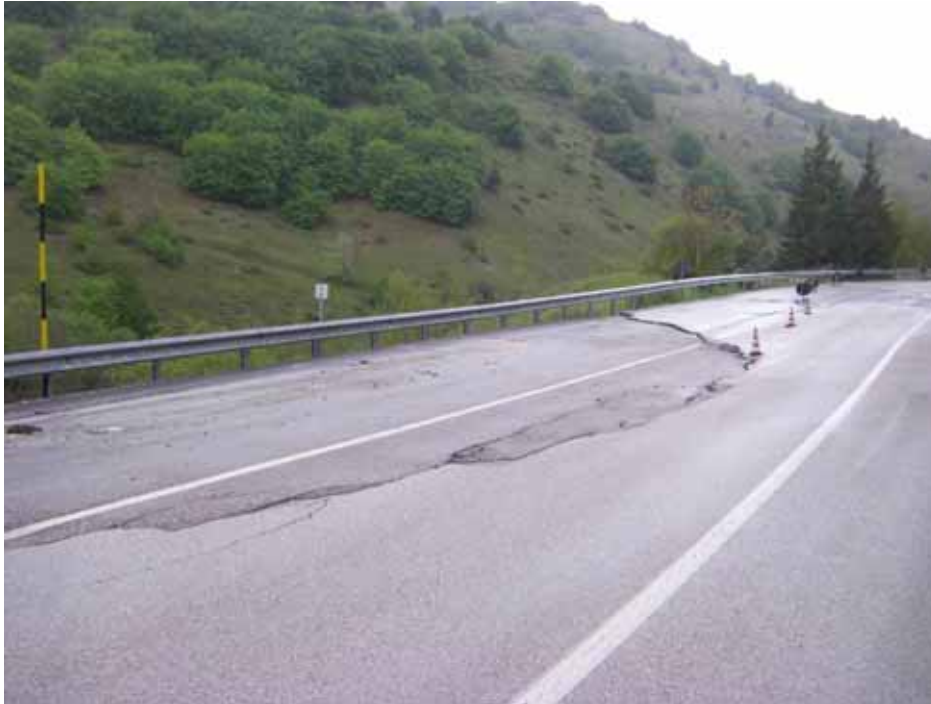
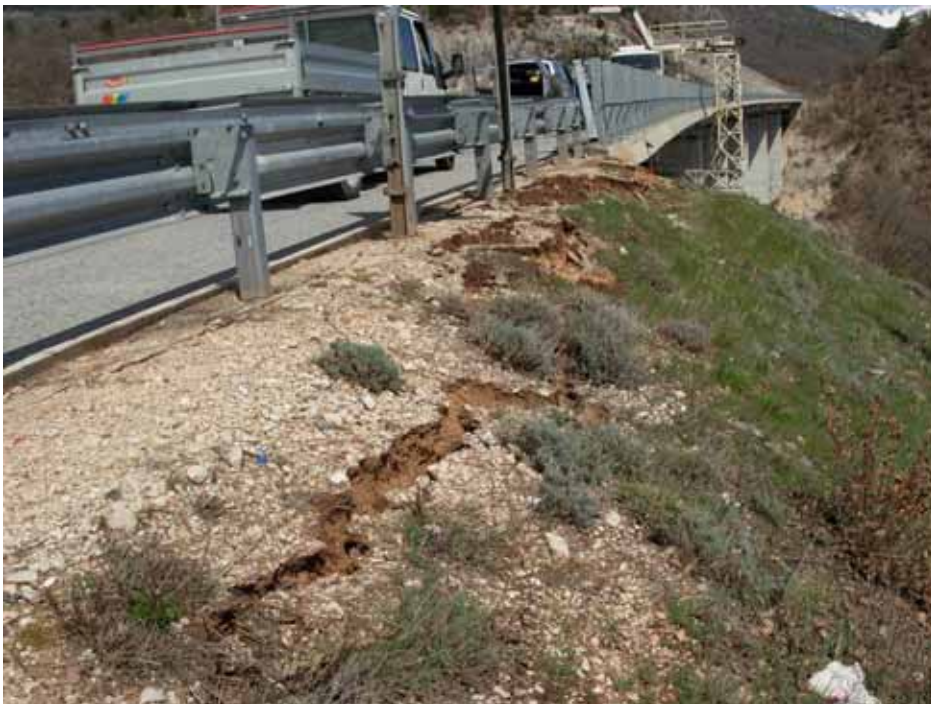
Other types of slope movements, generally affecting artificial material and anthropic deposits, occurred along the SS80 (Fig. 34), at San Giacomo, near Collebrincioni (Fig. 35) and along the access road to the Bazzano village.

*Fig. 34 – Above: Gravitational movement affecting the SS80 Road, km. 27,4.
Below: A small landslide in artificial material along the Highway A24, between L'Aquila Est and Assergi*

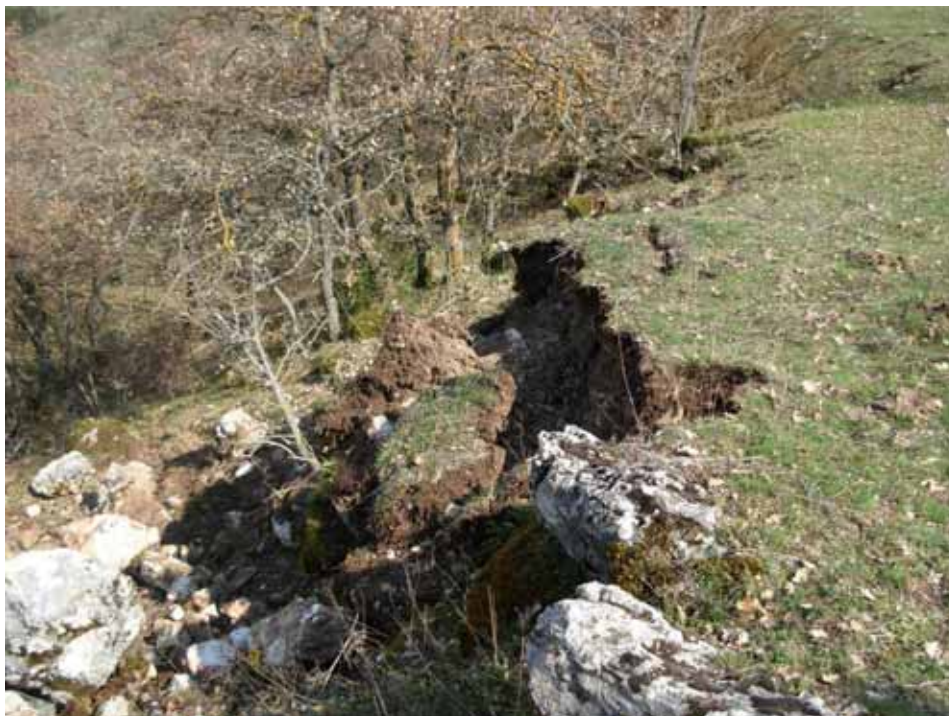
Fig. 35 – Gravitational movement near Collebrincioni

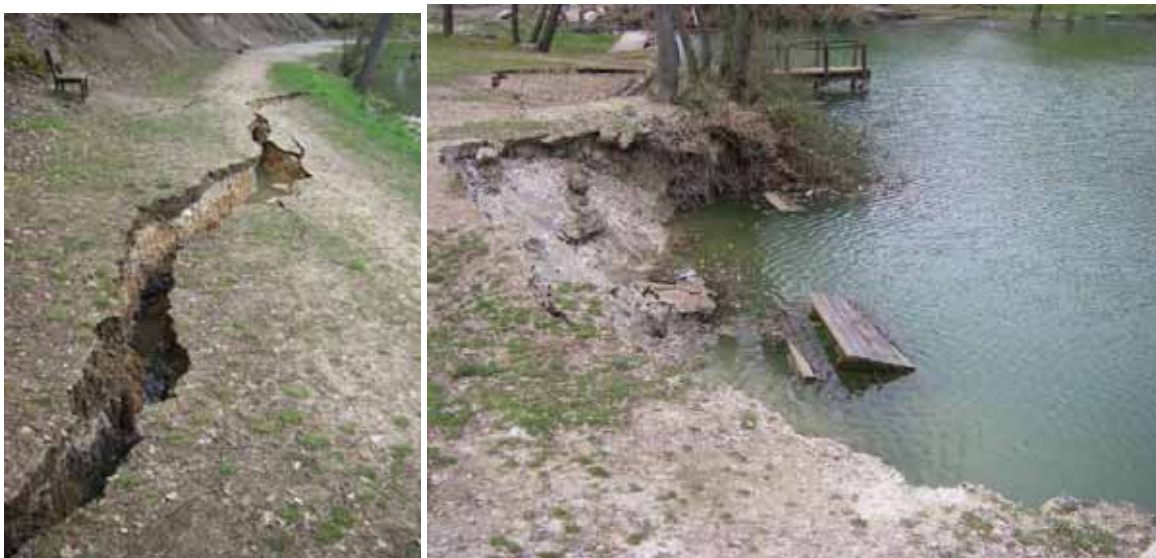
Around the Lake Sinizzo, near San Demetrio ne' Vestini, very impressive ground failures along the whole shoreline were observed (see front cover and Fig. 36). Their post-seismic evolution was very high. In the other sinkholes of the area (generally empty of water) no remarkable effects were found.

Fig. 36 – Ground failures along the shorelines of Lake Sinizzo banks

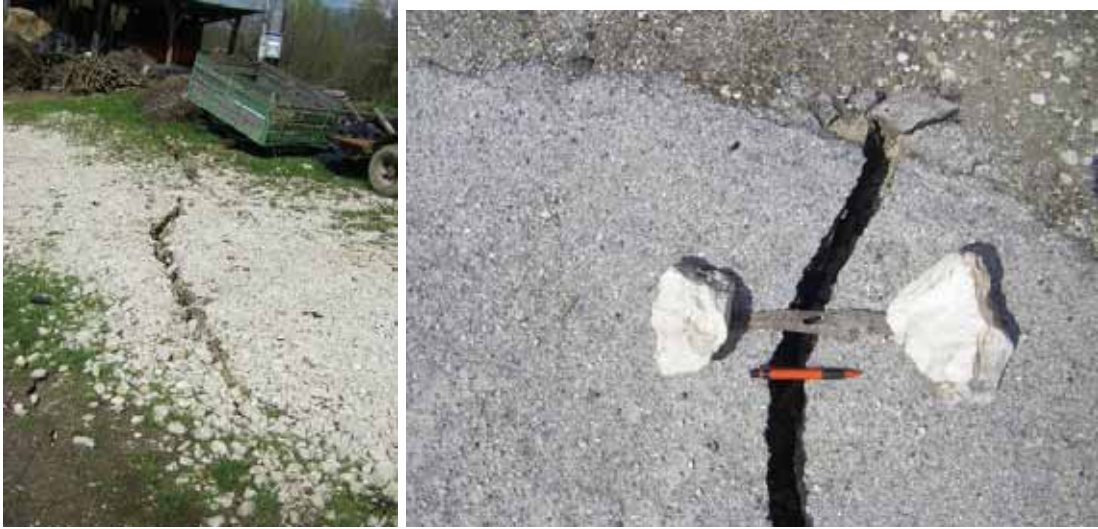
Besides the fractures previously described as primary effects, many fractures have been induced by the shaking in the ground as well as in paved roads and in artificial works (Fig. 37). Two bridges on the Aterno River (near Onna, Fig. 38 and near Fossa, Fig. 39) collapsed by the progressive ground failures of the embankments.

Fig. 38 – Onna: fractures in artificial material and in paved road near a bridge on the Aterno River.

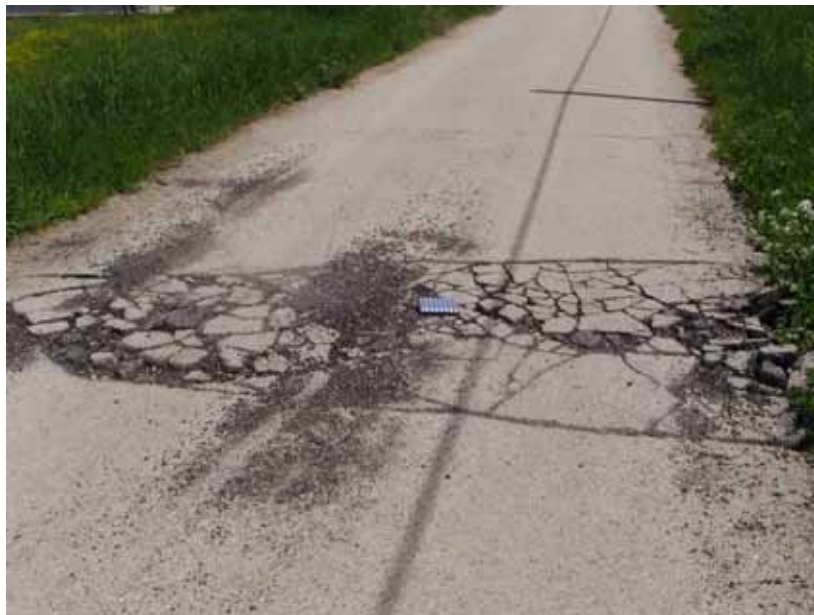
Fig. 39 – Fossa: fractures in paved road near a bridge on the Aterno River.

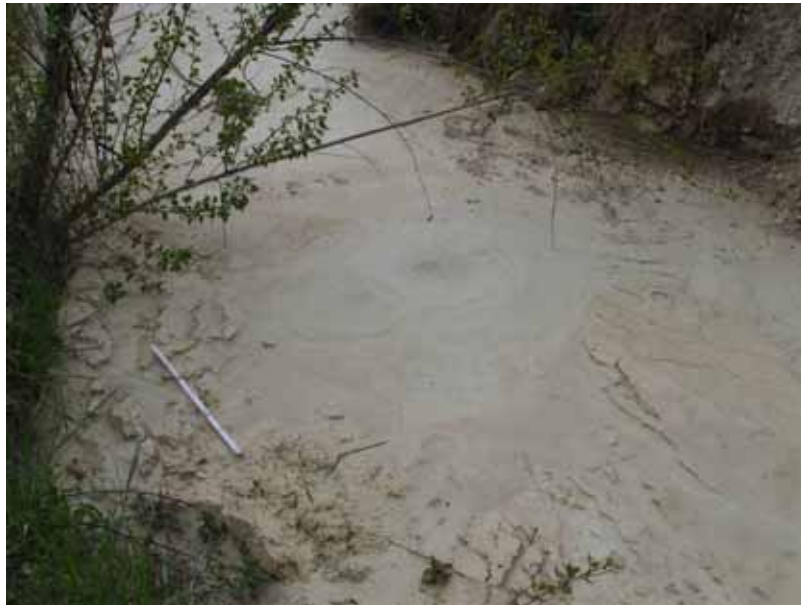
Modest evidence of liquefaction (flat sand volcanoes less than one meter in diameter) were found in a quarry at the north-eastern border of the Bazzano industrial area (Fig. 40).

Fig. 40 – Liquefaction in artificial material in the industrial area of Bazzano

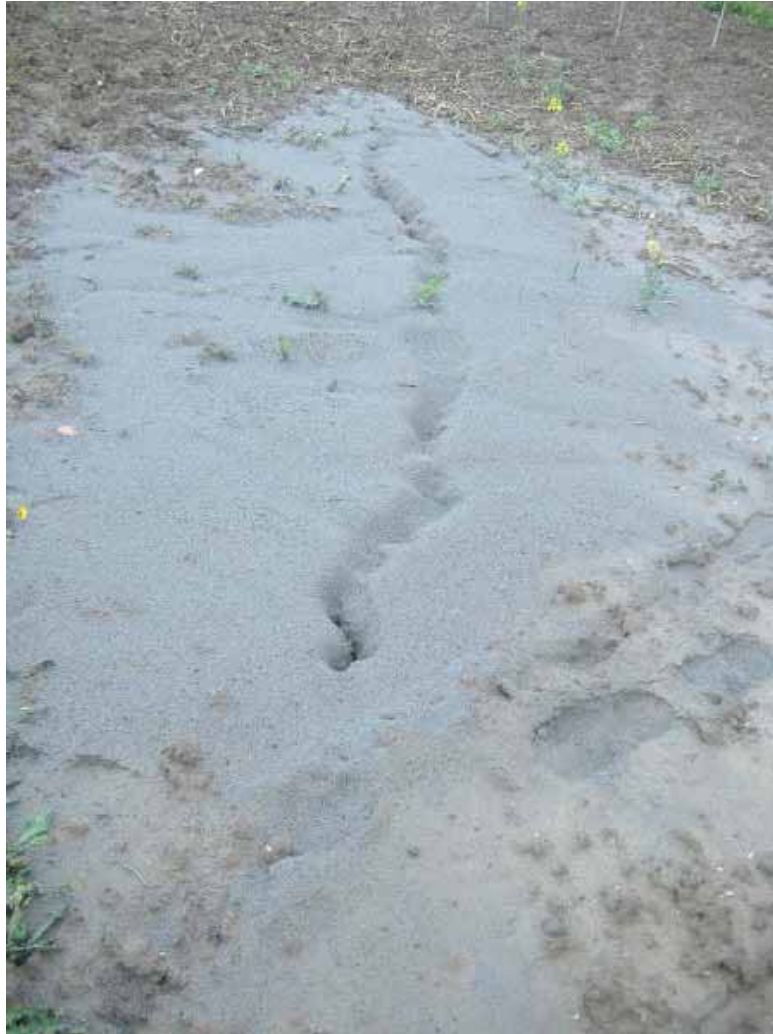
Another remarkable liquefaction feature was found in Vittorito (near Sulmona), hence relatively far from the epicenter, by the geologists of the Abruzzo Region River Basin Authority (Fig. 41).

Fig. 41 – Mud/sand volcano near Vittorito (courtesy by G. Pipponzi, AdB Abruzzo),

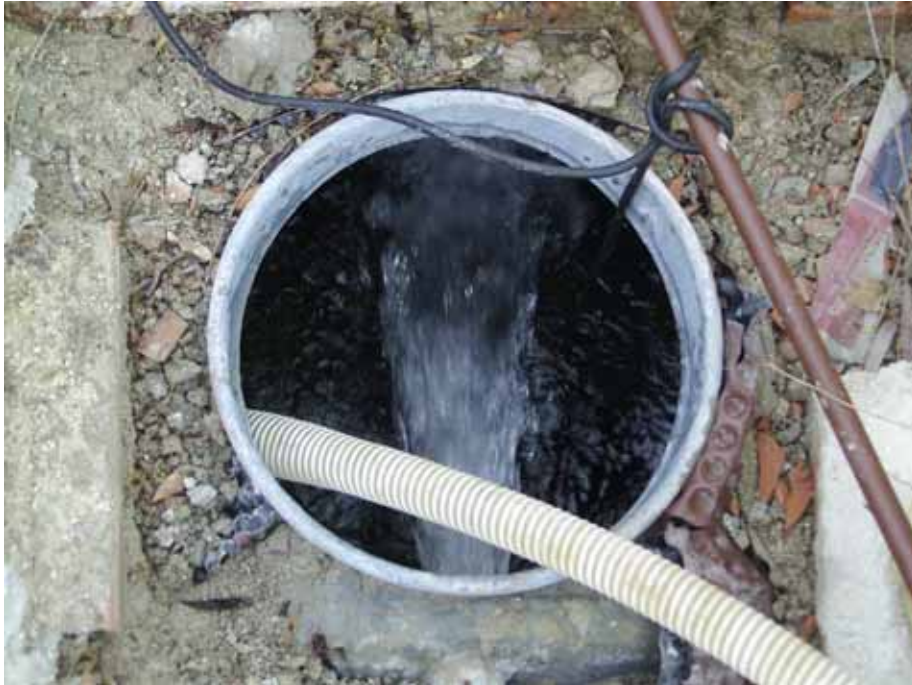
At Tempera were recorded temporary effects of turbidity, and significant changes of water discharge (Fig. 42). Springs disappeared or shifted for some hundreds of meters. A shallow well ran dry.

Fig. 42 – An increase in water discharge was recorded in local springs at Tempera
