Fire in a chemical plant (Venezia, Italy)

Lessons Learnt from INDUSTRIAL ACCIDENTS. 15th Seminar. IMPEL

24 May 2023

TOPIC: Environmental monitoring and decomposition of products in smokes

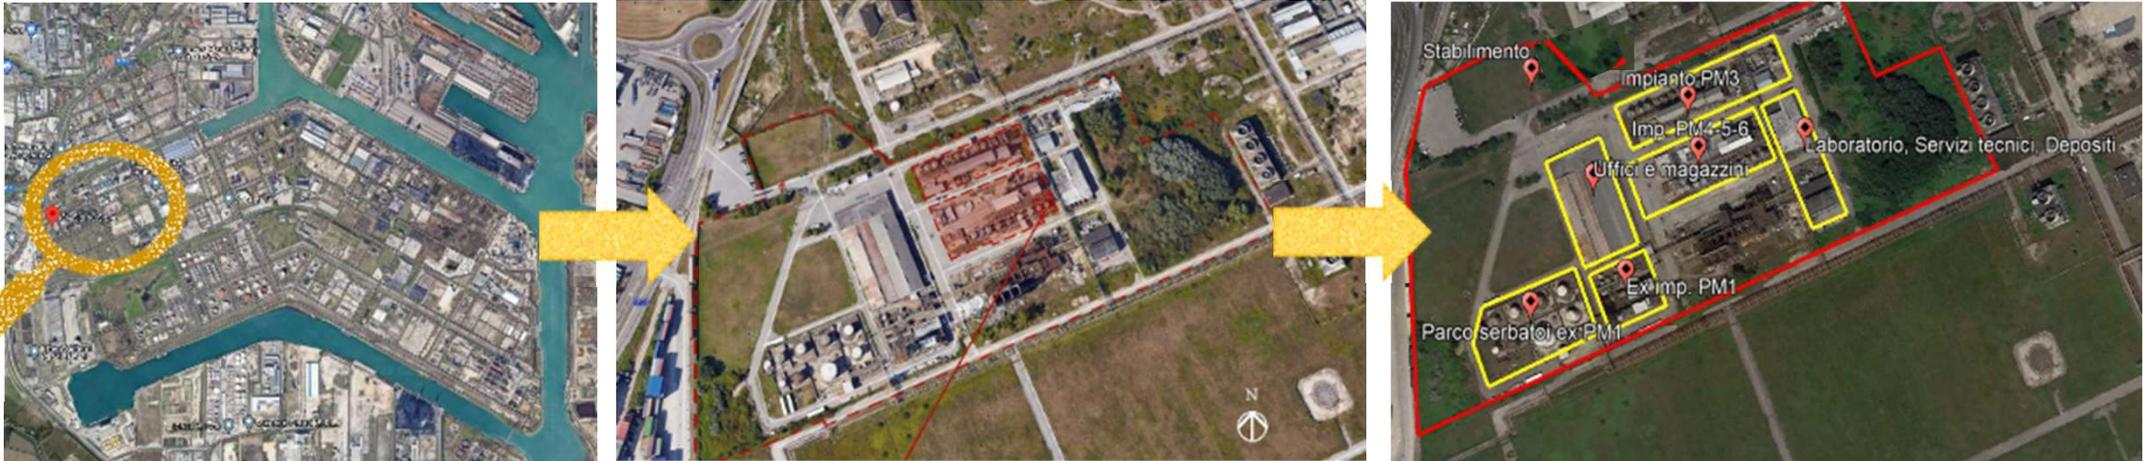
The site of the industrial establishment

The area within a **two-kilometers** include **industries** and populated **buildings**, **airport**, **port**, **lagoon**

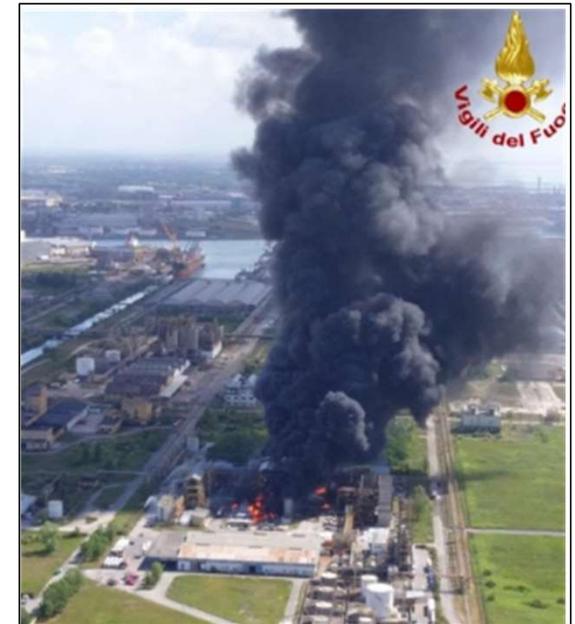
Accident dynamic

The accident occurred in the **morning** during **modification** works, by an **external firm**, which was connecting **tank TK 2.2 to the wastewater network**

One hour **before** the event, these **workers had cut the pipe** that was being worked on

The event occurred when **the cut pipe was being sealed**, while an **electric arc welder** was in use

The **trigger** gave rise to the **explosion and catastrophic rupture** of the atmospheric tank

An **internal domino effect** was generated, in a succession of **fires and explosions**

- ✓ A risk analysis on all **changes** (**preliminary** risks, risks during **implementation** and risks during **operation**), resulting in the identification of **preventive and protective measures** to be implemented, as well as the related **training activities** for the staff
- ✓ Always keep systems subject to **modification works under isolated and inert conditions** to prevent the environmental conditions from changing, which could lead to the **formation of potentially flammable and/or explosive atmospheres**

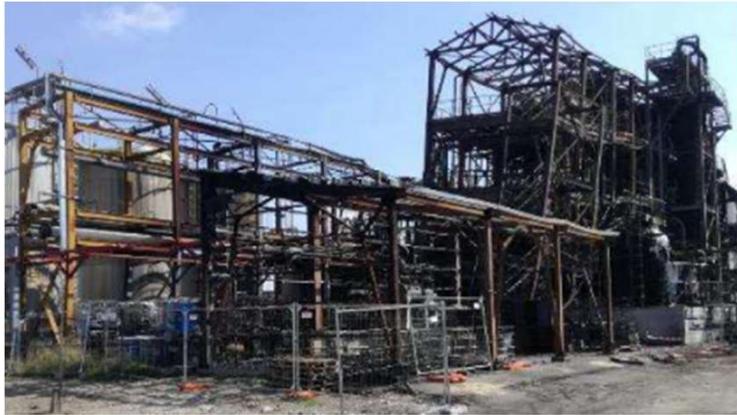
<< Plant Unit #3

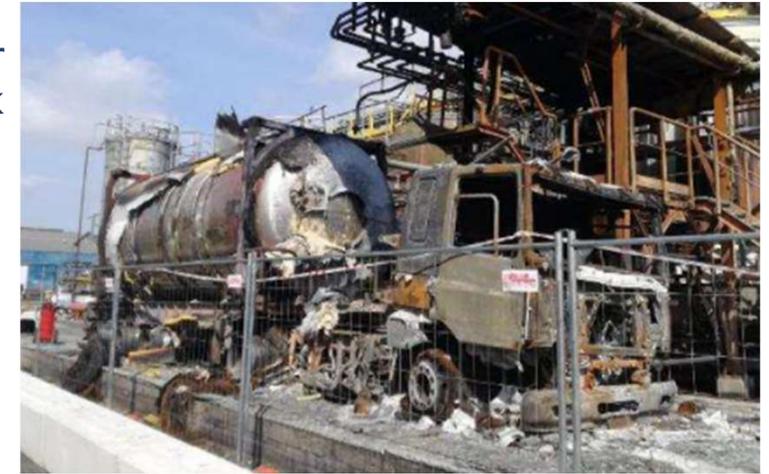
Tanker Truck
>>

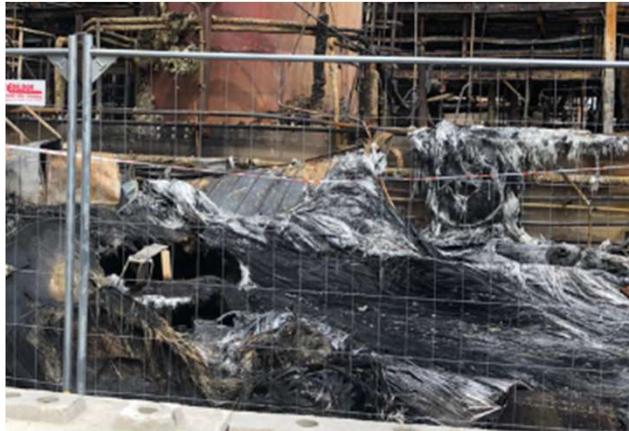
Collapsed Fiberglass tank

IBC and DRUMS
>>>>

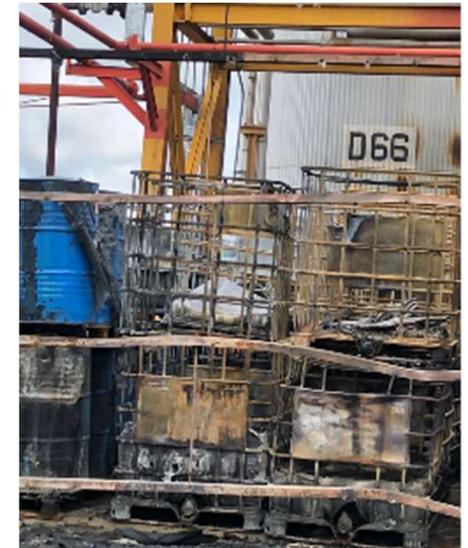
<<<<
Plant Unit #6
