Date: 20th May, 2011

GEOLOGICAL PRELIMINARY FIELD REPORT OF THE LORCA EARTHQUAKE (5.1 M_w , 11TH MAY 2011)

Translation from the original report in Spanish

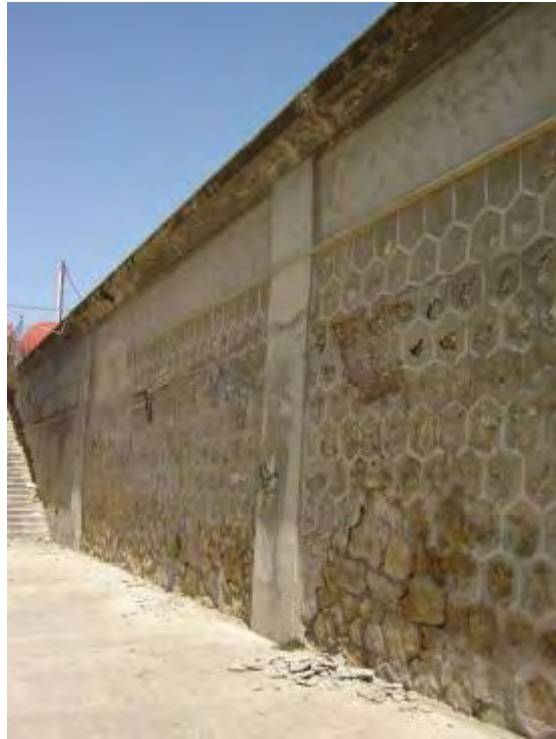
In the village of Lorca we walked along the Guadalentín river banks where the FAM crosses the river. In this area the river course is flanked by two masonry walls more than 6 m high and a concrete channel passing through the city (Fig. 3.1). The orientation of the walls is N113° E in the western section and N140° E in the eastern part. The walk was 600 m long on both margins and no evidences of ground breaking associated with fault displacement were found. The numerous cracks present on the walls do not show movements throughout the wall, and they do not have continuity in the bed of the valley. It is noteworthy that the north wall (Fig. 3.2) has more cracks and pill offs than the southern wall that is only affected by several cracks.

Figure 3.1. Masonry wall along Guadalentín river bank passing through Lorca, used as a marker.

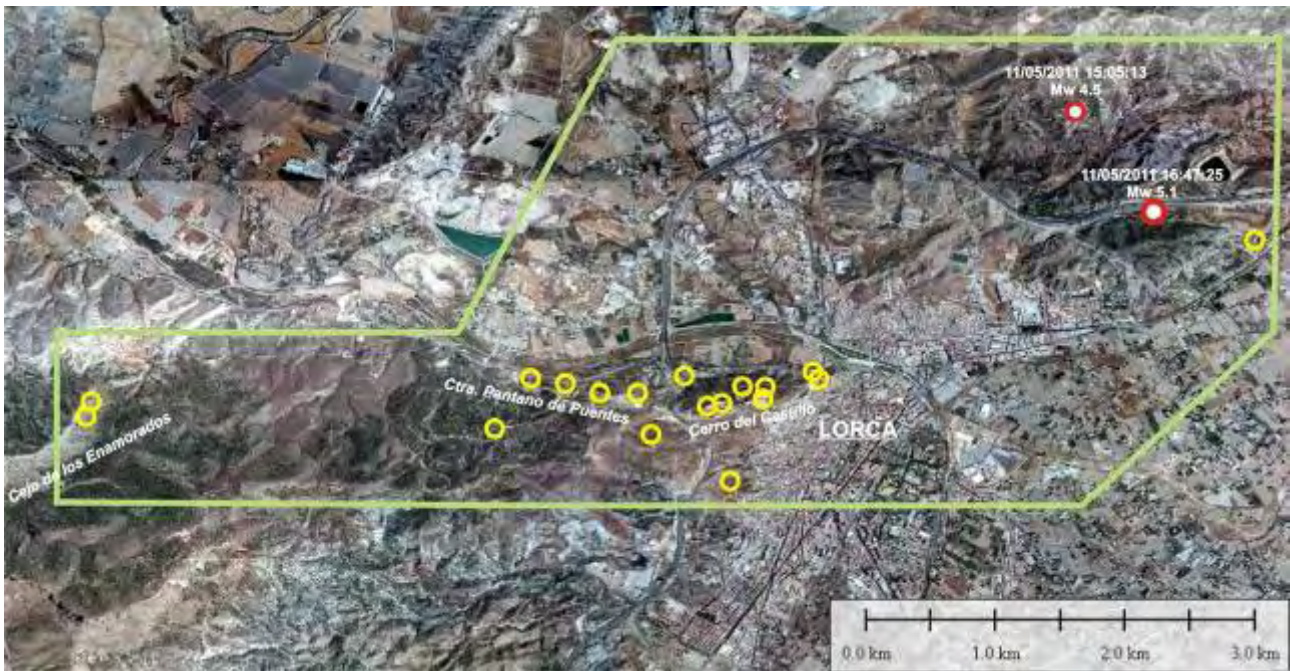
Few of the instabilities produced by the earthquake can be referred as significant in the sense that they have produced some damage in buildings and temporal road-cuts.

In particular, at the easternmost point of Lorca's Castle cliff, a fallen rock-block has destroyed part of the wall enclosing the patio of a house. Alike, on the road up-the-hill to the castle few rock-falls have badly damaged the pavement. A similar situation has taken place on the road to the Pantano de Puentes, which was temporarily closed to traffic. It is remarkable that on Friday 13th (aprox 24 h after the earthquake) both situations were already solved and driving was possible with relative normality.

Figure 4.1: Situation of the main slope instabilities identified in the field survey.

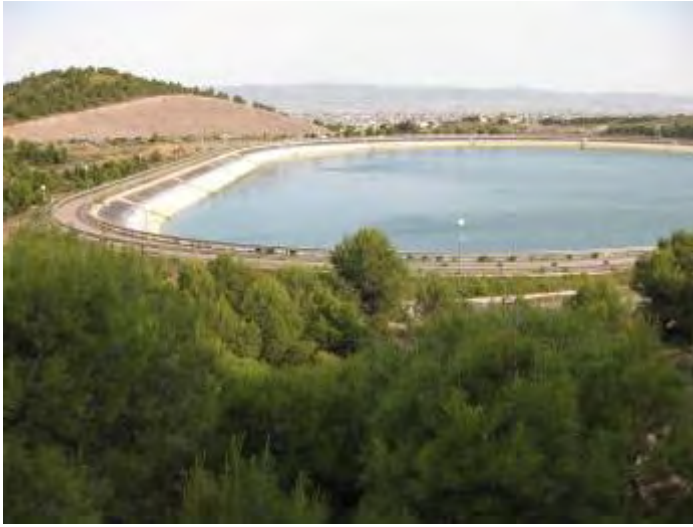
Figure 4.7: Irrigation pool situated nearby the epicentres of the 11 May earthquakes. Neither damage was observed in this area, nor instabilities on the talus on the background.

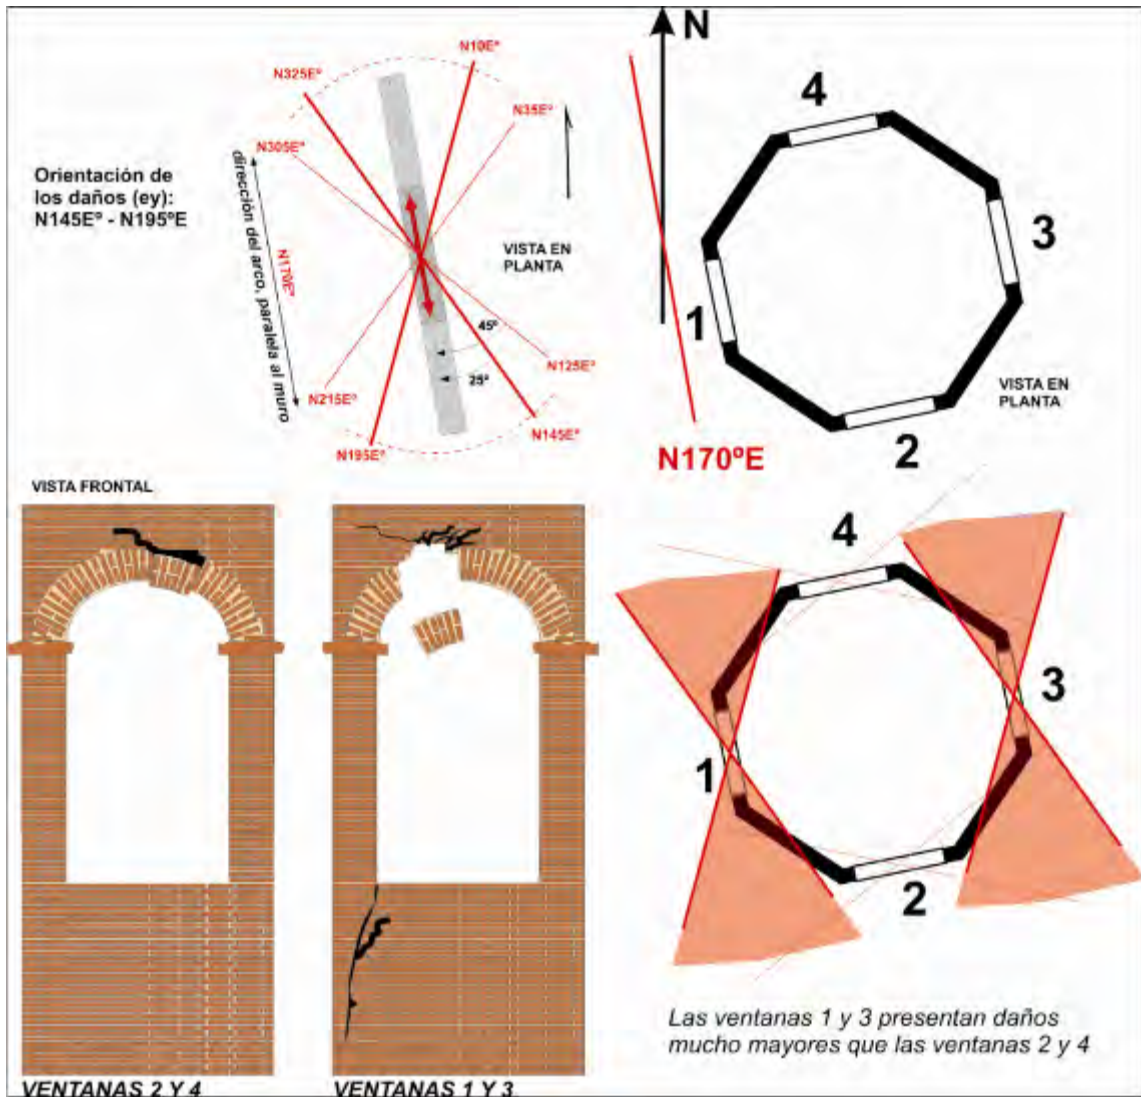
Figure 5.8: Example of analysis of deformation structures and the results of the orientation assessment of the strain (San Juan's Church).
